**Landslides triggered by the 1946
Ancash Earthquake (Peru) and geologic
controls on the mechanisms of initial
rock slope failure**

A thesis
presented to the University of Waterloo
in fulfillment of the
thesis requirement for the degree of
Master of Science
in
Earth Sciences

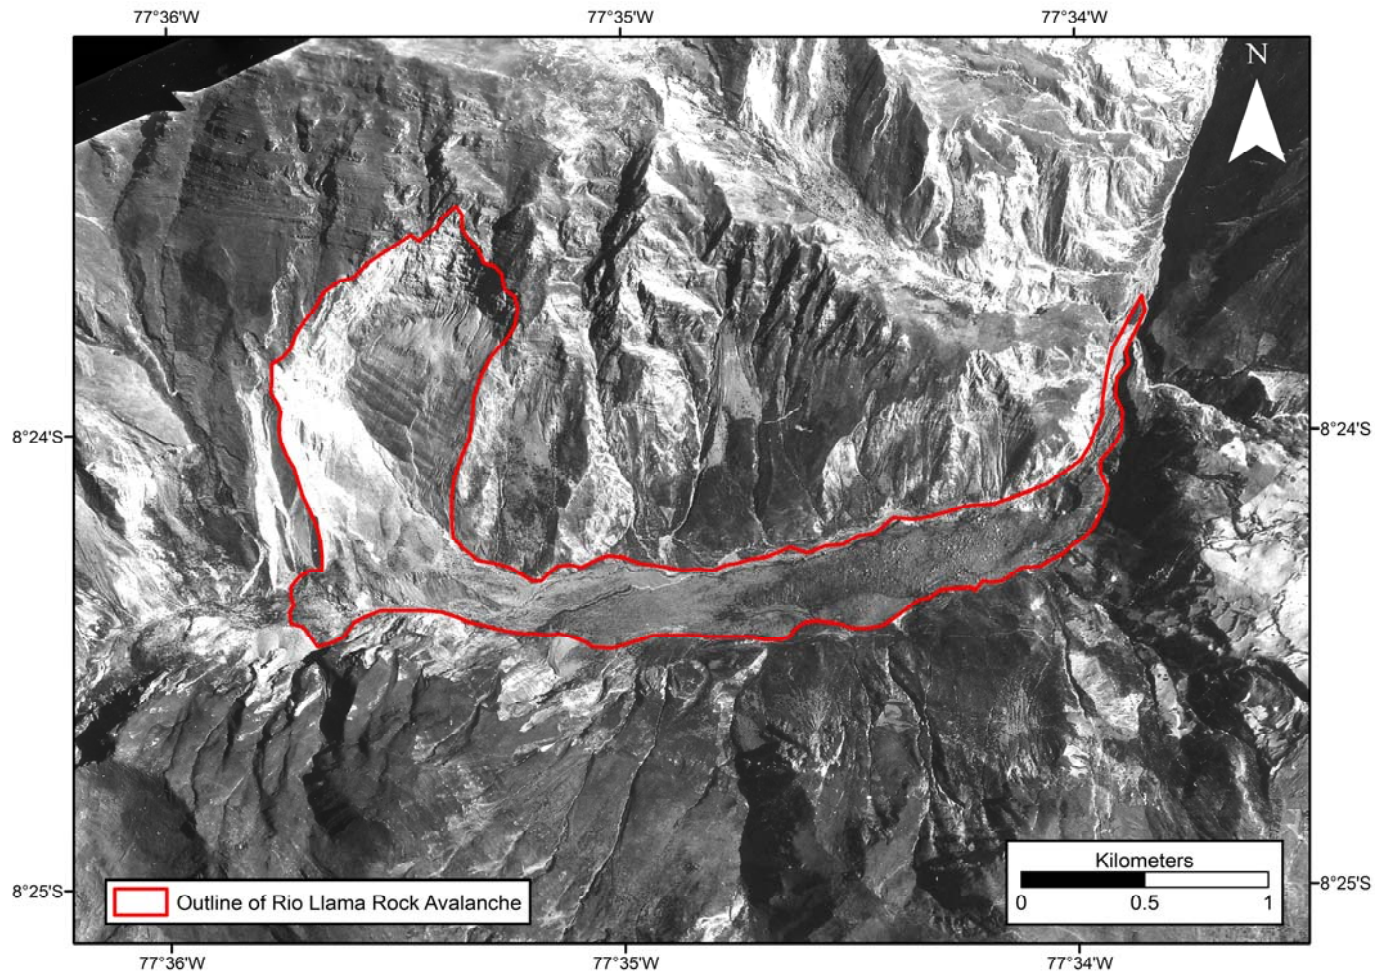
Figure 2. 13: Aerial photograph (1370PMW-M255-31448) showing the Rio Llama rock avalanche

Failure initiated on a southwest dipping bedding plane and was directed south by topography until it reached the valley bottom where it flowed downstream to the east.

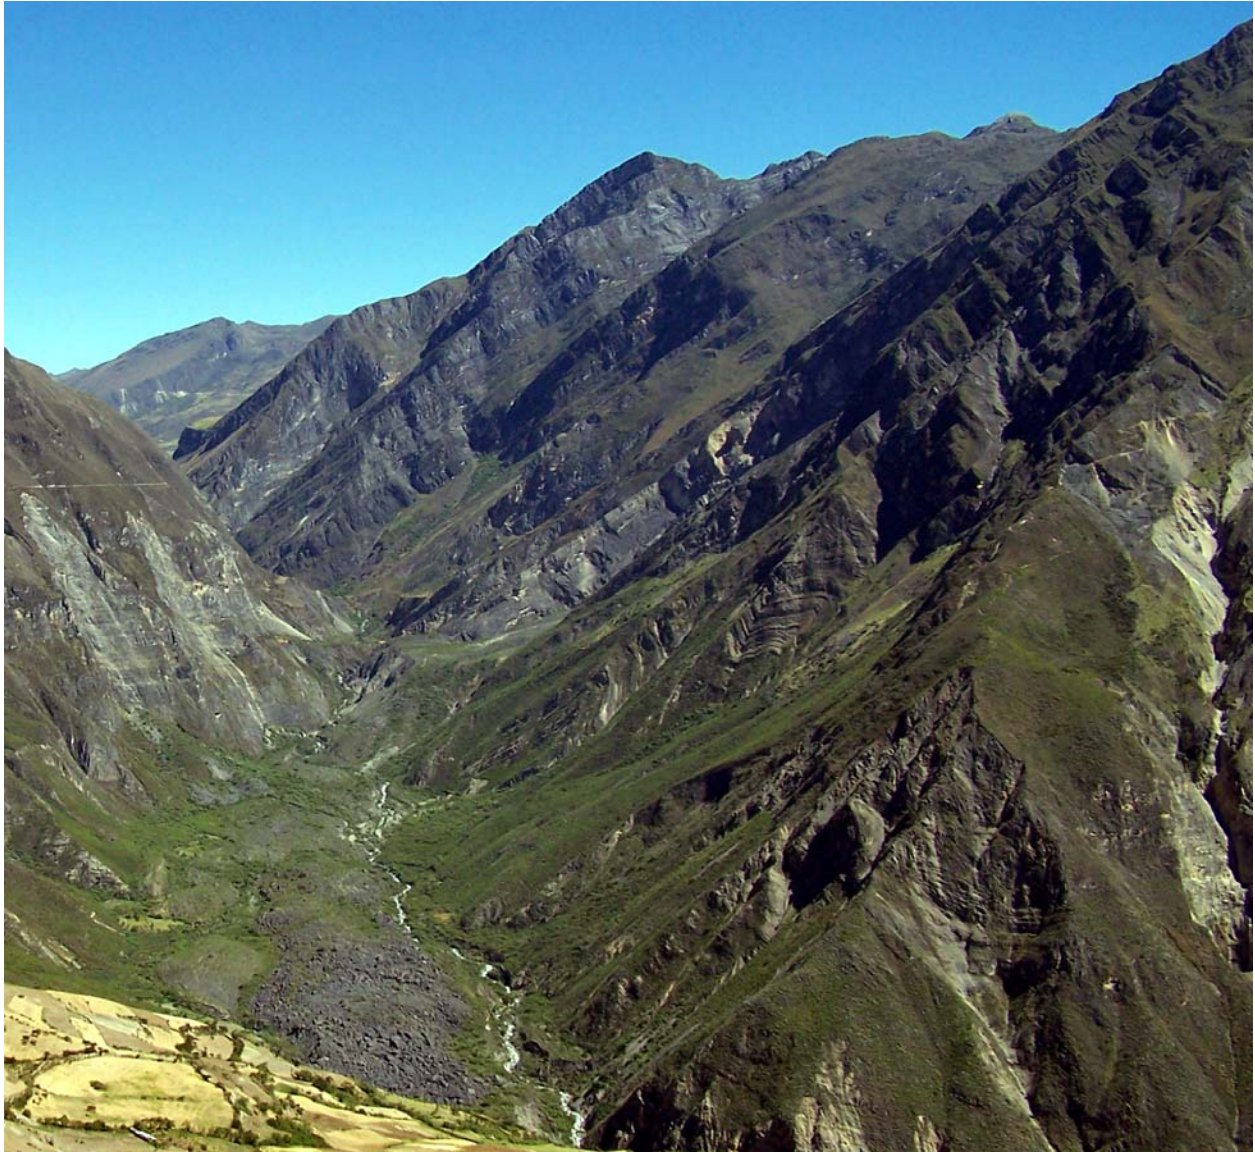
Figure 2. 14: The Rio Llama rock avalanche, looking west

Partial view of the southwest dipping bedding planes in the source area of the Rio Llama rock avalanche on the slope to the right. Debris from the Rio Llama rock avalanche covers the valley bottom (foreground).

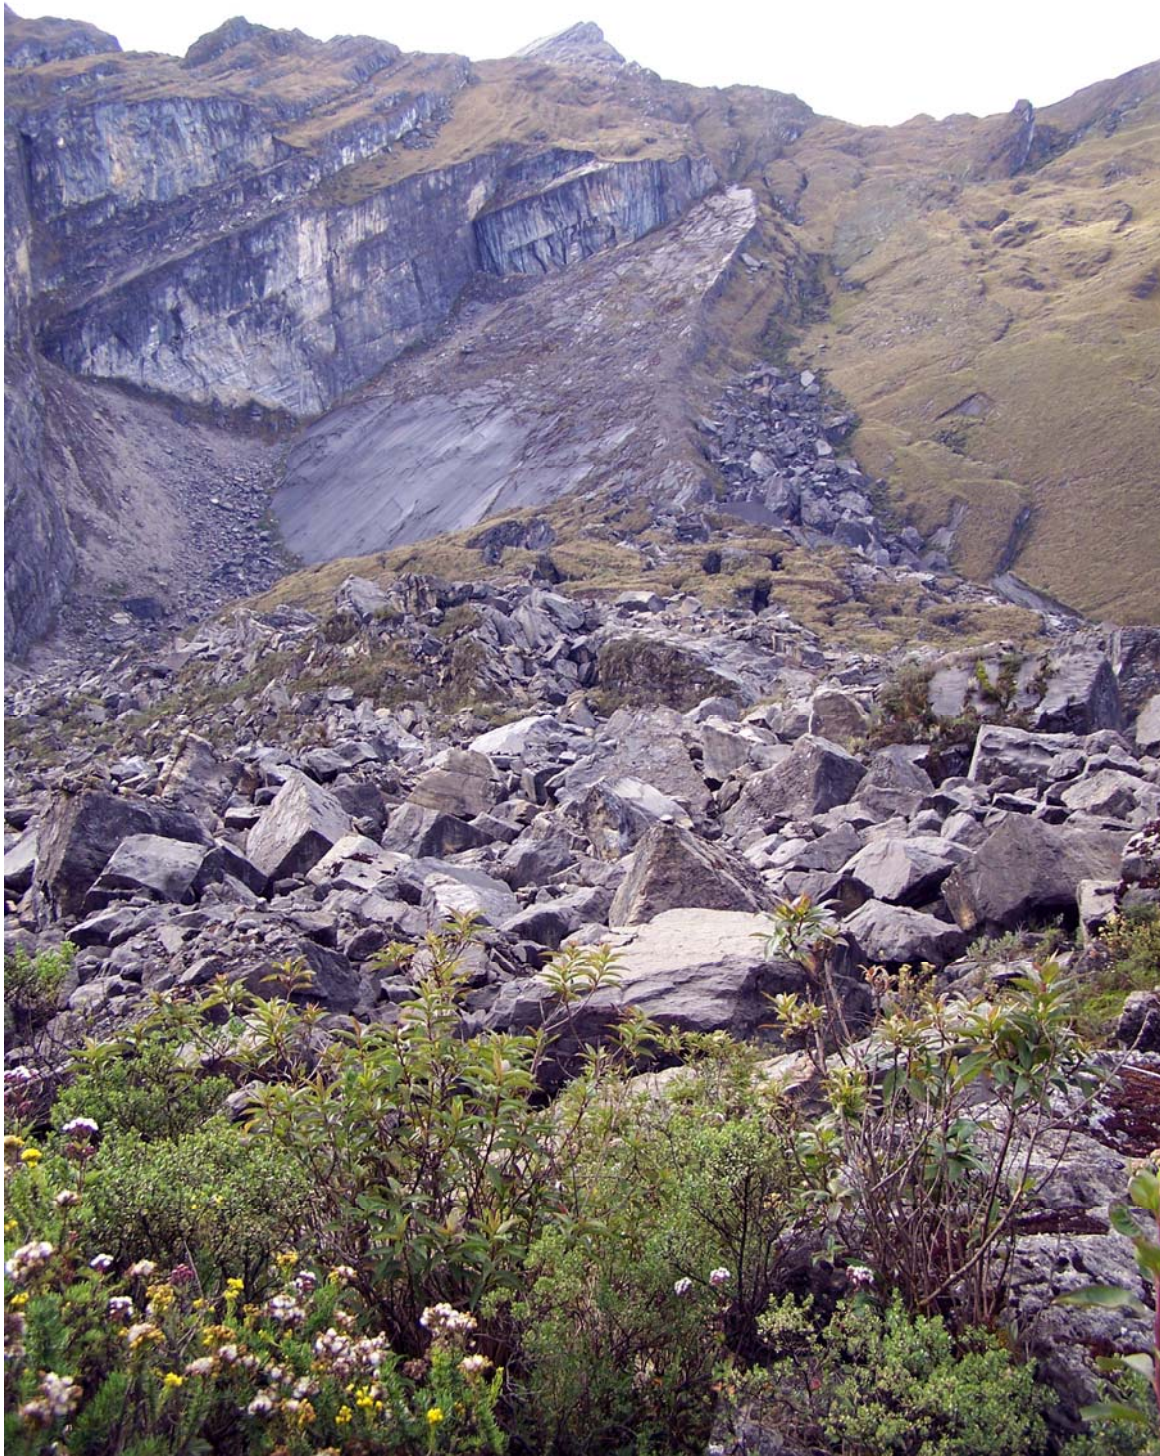
Figure 2. 15: The Suytucocha rock avalanche, looking north

The source slope is underlain by limestone, shale and calcareous sandstone of the Parihuanca, Chulec and Pariatambo formations (Sanchez Fernandez, 1995) (Figure 2. 7). An average slope angle of 40° and slope dip direction of S 152° E was estimated for the source area (Table 2. 3). Field observations indicate that the Suytucocha rock avalanche is a wedge failure (Hoek and Bray, 1977) formed by the intersection of southwest dipping bedding planes and a set of east dipping discontinuities, in addition to a nearly-vertical southeast dipping set of discontinuities forming the backscarp (Figure 2. 15).

The Suytucocha rock avalanche is a wedge failure formed by the intersection of a set of southwest dipping bedding planes shown on the right and a set of east dipping discontinuities shown on the left. A nearly-vertical southeast dipping set of discontinuities forming the backscarp is also evident near the top of the source slope.

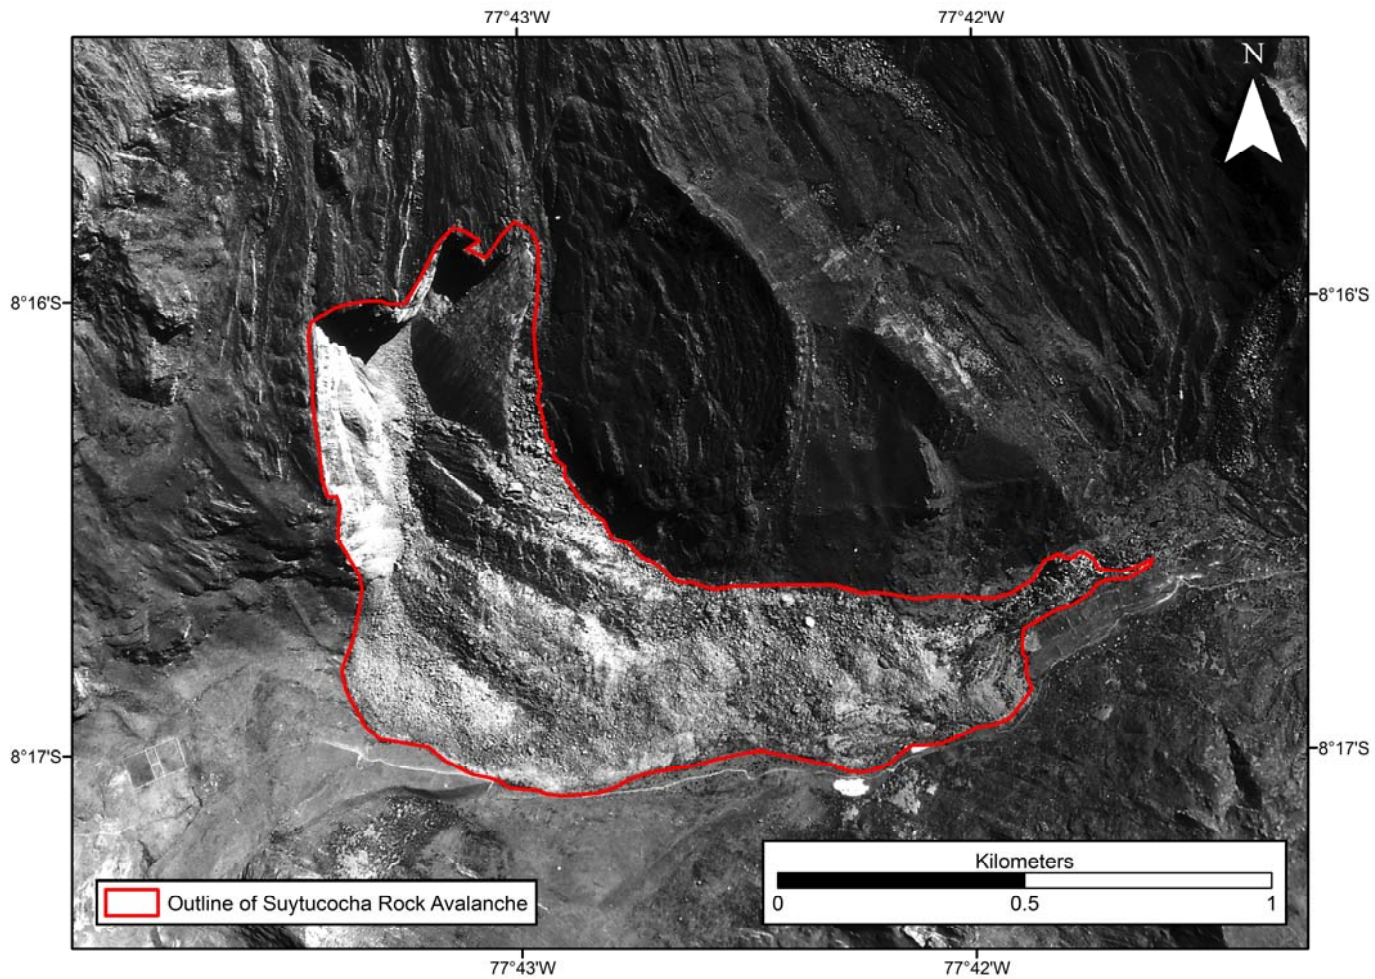
Figure 2. 16: Aerial photograph (1370PMW-M130-16416) of the Suytucocha rock avalanche

Wedge failure involves a southwest dipping bedding plane before descent in a southerly direction to the valley bottom due to the line of intersection. Debris is re-directed in the valley bottom downstream to the east.

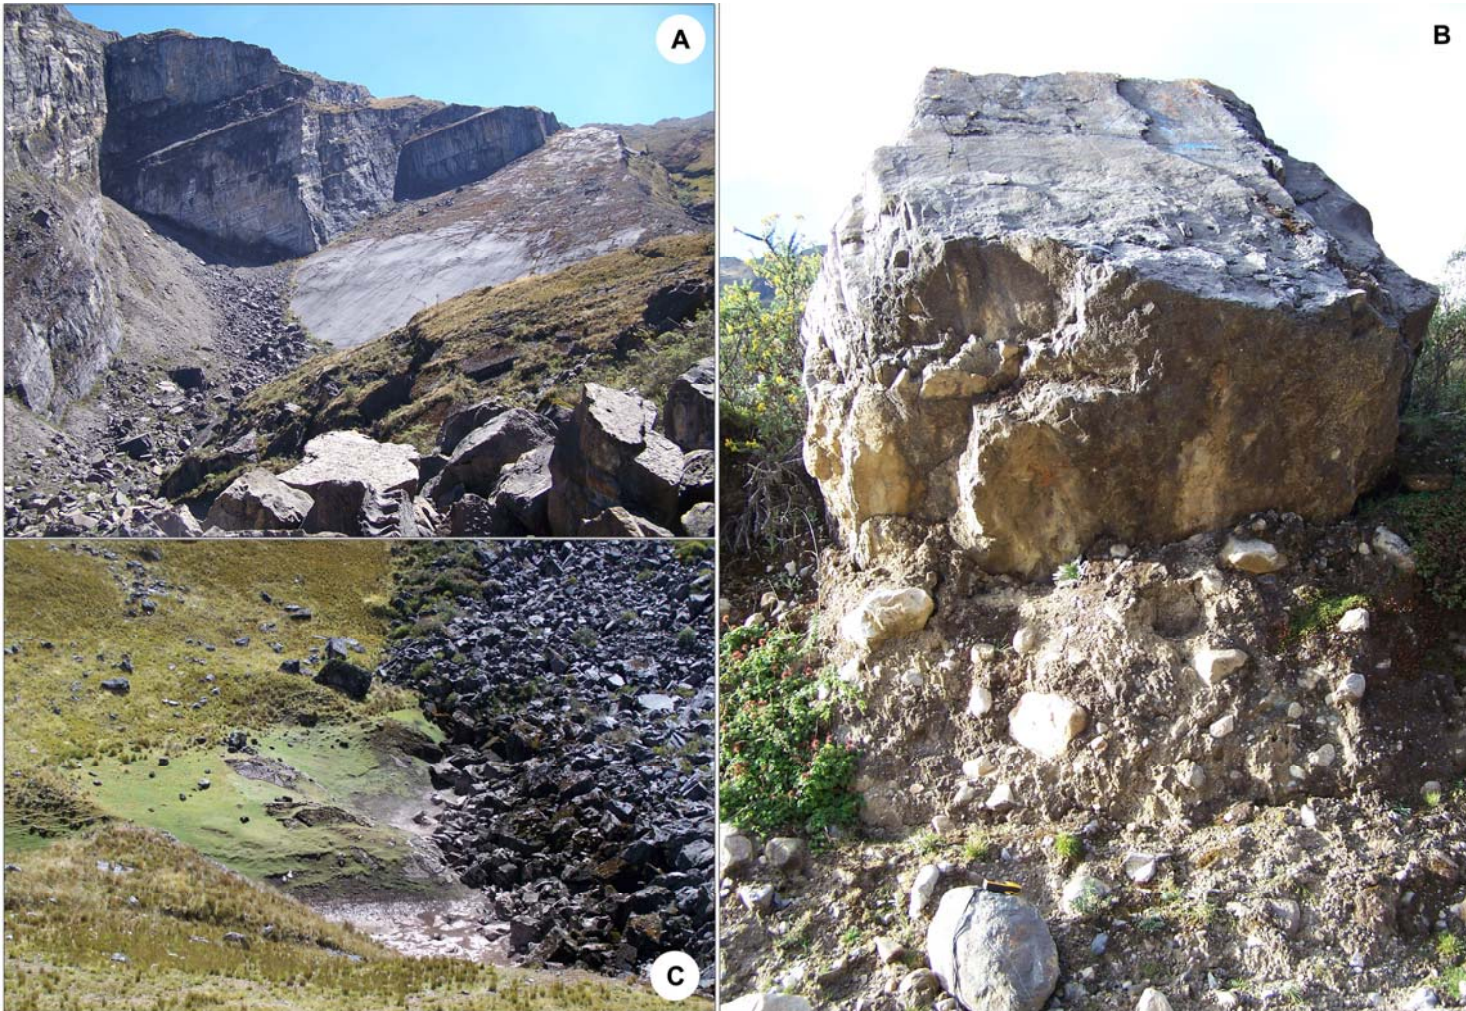
Figure 2. 18: Field observations at Suytucocha rock avalanche

A - Large amounts of land surface were preserved throughout the debris. B - A large boulder is shown overlying finer valley bottom sediments probably due to secondary movement. C - Evidence of a former lake/pond on the upstream boundary of the debris in the valley bottom.

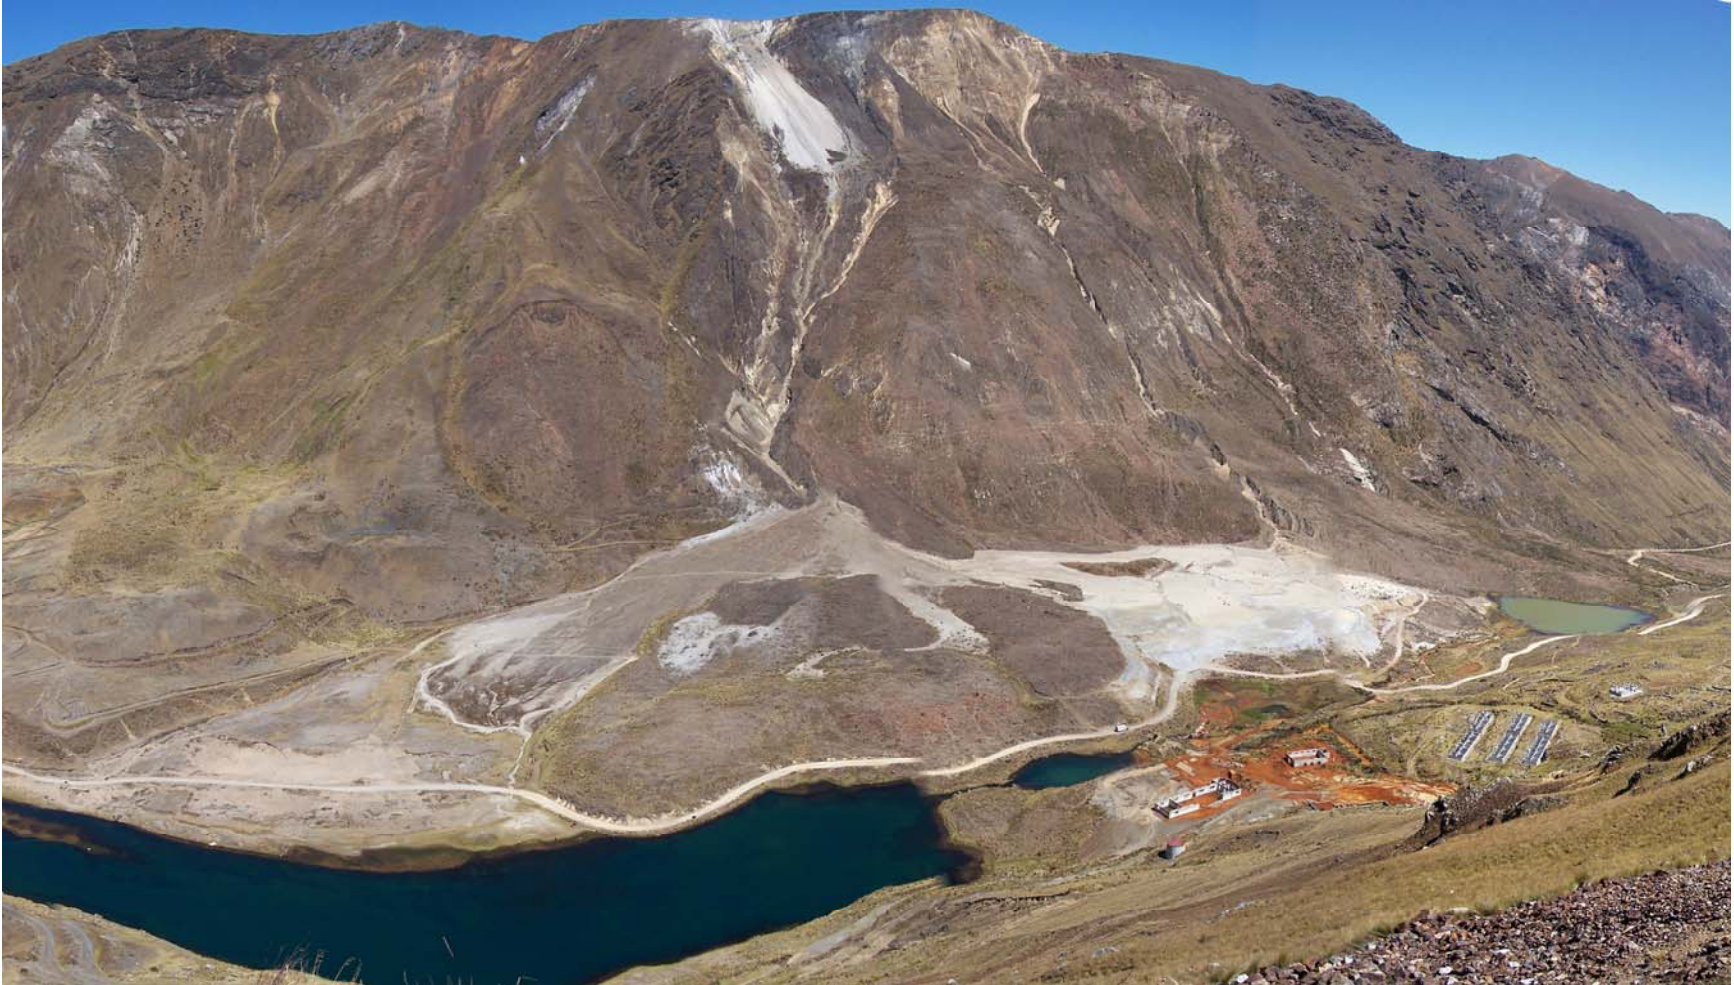
Figure 2. 23: The Pelagatos rock avalanche, looking south

Showing the debris which slid downslope to created a landslide dam in the valley bottom forming a number of ponds.

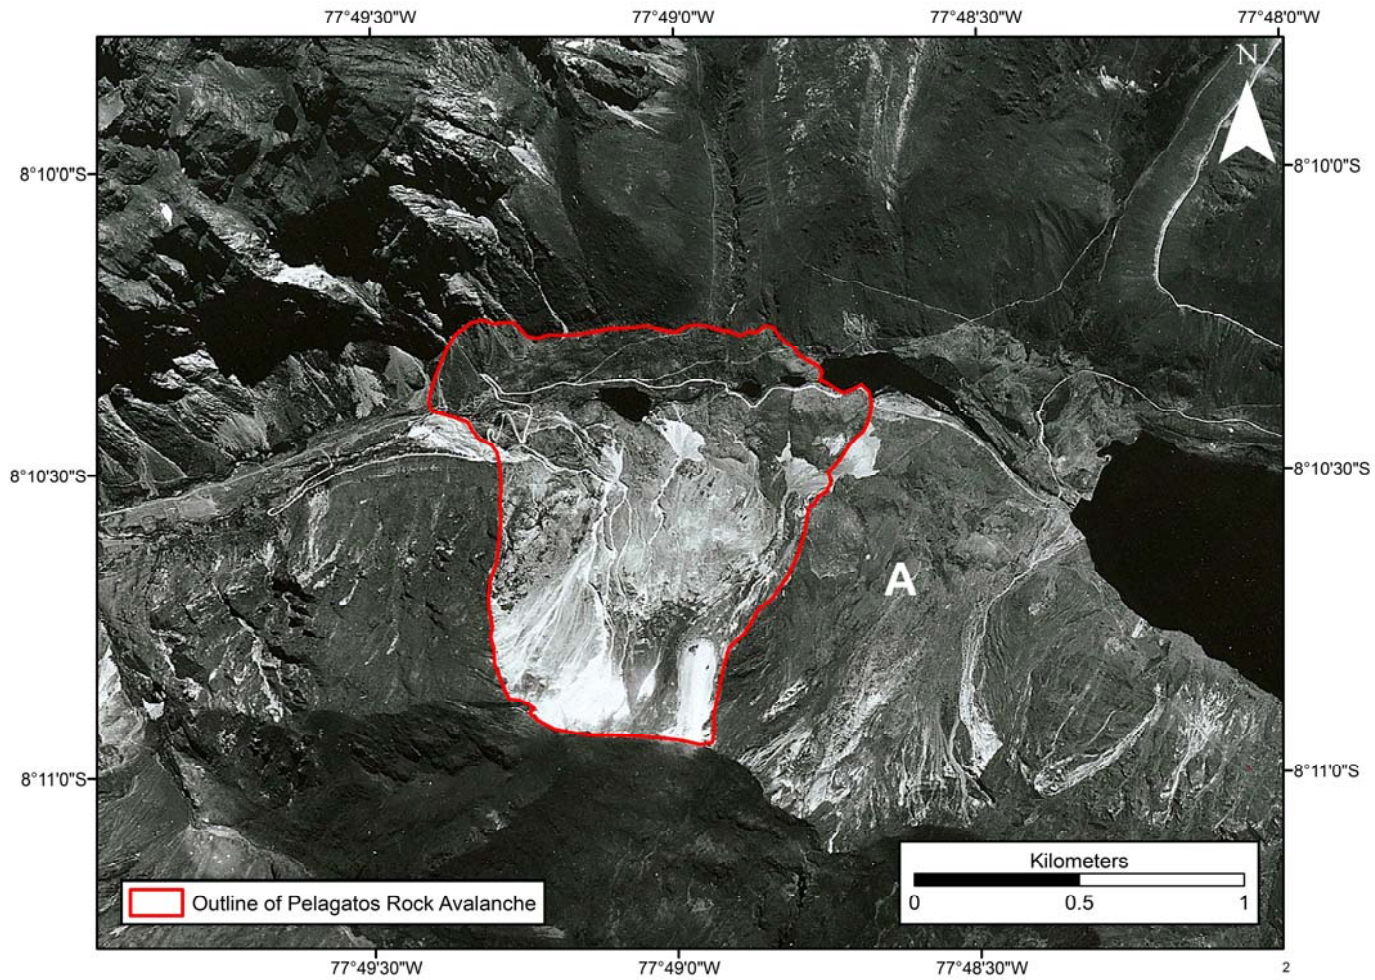
Figure 2. 24: Aerial photograph (1370PMW-M156-20024) of the Pelagatos rock avalanche

Extent of the failure is shown as well as the landslide dam which created a number of ponds in the valley bottom. Prehistoric landslide (A) referred to in text.

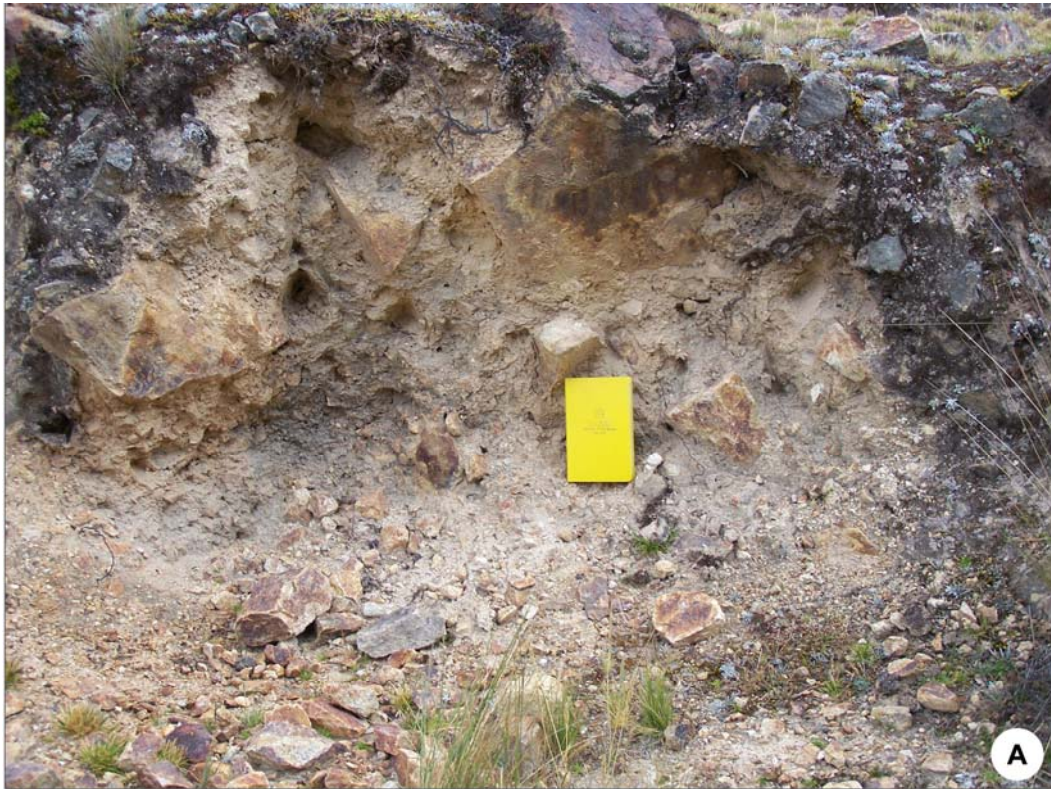
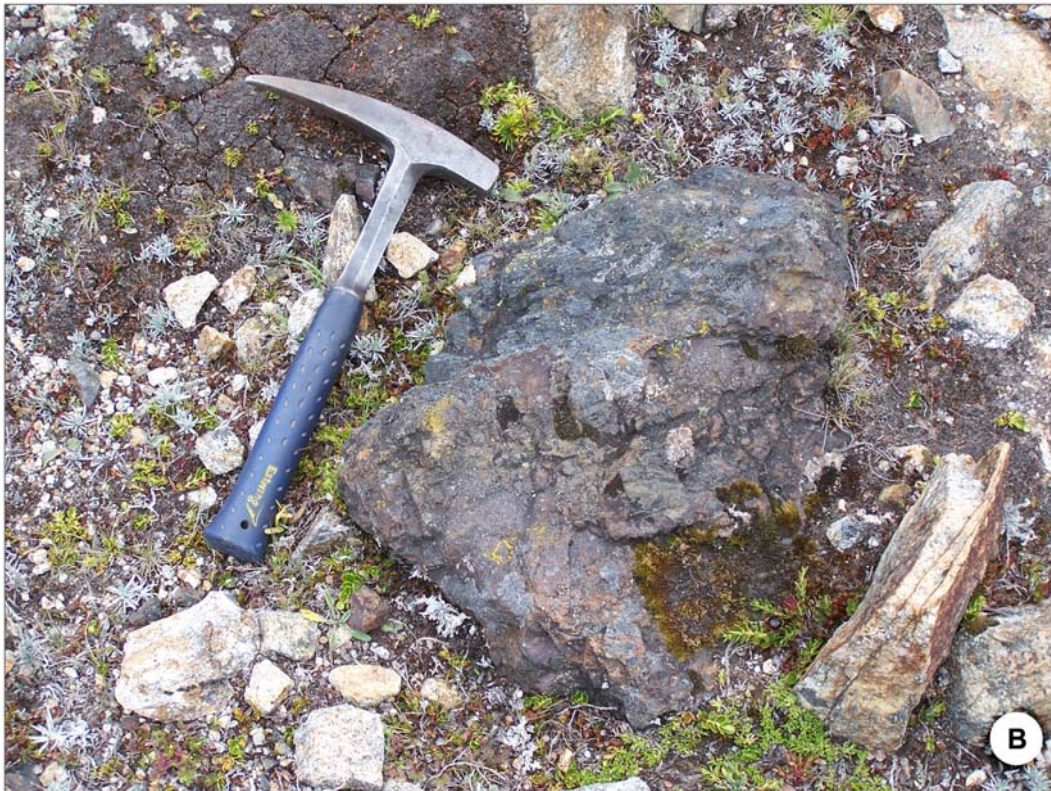
Figure 2. 25: Field observations of the Pelagatos rock avalanche debris

A - Debris of blocks within a finer matrix. B - Highly metamorphosed rocks within the debris.

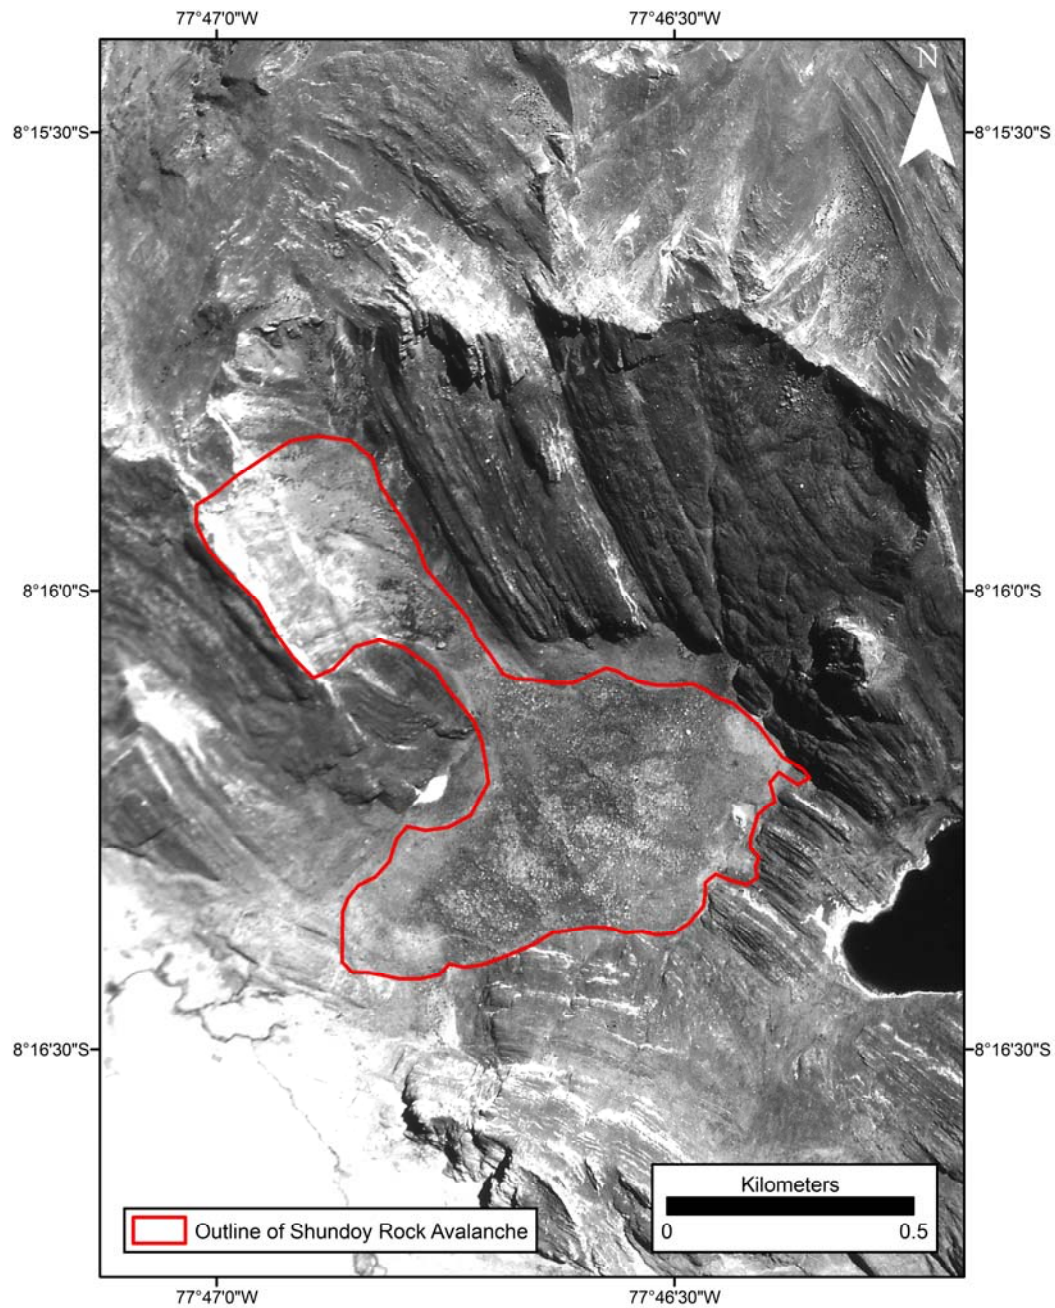
Figure 2. 26: Aerial photograph (1370PMW-M156-20027) of the Shunday rock avalanche

Initial failure of the Shunday rock avalanche occurred on northeast dipping bedding planes and debris diverted to the southeast by topography.

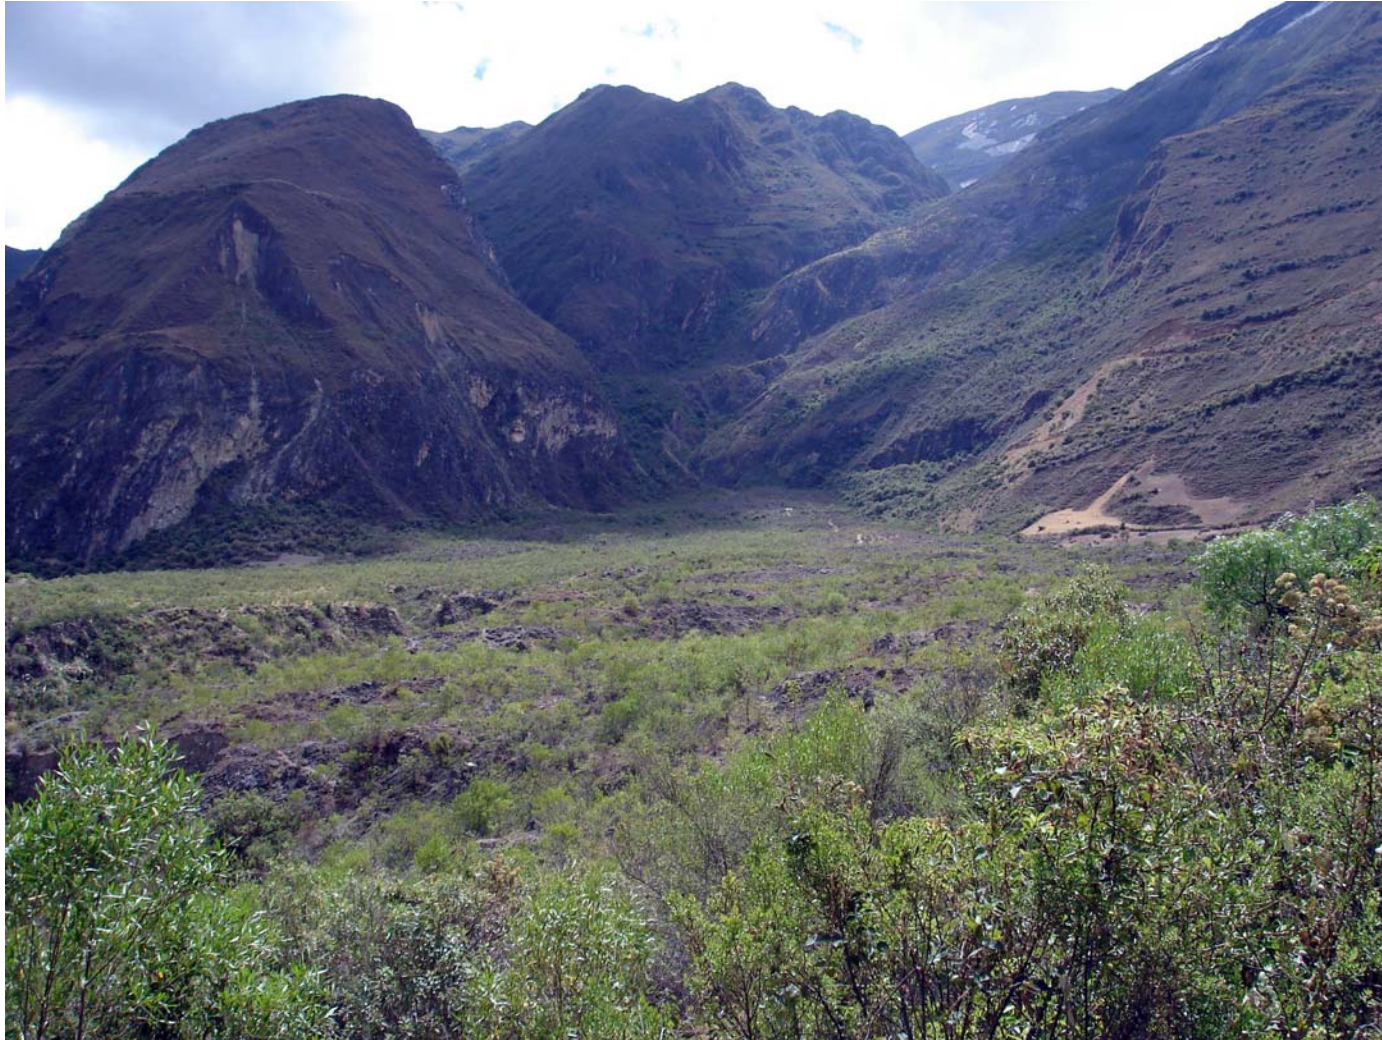
Figure 2. 27: The Acobamba rock/debris avalanche, looking north

View of the Acobamba rock/debris avalanche from the distal limit of debris showing location of initial failure at the top right which travelled down the valley covering the village of Acobamba in foreground.

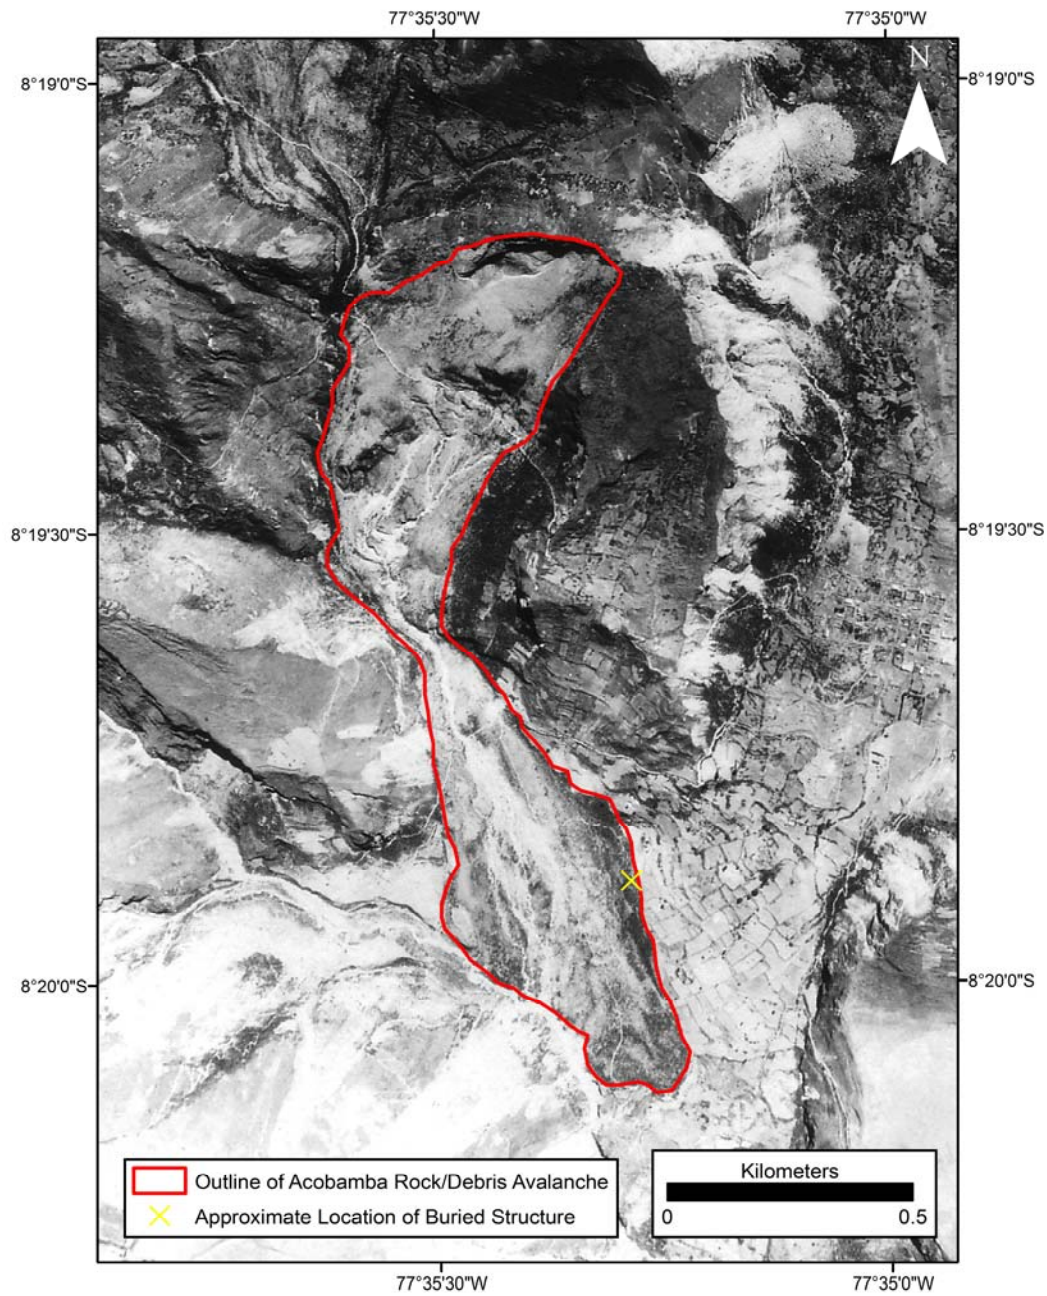
Figure 2. 28: Aerial photograph (1370PMW-M173-22501) of the Acobamba rock/debris avalanche
Location of the buried structure found along the eastern boundary of the debris is denoted by the yellow cross.

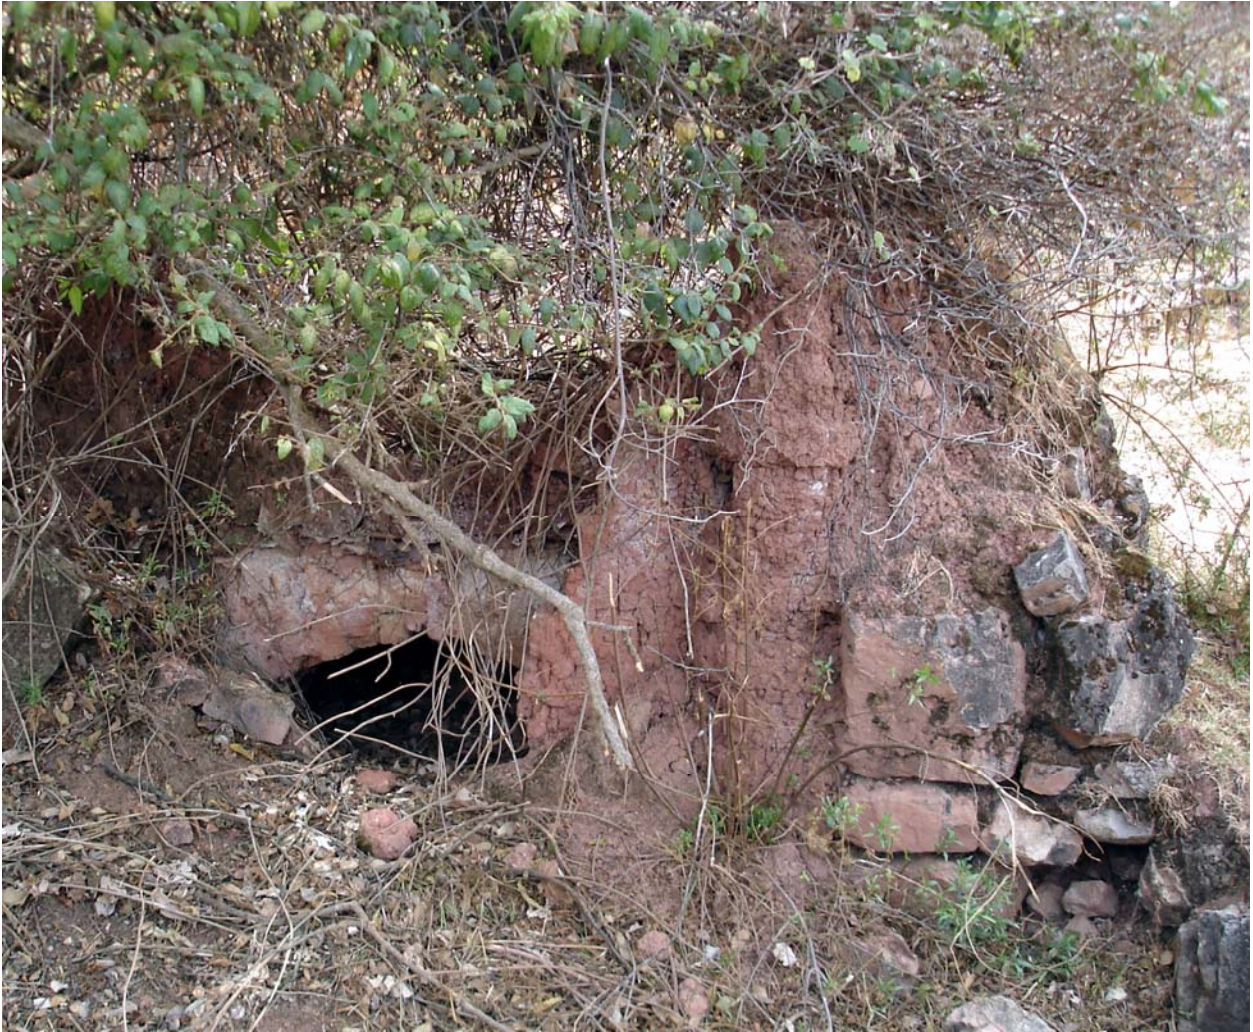
Figure 2. 29: Dwelling/structure of Acobamba village found buried within the rock/debris avalanche debris along the eastern boundary

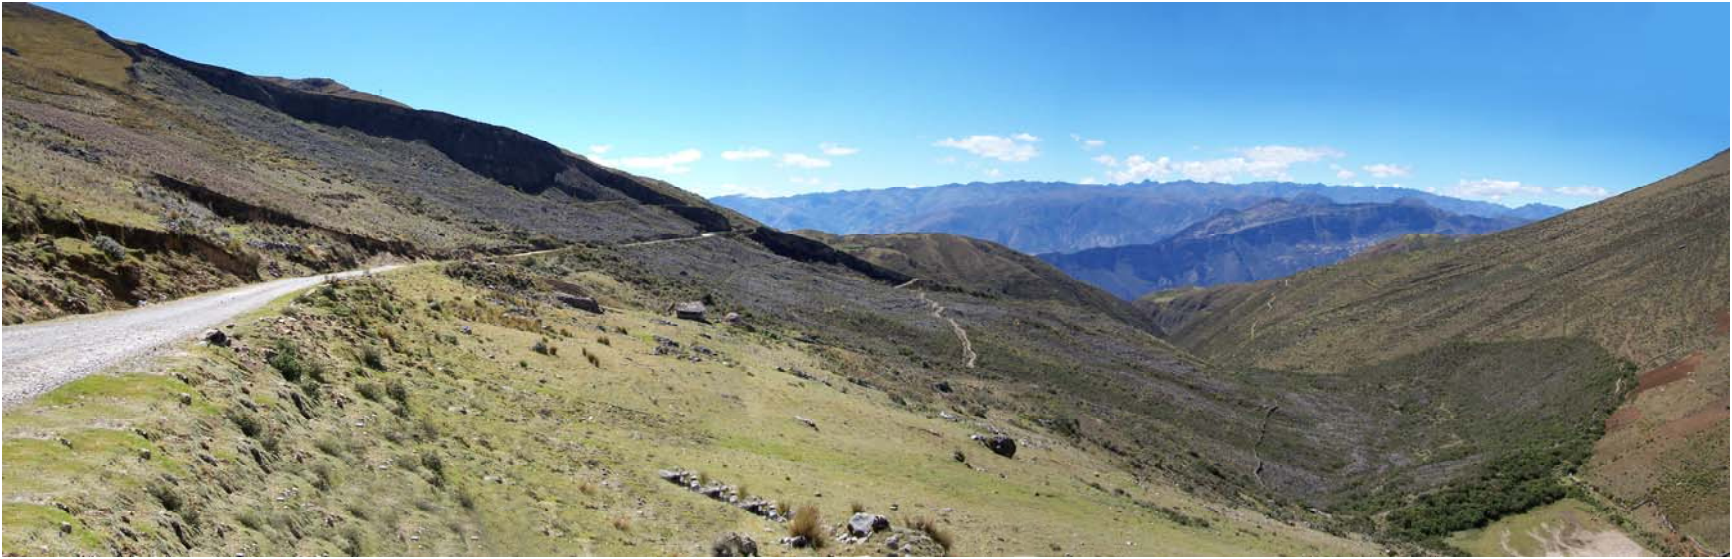
Figure 2. 33: The Paccha flowslide, looking northeast

Initial failure occurred within glacial cover. Flowslide demonstrates high fluidity in run-up on the opposite valley side slope.

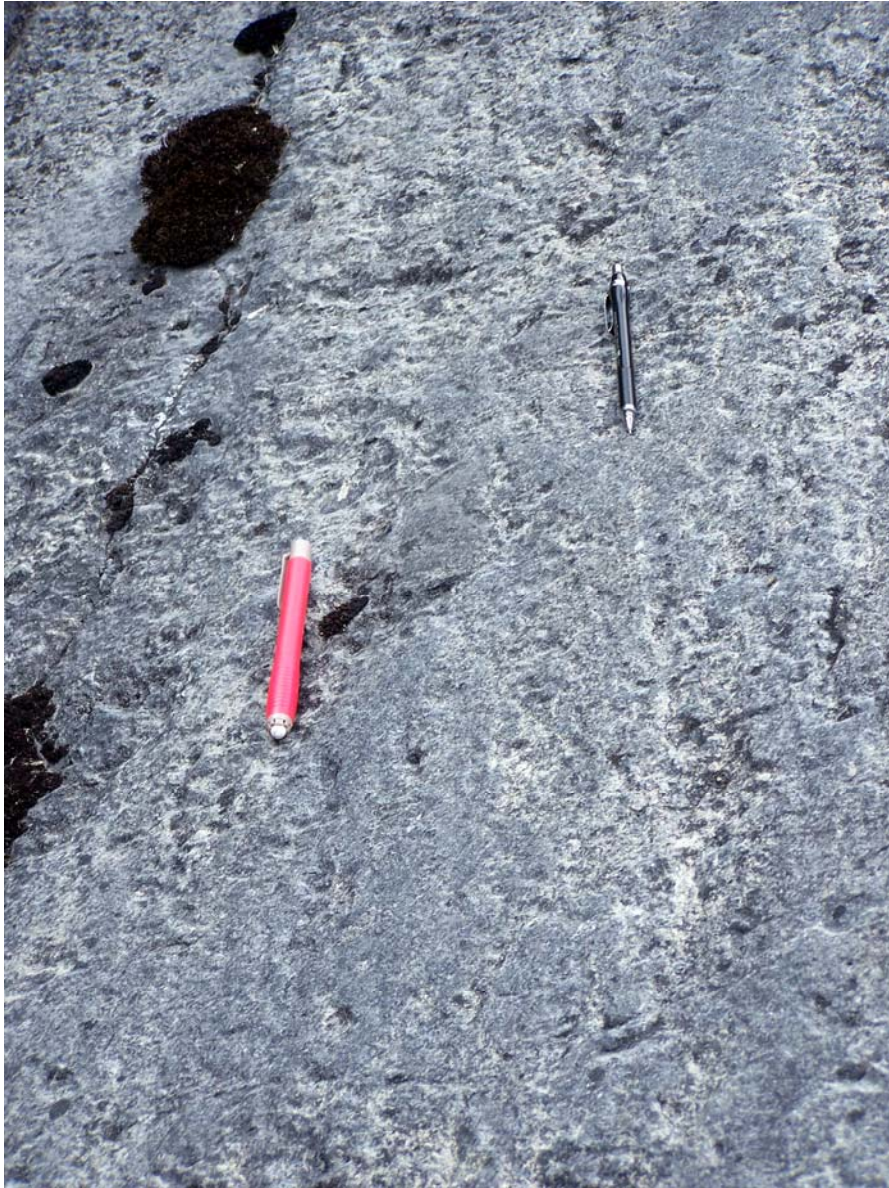
Figure 2. 41: Striations plunging to the southwest on the west dipping bedding plane surface of the Trucha rock avalanche
