Managing Accessibility: A Case Study at the University of Waterloo

A thesis
presented to the University of Waterloo
in fulfillment of the
thesis requirement for the degree of
Master of Environmental Studies
in
Planning

Waterloo, Ontario, Canada, 2016

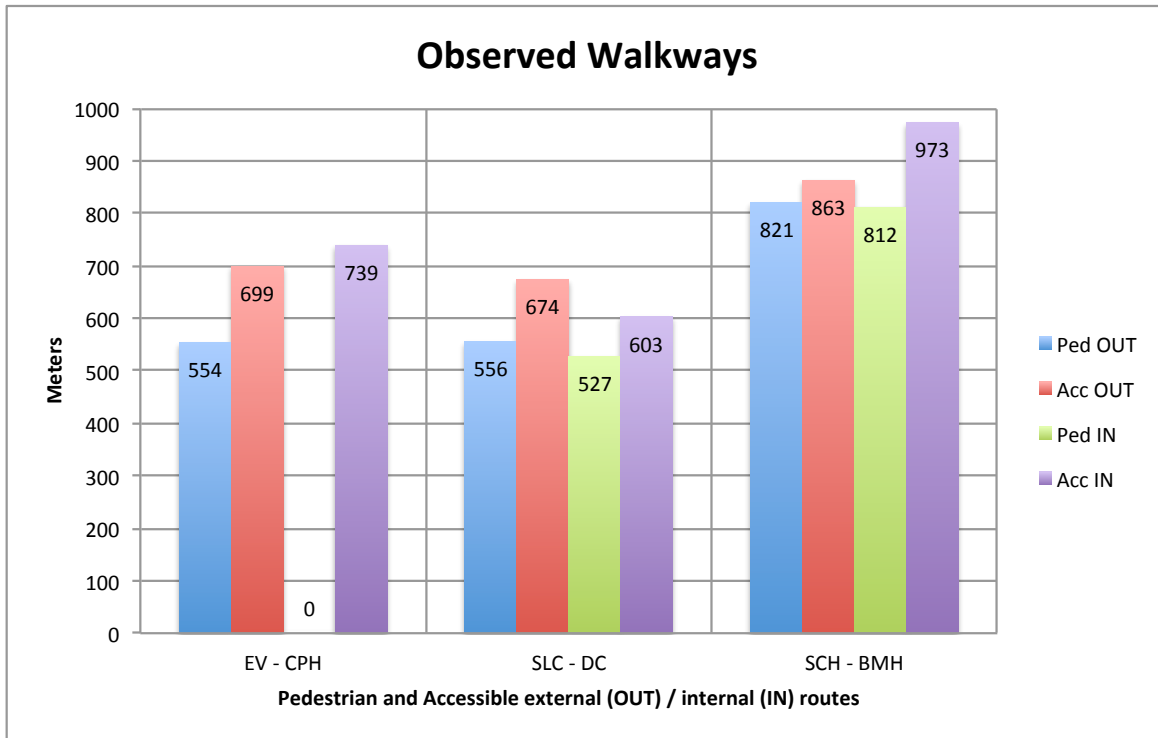
Figure 4.2: Chart of observed walkways. The bars represent the length of the observed routes. The difference between the accessible and pedestrian route is evident. The zero value of the EV-CPH route indicates that there was no probable route that enters or exited a building that would save time.

The chart reveals that accessible routes tend to be longer than pedestrian routes. The zero-value of the pedestrian route from EV to CPH was because no buildings were in the direct path between the two points. There is not a drastic difference between accessible and pedestrian routes. However, in the course of a day the extra distance could develop as a limitation. The characteristics of the routes will be highlighted in great detail in the next section.

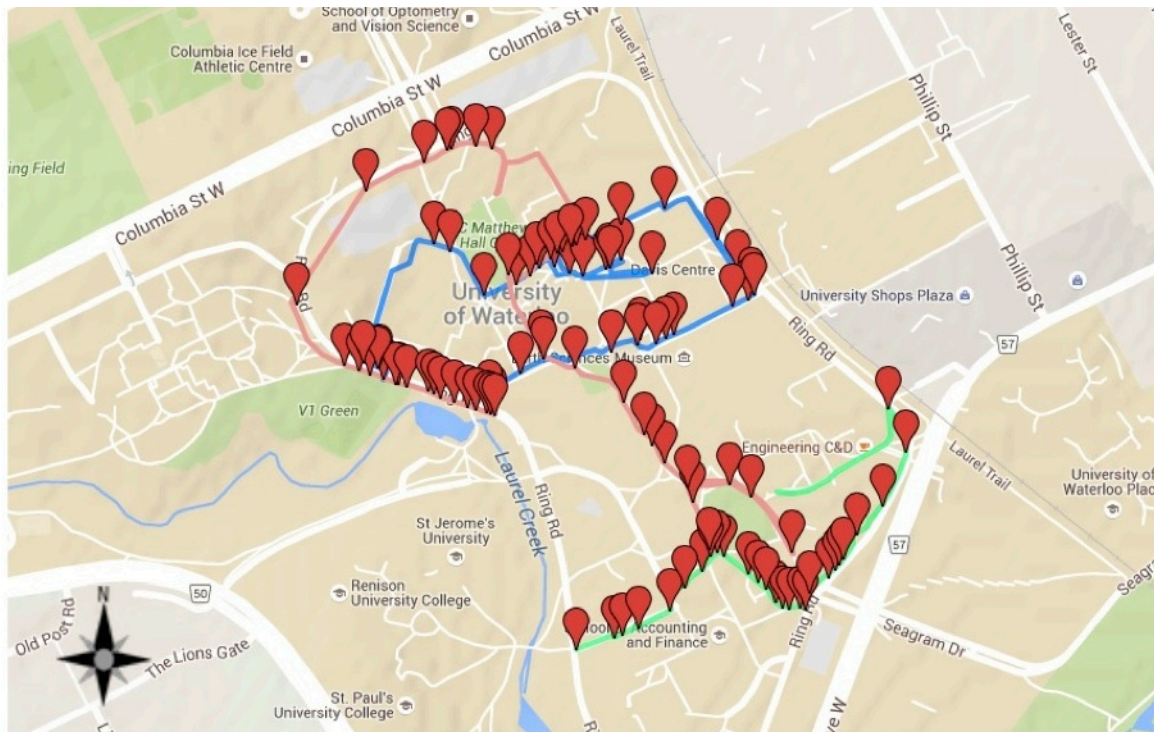
Figure 4.3: Observed routes and waypoints. Three routes are displayed in different colors – green: EV to CPH; blue: SLC area to DC area; pink: SCH to BMH. Places of pathway inconsistencies (e.g. holes in pavement) were plotted with waypoints along the routes.

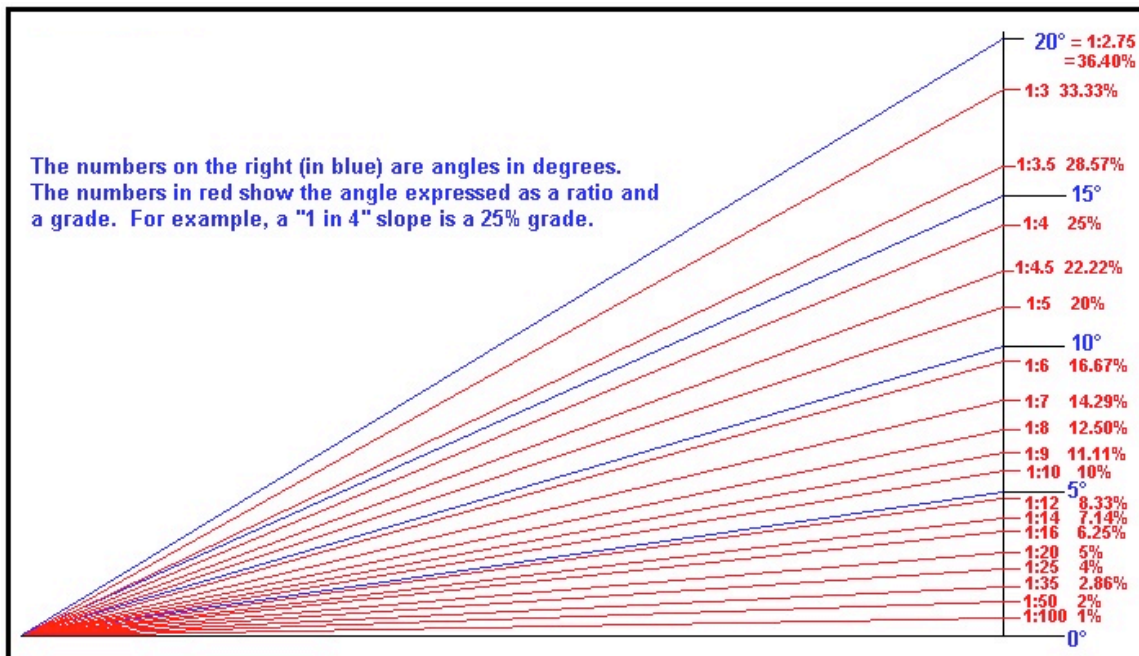
Figure 4.4: Illustration of slopes and their ratios. There are many percentages and ratios discussed in the OBC, AODA and this study. The illustration aids in understanding what a discussed incline may look like. (Image source: www.1728.com)

Ramps in barrier-free paths of travel should have clearance of 90cm between handrails. The slope of the ramp should not exceed 8.33%. Ramps longer than 9m should have a level area between sections also if the ramp changes direction. Barrier-free paths with inclines greater than 5% should be designed as ramps. To assist in comprehension an illustration of inclines has been provided. (See Figure 4.3.4.)

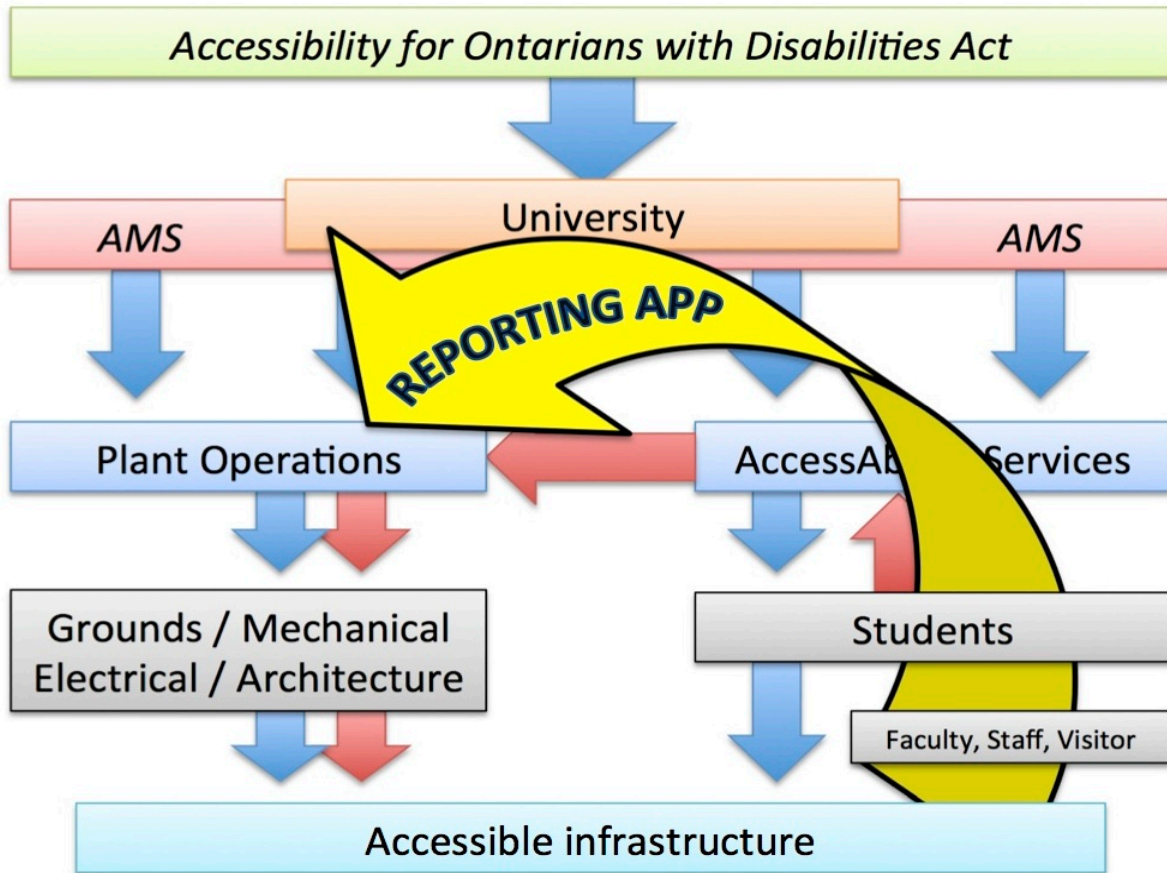
Figure 5.2: Communication flow and inputs. The communication of issues will expand to include faculty, staff, and visitors with the smartphone reporting application. The yellow arrow shows the origin of reports from users that will bypass the current reporting process by students to the AAS.

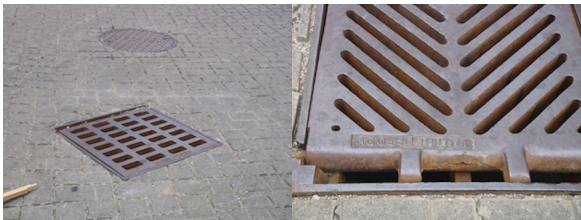
WP006 – 2 Grates in walkway with large holes dangerous to pedestrians or wheeled mobility.

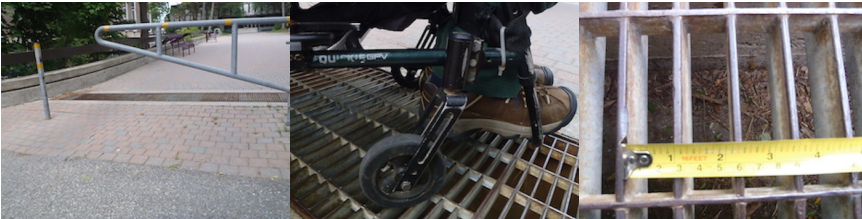
WP008 – Gate and grate (EV1/ML) narrow passage between tree/post/wall. Transition from brick to concrete 0cm to 1.9cm. Grate holes are not horizontal to the incline. Holes are 2.54cm wide and 10.16cm long. Side note: on one occasion the observer's wheels were seized in the grate requiring assistance to get free.

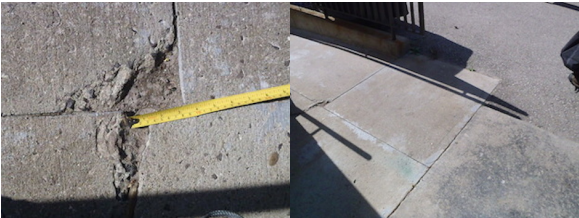
WP011 – Hole in surface at top of the ramp has 1.27cm - 6.35cm depths.

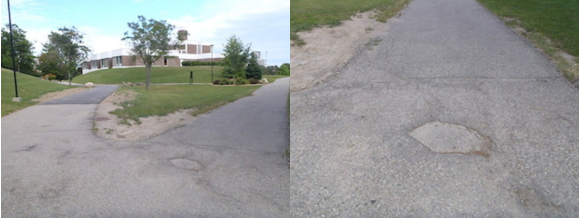
WP012 – Seam in pavement width 137.16cm wide with whole in surface.

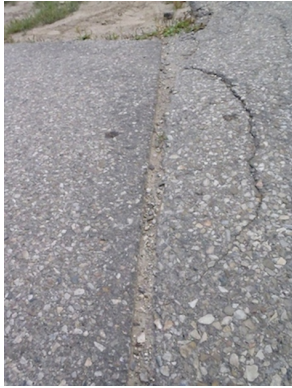
WP013 – Seam in pavement with 2.54cm width.

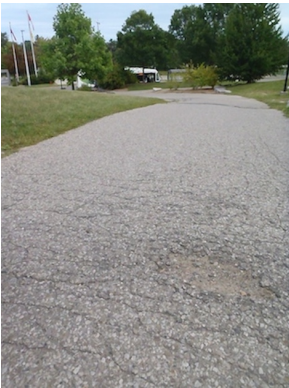
WP014 – Broken pavement with 2.54cm hole in center of walkway. Width of hole was 43.18cm wide and 22.86cm in length.

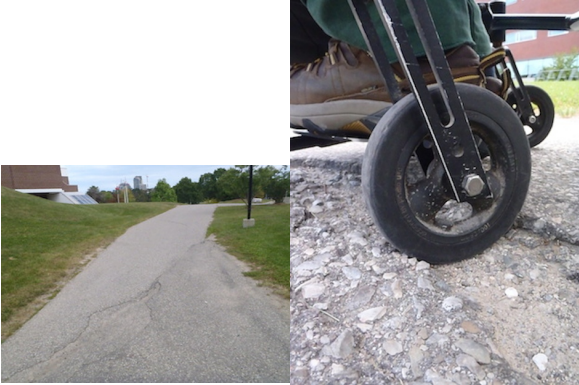
WP015 – Seam in pavement. Deepest portion has 12.7cm x 60.96cm area. Depth of crack measured down to 10.16cm.

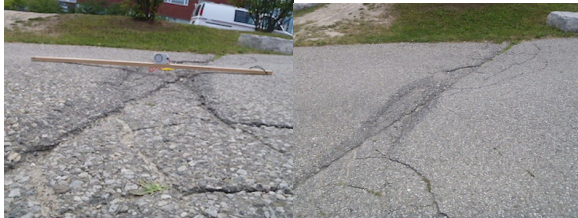
WP016 – Large diagonal crack 360cm across pathway on a 5° downward slope. Broken pavement borders the fractured surface. Widest part of damage was 40.6cm. The downward slope and surface issues could be hazardous.

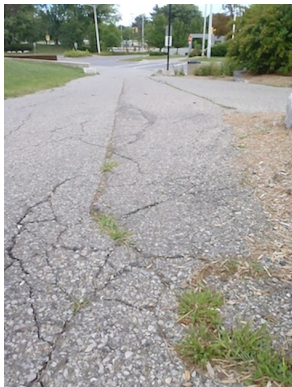
WP018 – Two paths converge. A large 14.93m seam has a transition between grades ranging from 2.54cm to 5.04cm on a downward slope.

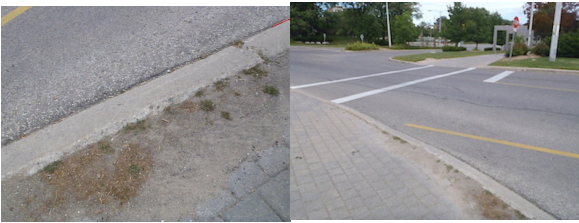
WP020 – Curb cut had protruding concrete by 3.81cm. Curb cut does not align with the crosswalk. Accessible crossing is 9.5m compared to the pedestrian crossing at 7.8m.

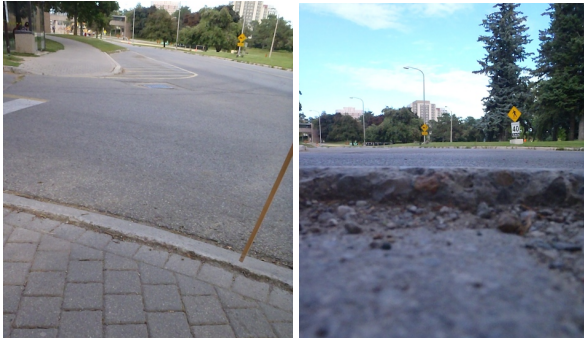
WP024 – Curb cut had protruding concrete of 2.54cm with a 3.81cm gap on the street side of concrete.

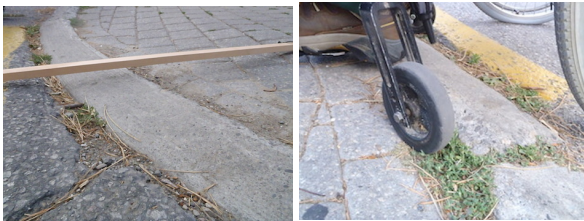
WP025 – Curb cut had protruding concrete ranging from 1.27cm to 6.35cm with a gap of 2.54cm to 5.08cm gap on the street side of concrete. Pavement on street side of curb cut was heaved 3.81cm.

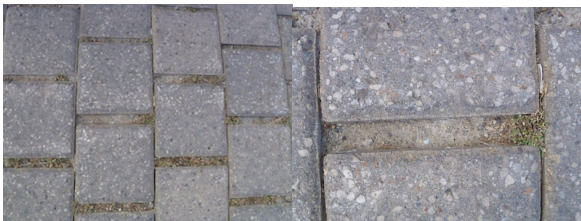
WP027 – Heaved pavers had gaps of 2.54cm.

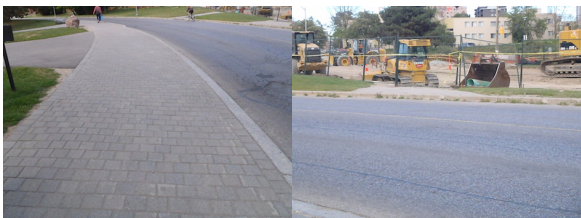
WP028 – Two curb cuts cross Ring Road to curbed walkways on far side. No access to sidewalk along University Avenue.

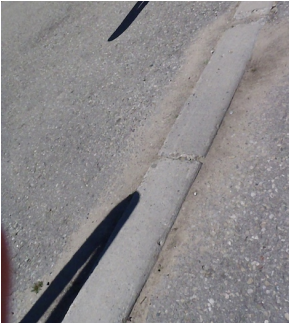
WP035 – Curb cut has protruding concrete with heights of 2.54cm to 5.08cm.

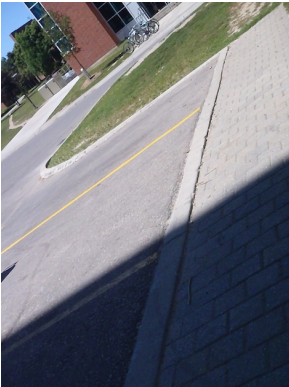
WP037 – Uneven transition of surfaces. Differences ranged from 1.27cm to 2.54cm.

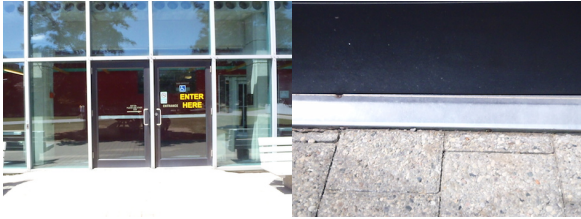
WP041 – Accessible entrance has threshold of 3.81cm to 5.08cm. Button for door opener is 2.5m from door with no distinguishing color to highlight location. Position of button is on a slight downward slope with a bench blocking a direct route to the button.

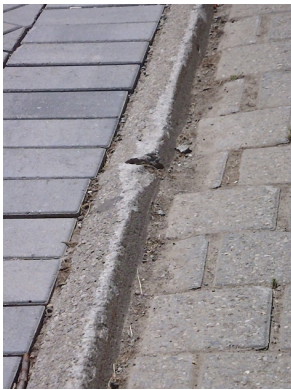
WP041a – Uneven transition between surfaces. Protruding concrete rose 2.54cm to 7.62cm above grade.

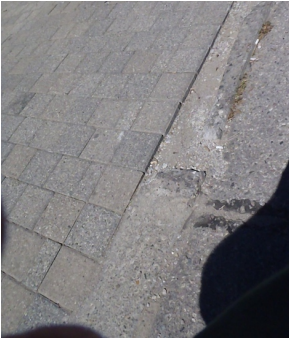
WP049 – Broken curb cut. Missing material causes a below grade depression creating a transition of 1.27cm to 1.9cm.

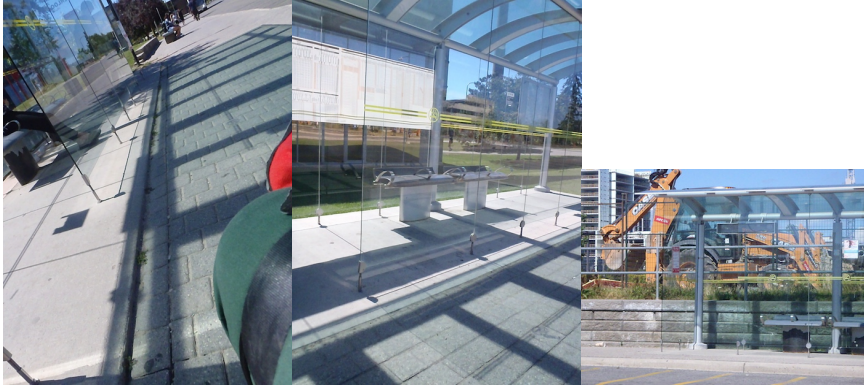
WP052 – Uneven transition into bus shelter with a 2.54cm difference in levels. Other two bus shelters in the DC area had smooth transitions.

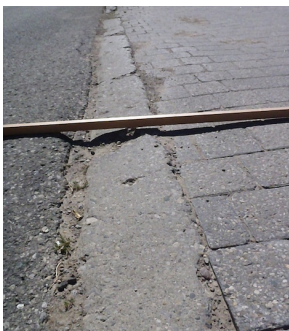
WP056 – Broken, uneven curb cut.

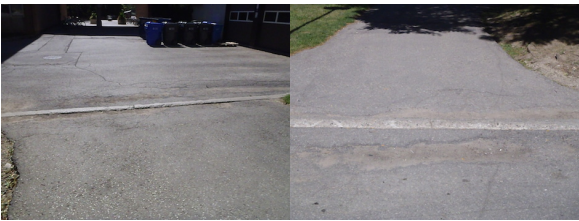
WP059 – Curb cut (on alternate walkway) had protruding concrete. Areas on each side of concrete are below grade. Curb cut with uneven transition.

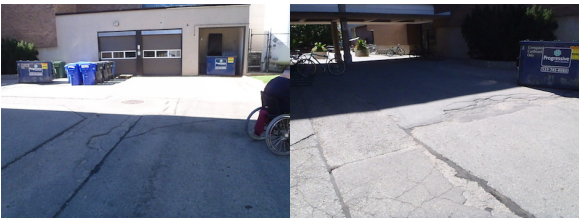
WP060 – Large area of pavement with multiple surface issues. Pavement is fragmented or missing creating an inconsistent surface.

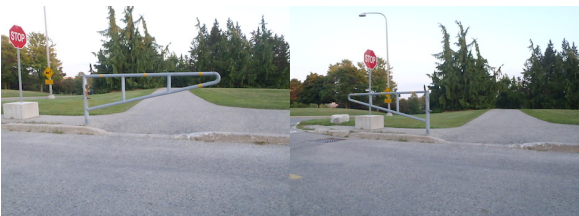
WP090 – Traffic control barrier blocked the curb cut along the path. Researcher was able to reverse direction of the barrier, which resolved the issue.

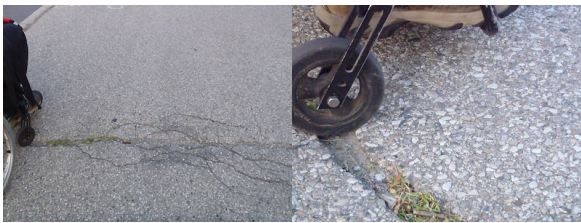
WP093 – Large seam of broken pavement covers the width of the pathway. The gap in the pavement could be hazardous as its width could halt forward movement of a wheeled mobility device suddenly.

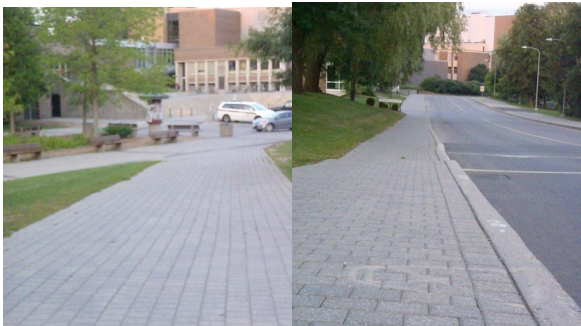
WP094 – This 500cm wide walkway is directed towards the steps of SLC. The 152cm wide walkway along Ring Road is narrower and has a cross slope that requires more effort in forward progress. Neither path would be preferable to the researcher, as the benefit of the downward slope would be diminished. The preferred path would be the walkway on the west side of Ring Road.

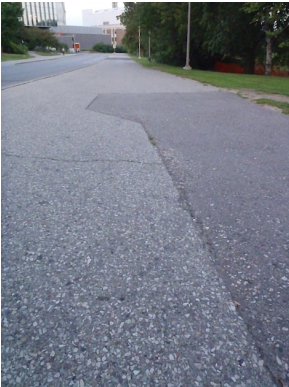
WP097 – Large section of pavement repair left a large seam between the old and new sections. Seam width ranged between 1.27cm and 1.9cm.

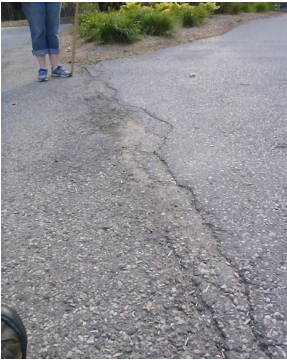
WP065a – Broken pavement has transition of 0cm to 6.35cm. Large area of dirt or missing pavement adjacent to transition.

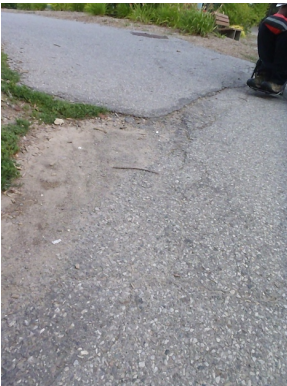
WP066 – Widening crack in pavement located in the middle of pathway. Pine needles disguised the severity of the fissure. The opening starts narrow at 0cm and widens to 4.44cm ending at a transition to pavers.

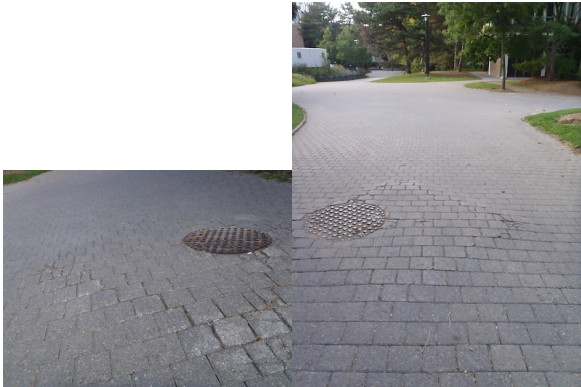
WP068 – Broken pavers had 1.9cm to 2.54cm depth.

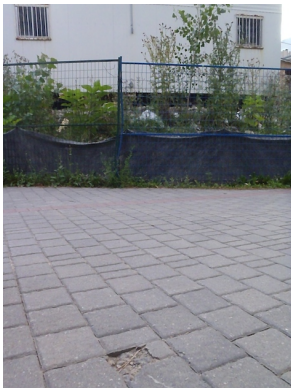
WP072 – Area of multiple broken pavers. Waypoint 72, 73, and 74 had numerous pavers that needed replacement. The characteristics of the broken pavers are similar to ones observed elsewhere. Observing each incident was prohibitive due to the enormous amount of broken pavers - it is why the waypoints 72, 73, 74 are listed as areas.

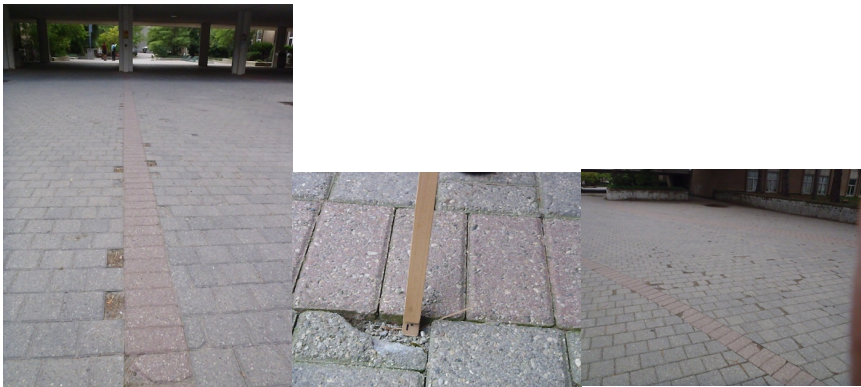
WP074 – Area of multiple broken pavers.

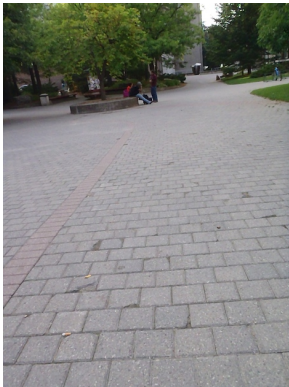
WP075 – Uneven transition between concrete and pavers measured 0.63cm to 1.9cm with slight sloping up to grade.

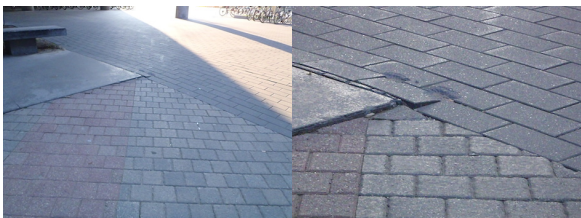
WP076 – Two utility covers rose above grade. Broken and heaved pavers were at edge of first cover. The second cover (third photo) was less of an issue.

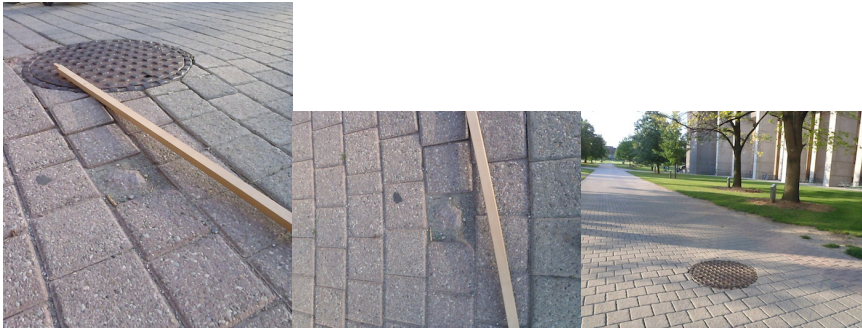
WP077 – Storm grate rose above grade. Grate and surrounding pavers (some broken) created a transition between grades up to 1.9cm. The grade difference caused water to collect at the edges of the grate, which may conceal the hazardous transition issue.

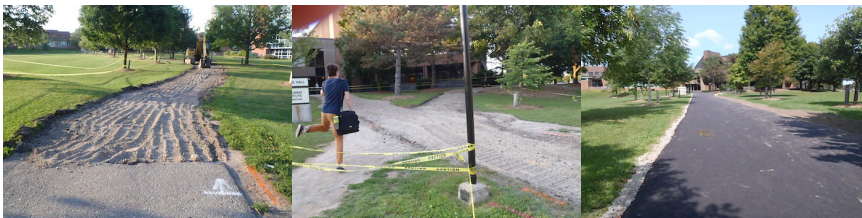
WP079 – Cross slope on walkway 10°.

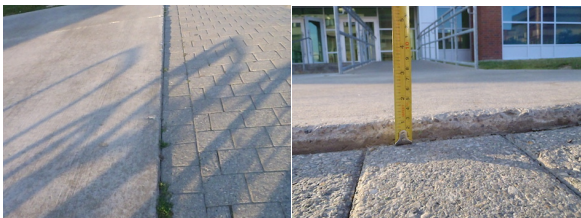
WP081 – Walkway/curb cut had 10° slope. Transition from walkway to concrete (to enter M3) had a difference of 2.54cm to 3.81cm grade difference with sloping up to concrete level. Curb cut has protruding concrete that rose 1.9cm to 3.17cm.

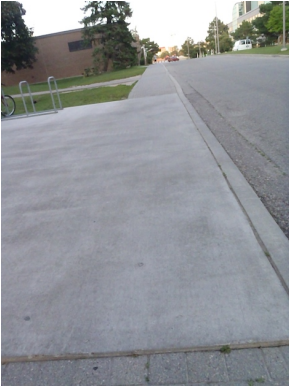
WP084 – Hole in walkway 2.54cm to 4.44cm.

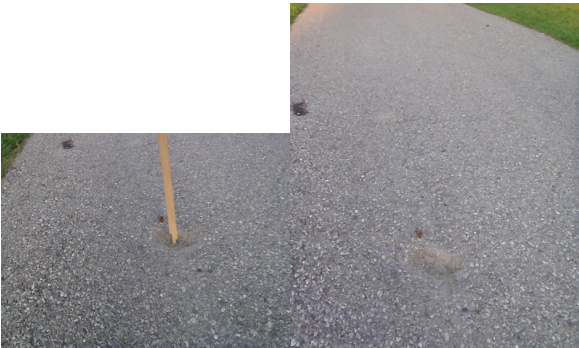
WP085 – Below grade utility cover. One edge had transition of 0.63cm.

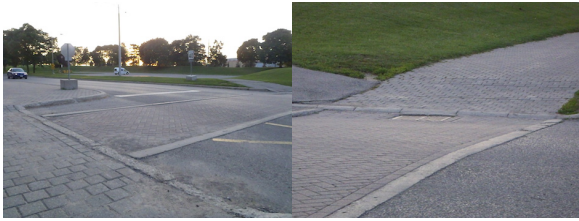
WP089 – Curb cut with uneven transition from pavement to concrete.
