Investigation on the implications of passive fire barriers on the fire fighting tactics of the Royal Canadian Navy

A thesis
presented to the University of Waterloo
in fulfillment of the
thesis requirement for the degree of
Master of Applied Science
in
Mechanical Engineering

Waterloo, Ontario, Canada, 2021

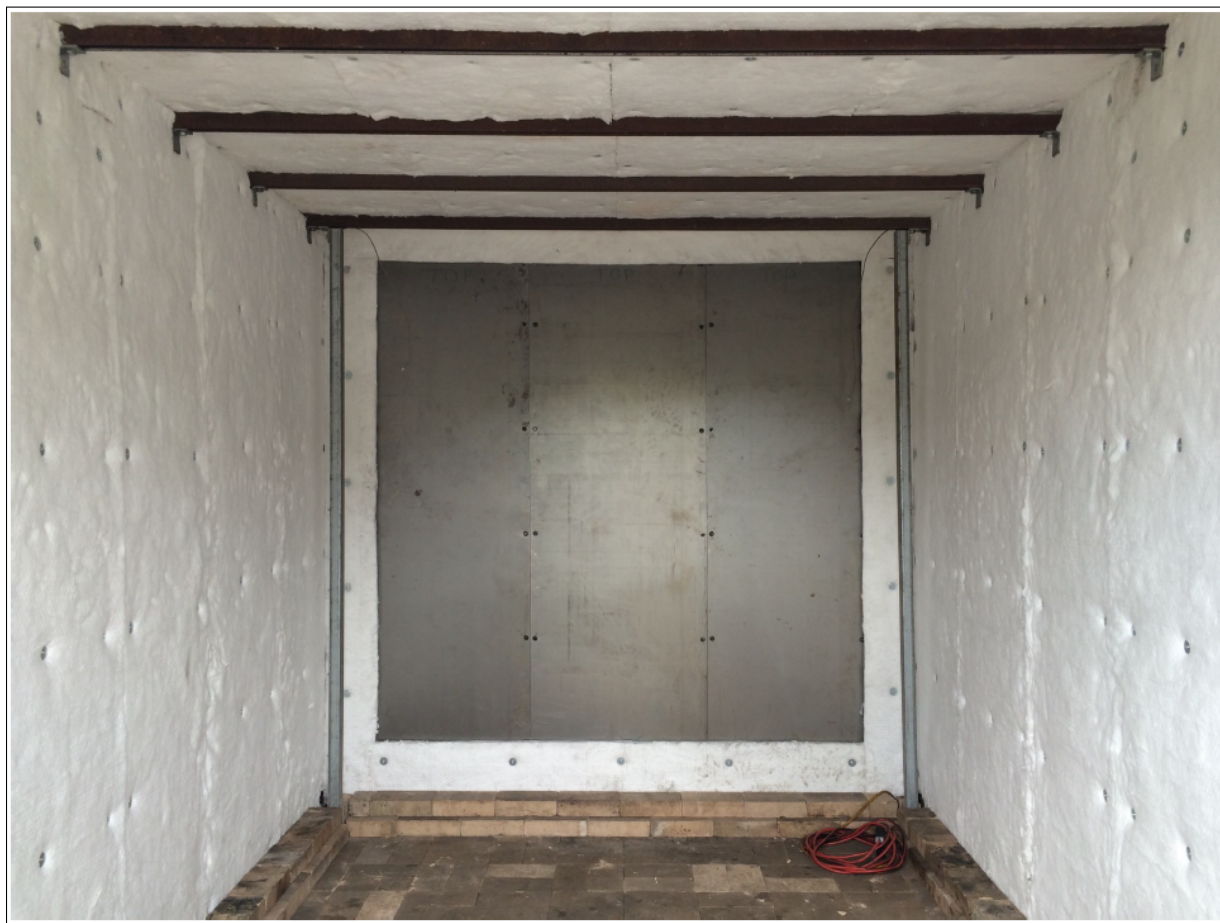
Figure 3.4: Panels shown installed in the wall test apparatus [8]

Figure 3.4 shows the interior of the fully insulated compartment with a wall test section mounted at the far end. The final internal dimensions of the fire compartment are 138 in (351 cm) long, 90 in (229 cm) wide, and 90 in (229 cm) high. The bottom of the wall frame is 12 in (31 cm) above the brick floor, and the top of the wall frame is 87.5 in (222 cm) above the brick floor, or 2.5 in (63.5 mm) below the ceiling. [8]

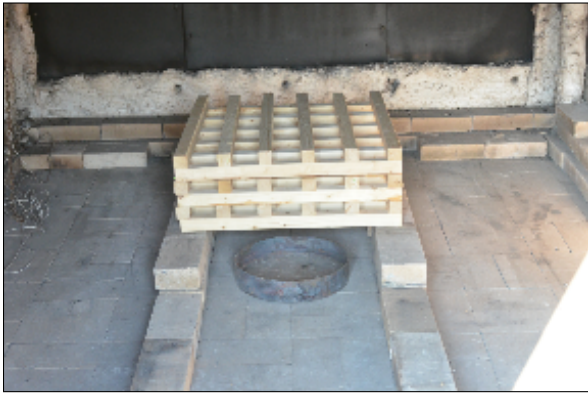
(a) Fuel tray configuration - single and two stacked wood crib configuration

For the single tray, an 8 inch (203 mm) round steel tray is used. For the two crib side by side configuration, two 4 inch x 6 inch (101 mm x 106 mm) aluminum trays were used. In both cases, the fuel burned for approximately 30-40 seconds, and this is sufficient to ignite the wood crib and allow a sustained burn to develop which then grew to fully consume the fuel. The two different configurations of starter fuel pan are shown in Figure 3.21. The chosen configuration meant that the wood crib combustion is initially biased towards the front side of the fire compartment (away from the test wall) but because the wood is well conditioned, the fire spread evenly across the fuel load. This method proved to be a safe and repeatable method for igniting all of the test fires.

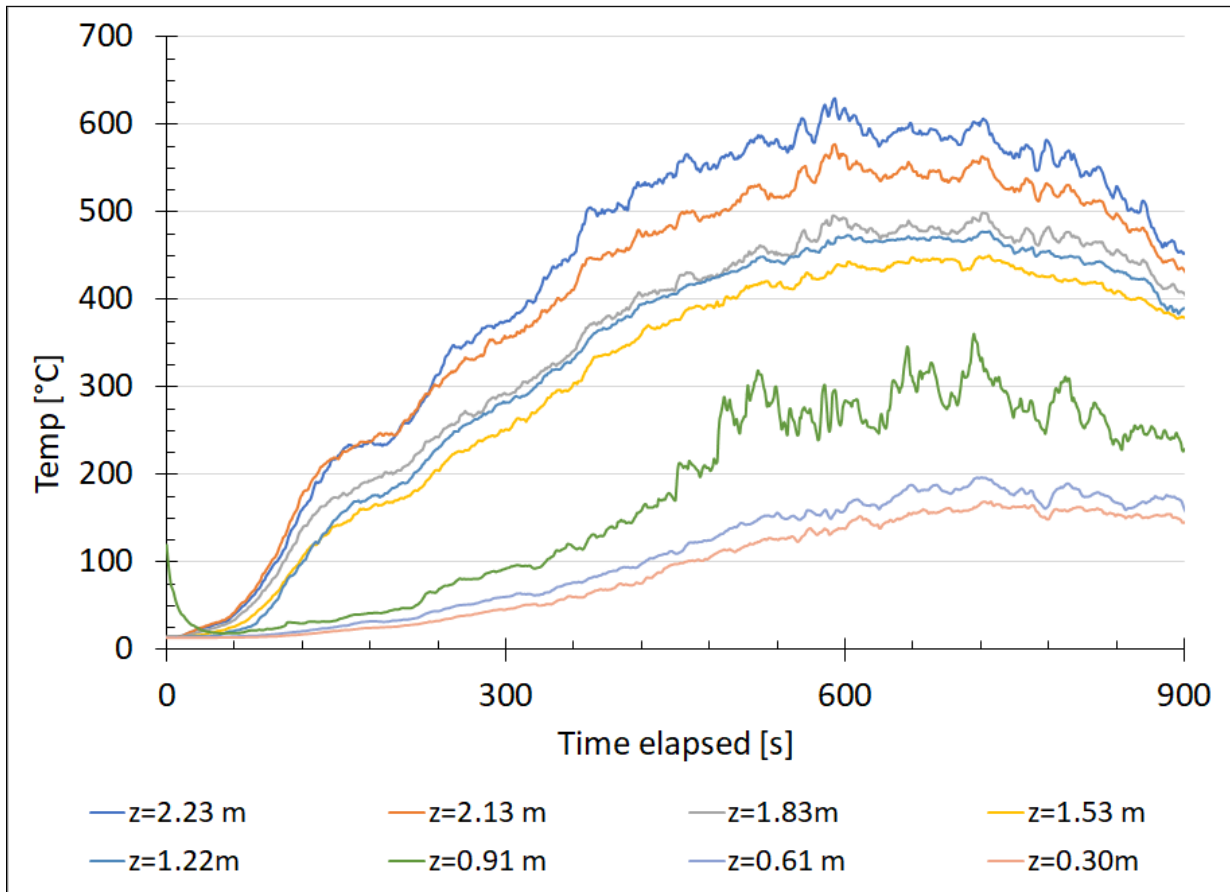
Figure 4.2: Test 2 fire compartment average wall gas temperature

In Test 2 using two stacked wood cribs, the average wall gas temperature increased until reaching a peak temperature range between 425 - 600 °C after approximately 600 seconds from ignition, as shown in Figure 4.2. This peak temperature is maintained for approximately 150 seconds, and then begins to decay. The interface between the hot layer and the cool layer is at approximately 1.5 m from the fire compartment floor, as measured by the vertically spaced thermocouples.

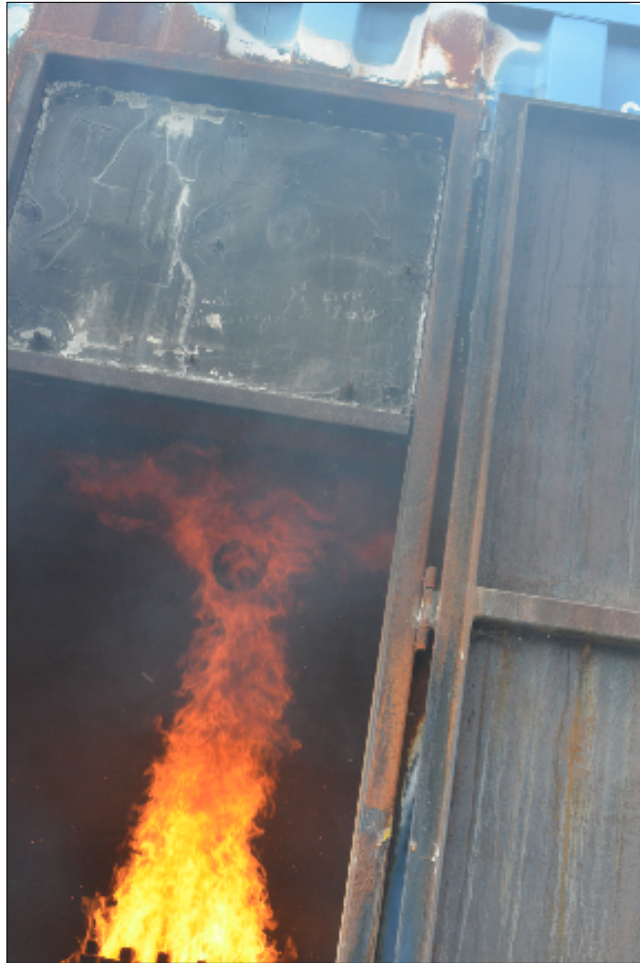
Figure 4.3: Photo of flame impingement on the ceiling with the two stacked crib configuration during Test 2

During the steady burning portion of this test, the constant flame height was nearly at the height of the compartment, with some intermittent direct impingement along the ceiling as shown in Figure 4.3. Although the ceiling is adequately protected by the ceramic fibre insulation and cement board backing panels, this direct flame exposure would reduce the lifespan of the panels, with no benefit to the test results. Therefore, in order to protect the test apparatus, a side-by-side two wood crib fuel load was used for subsequent testing.

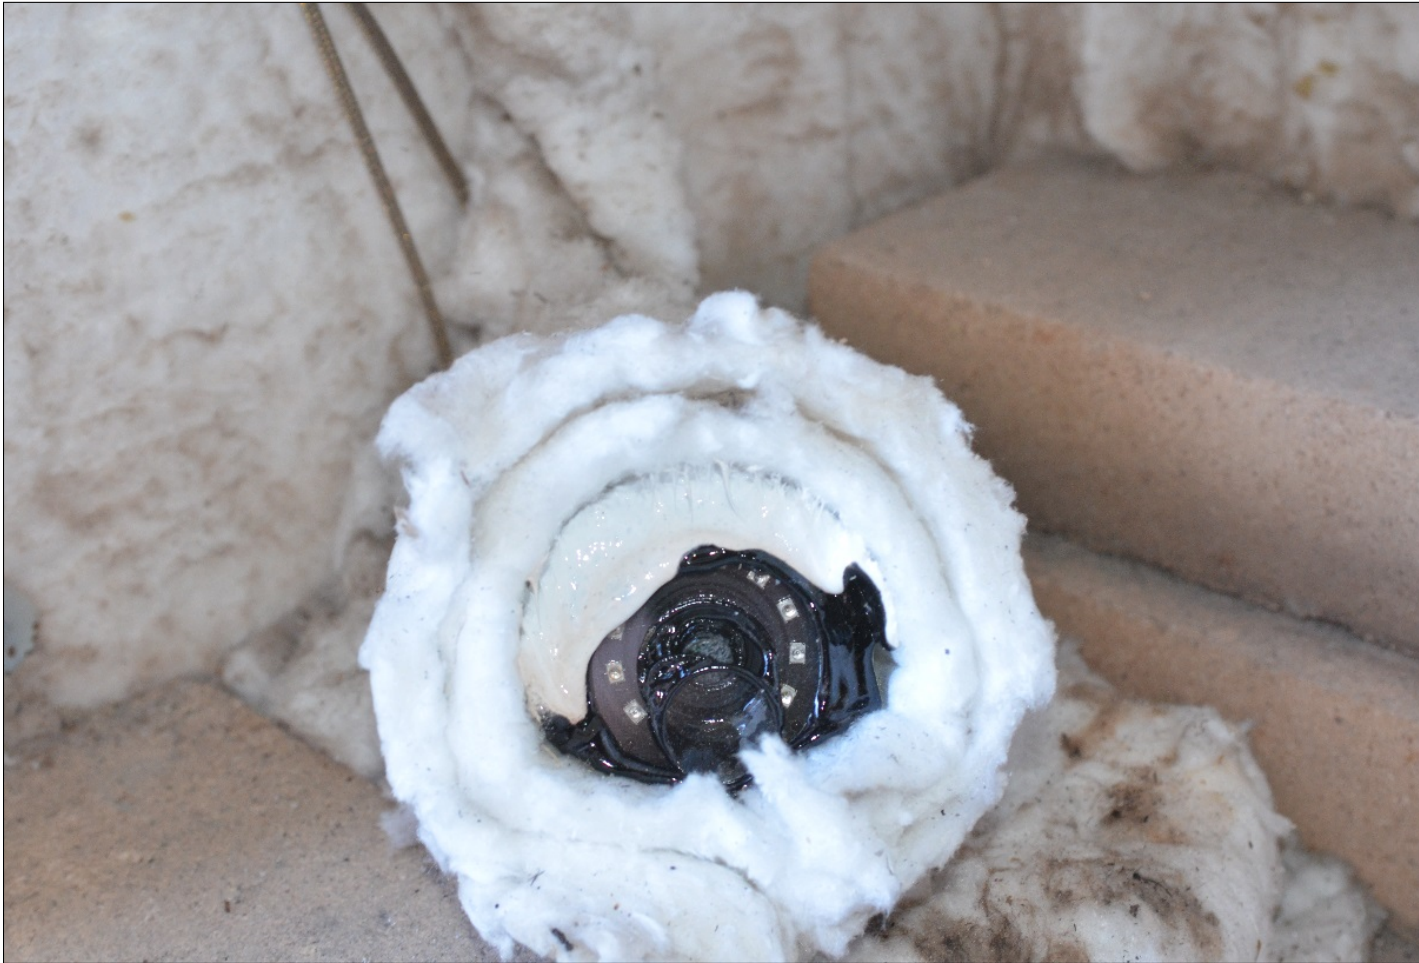
Figure 4.4: Photo showing damage to CAM1 from fire compartment conditions during Test 2

During Test 2, the video camera in the fire compartment (CAM1) failed due to exposure to the high fire compartment temperatures at approximately 11 minutes after ignition, as shown in Figure 4.4.

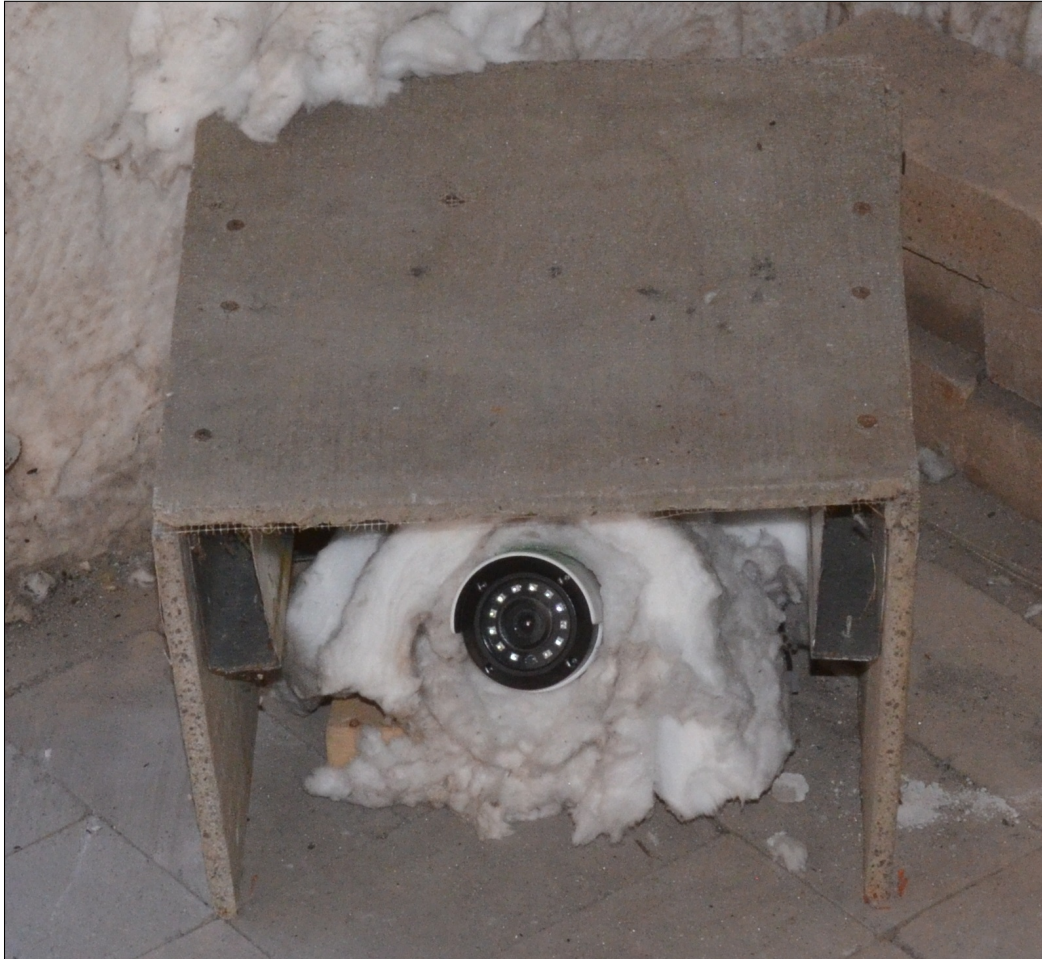
Figure 4.5: Photo showing additional camera protection used for tests 3 and 4

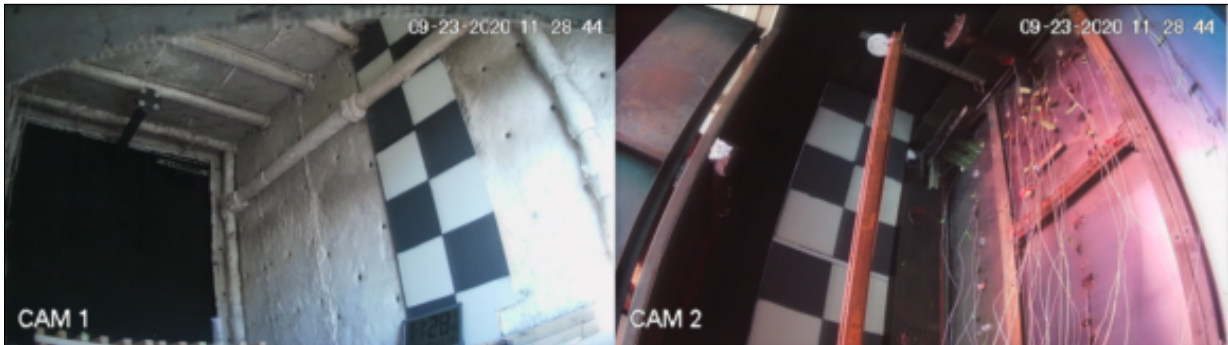
Figure 4.7: Video capture of Test 3, with smoke detector shown mounted in the transition compartment

The smoke detector in the main compartment is co-located with a checkerboard used to monitor the visibility in the compartment at a distance of 600 mm from the wall. The smoke detector in the transition compartment is mounted on a bracket connected to the specimen mounting frame, and is located approximately 600 mm from the checkerboard panel, and equidistant between the back of the specimen mounting frame and the rear wall of the transition compartment. Figure 4.7 shows screen captures from the video footage for Test 3, which shows the smoke alarm on 'CAM2'. Due to the camera location for CAM1, the smoke alarm in the fire compartment is not visible within the field of view, but the indicator light is visible in the image on the CAM2 feed and could be used to verify the timing of detector activation on completion of the test.

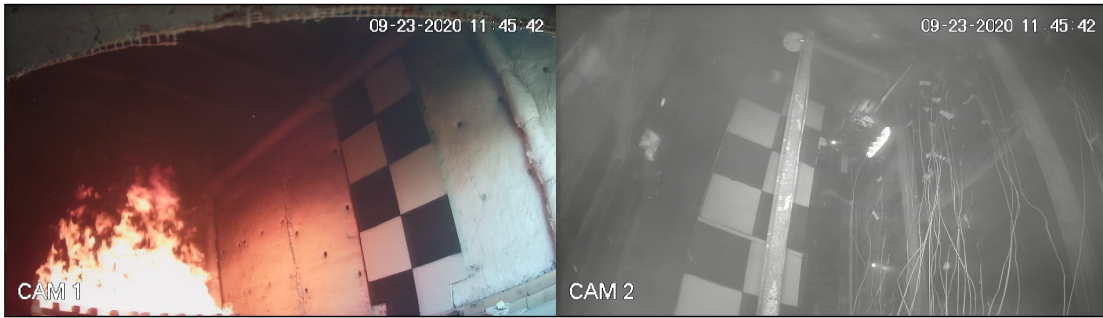
(a) Test 3 video output at $t= 3$ mins

In Test 3, the smoke alarm in the fire compartment activates approximately 10 seconds after ignition, with the smoke alarm in the transition compartment activates approximately 15 seconds after ignition. Therefore the door to the fire compartment is closed at 250 seconds following ignition. Prior to the fire compartment door being closed, smoke is observed venting out the top half (approximately) of the door opening. The compartment temperatures very quickly decrease as the fire dies down, and the smoke layer is observed to very quickly drop towards the floor, resulting in almost zero visibility in both the fire compartment and the transition compartment. In the video stills included in Figure 4.8 the fire growth and decay as the fire becomes under ventilated can be observed, along with the rapid loss of visibility in both the fire compartment and the transition compartment.

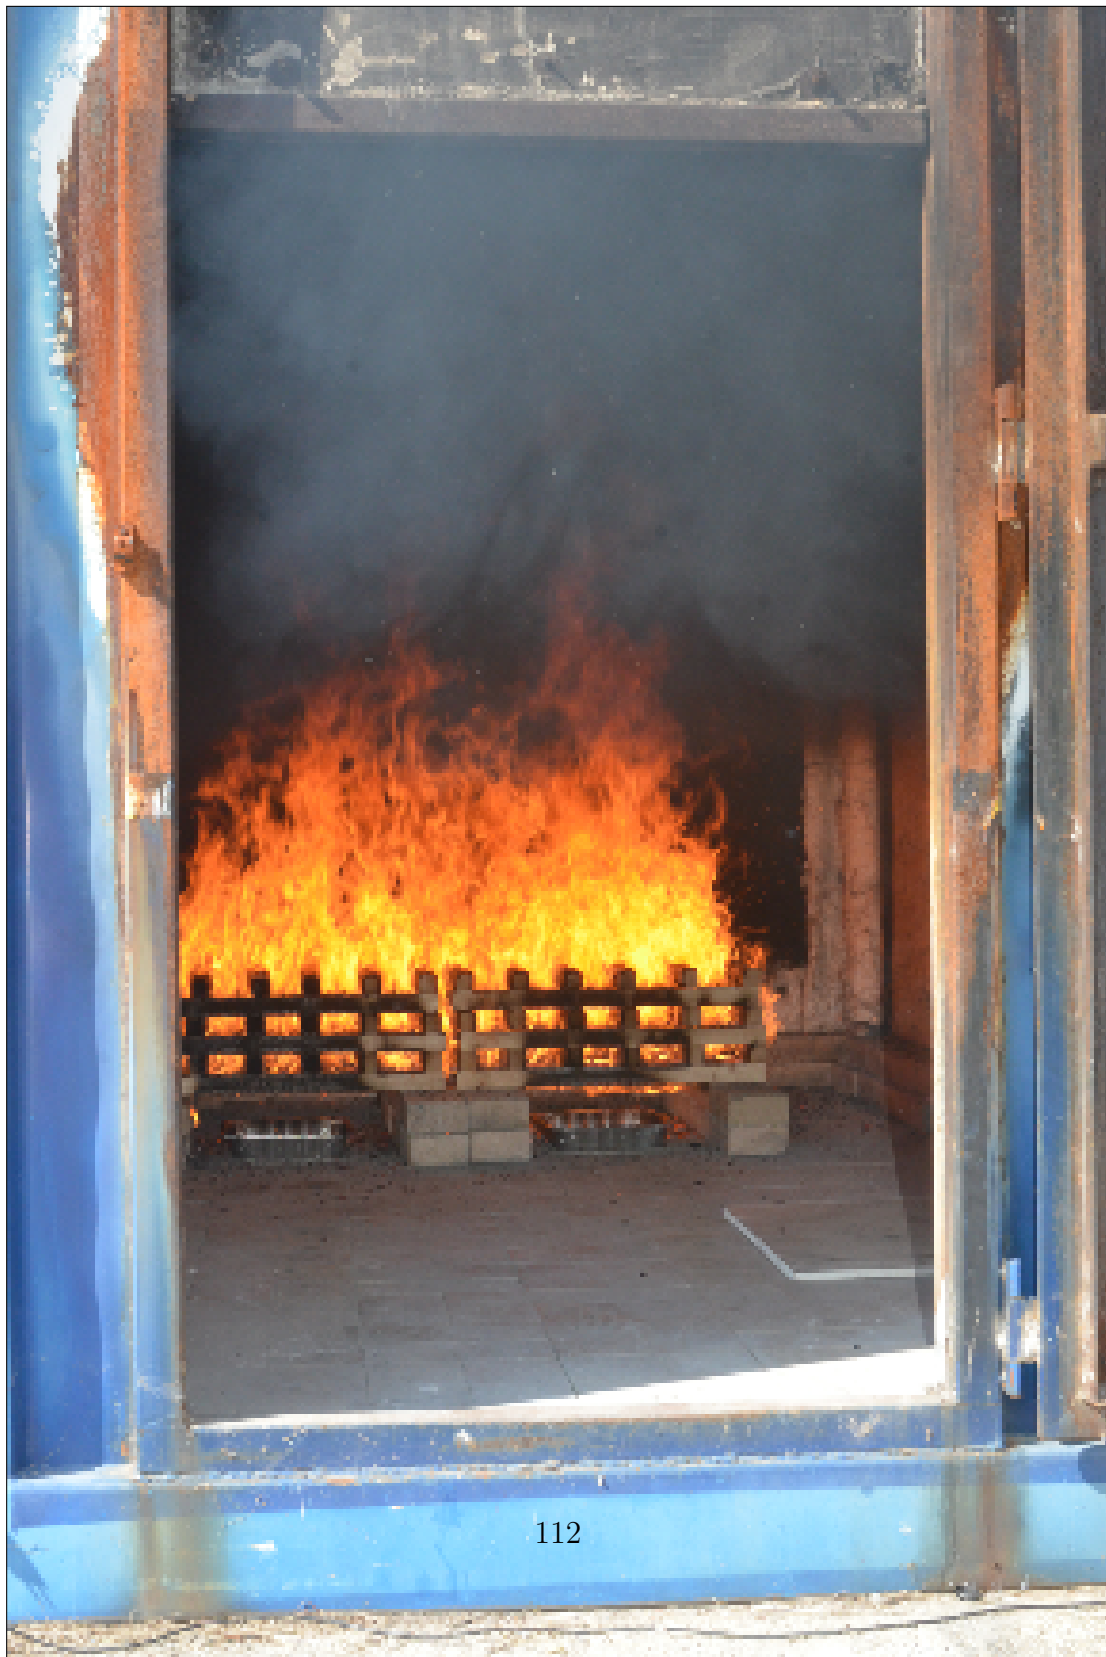
Figure 4.9: Photo showing representative flame height of the two SBS crib configuration

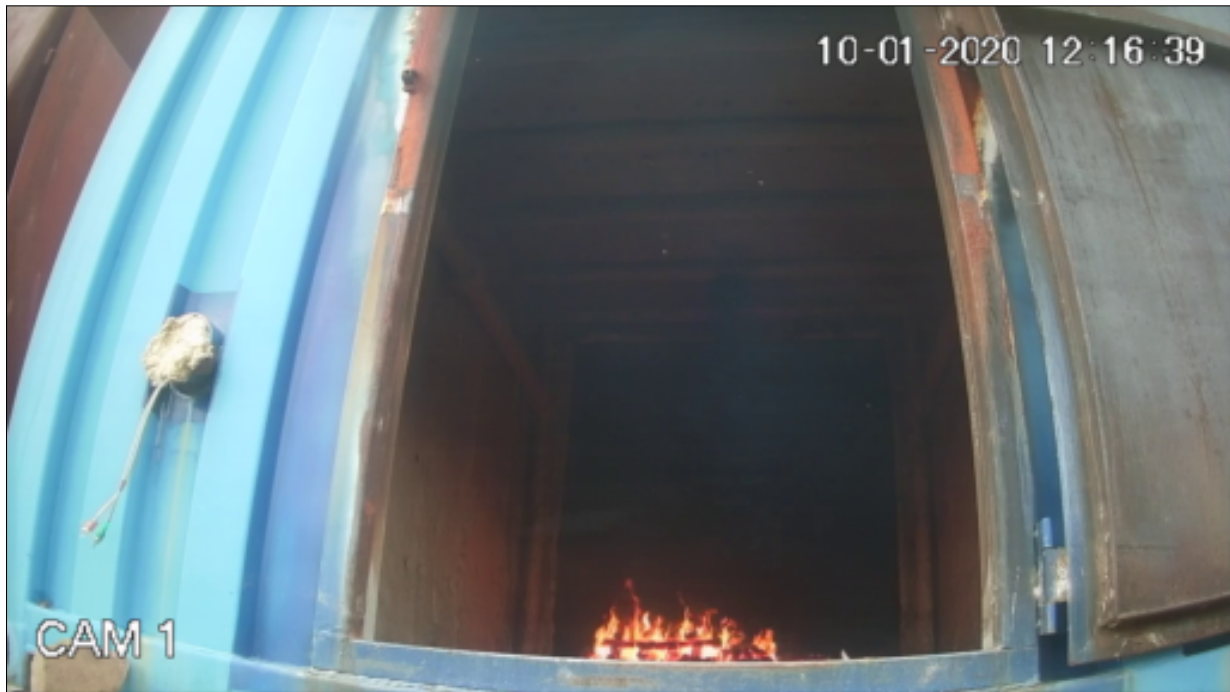
Figure 4.22: Test 6: Video still at t=15 min looking into the fire compartment

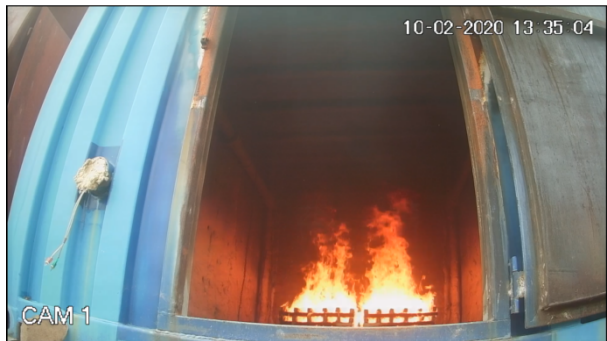
(a) Test 7: Video still at t=15 min looking into the fire compartment

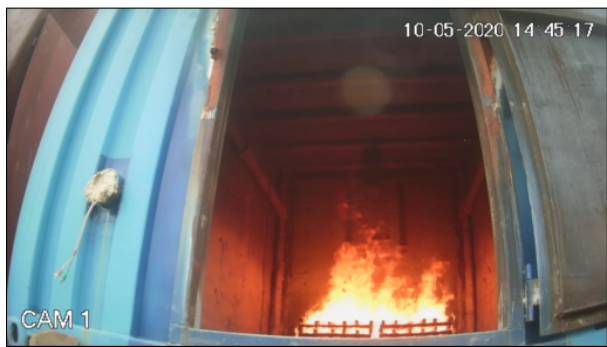
(a) Test 8: Video still at t=15 min looking into the fire compartment

Figure 4.31: Test 8: Video still of fire compartment and IR image at t=15 min

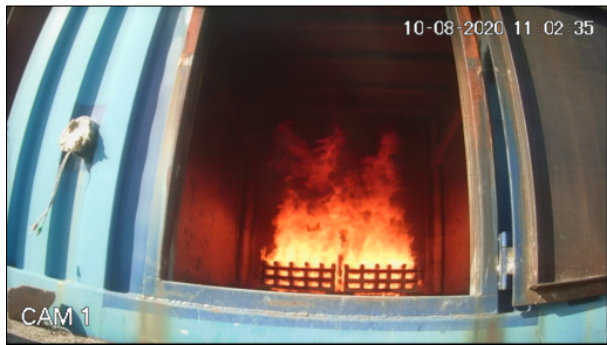
(a) Test 10: Video still at t=8 min looking into the fire compartment

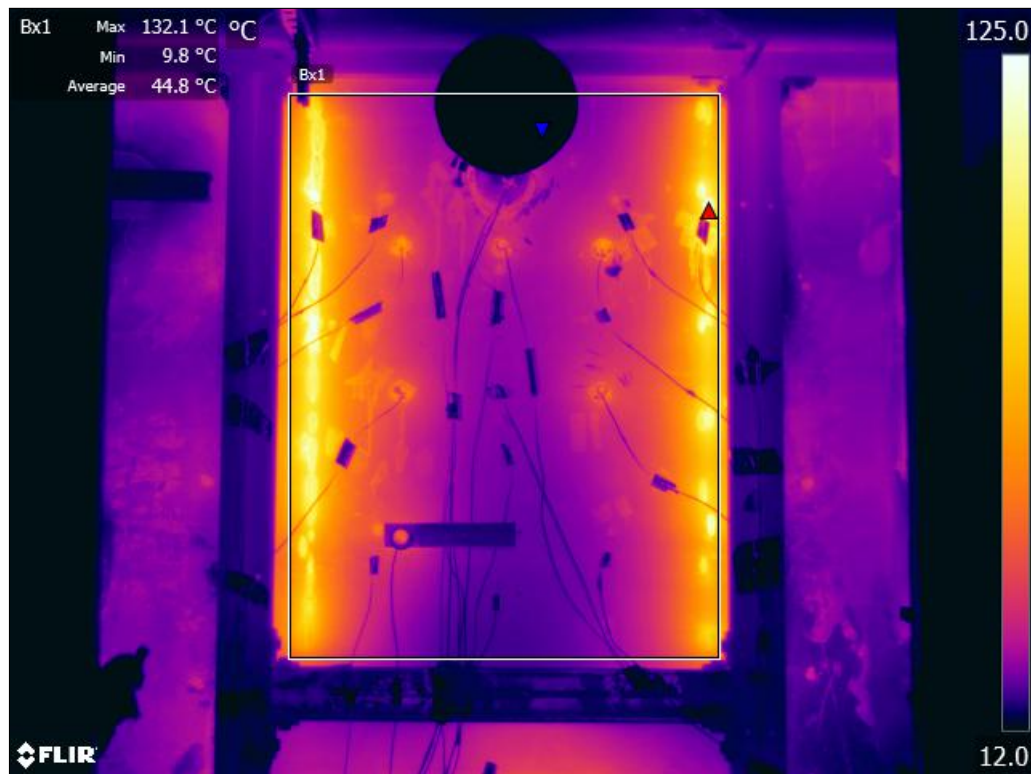
Figure 4.42: IR image at 15 minutes of Test 10 with IMO A-15 insulation fitted, showing an average surface temp of 45 °C in the test area of interest

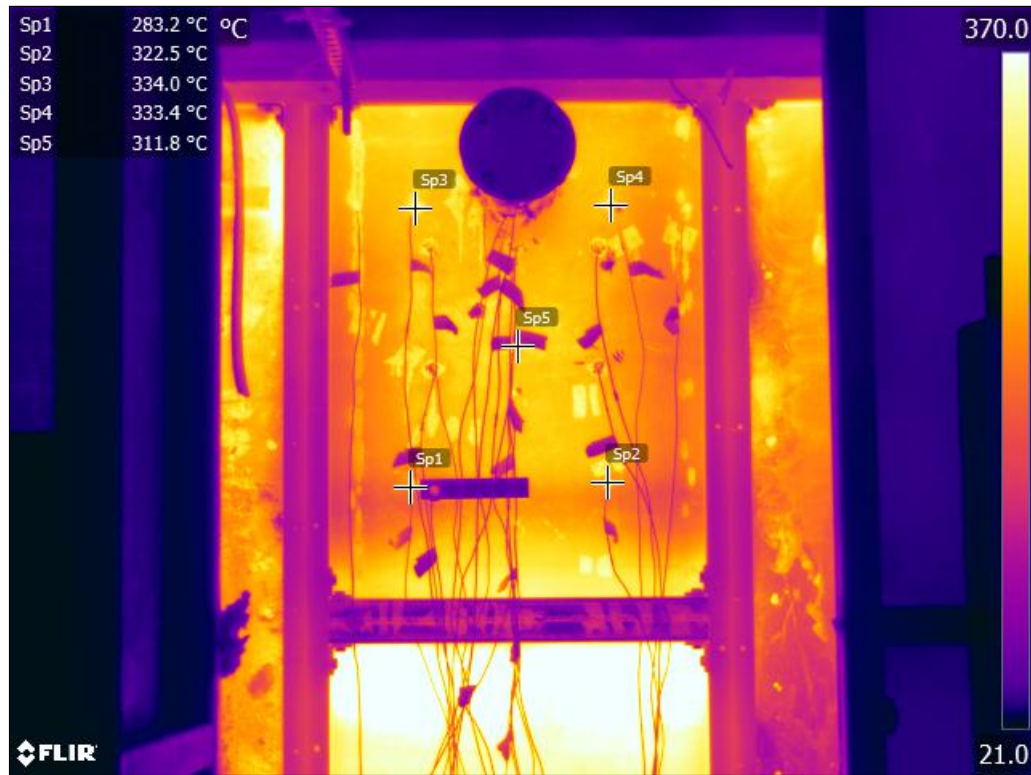
Figure 4.44: Test 6: IR image at 12 minutes, $\epsilon = 0.85$, 5 IMO monitoring points shown (Note center quadrant point obscured)

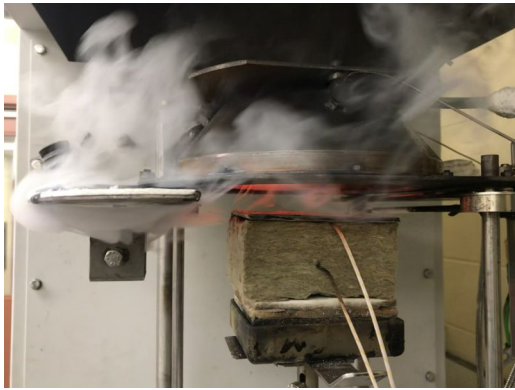
(a) Cone calorimeter scenario 1: Smoke production prior to ignition

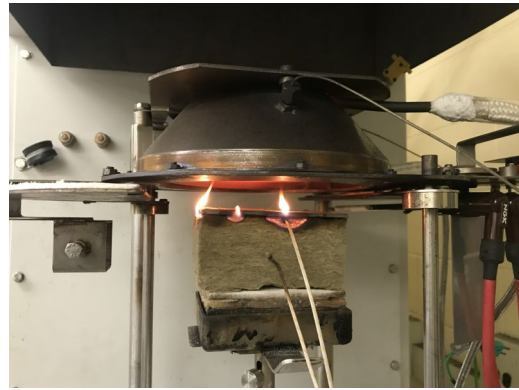
(b) Cone calorimeter scenario 1: sustained burning following ignition

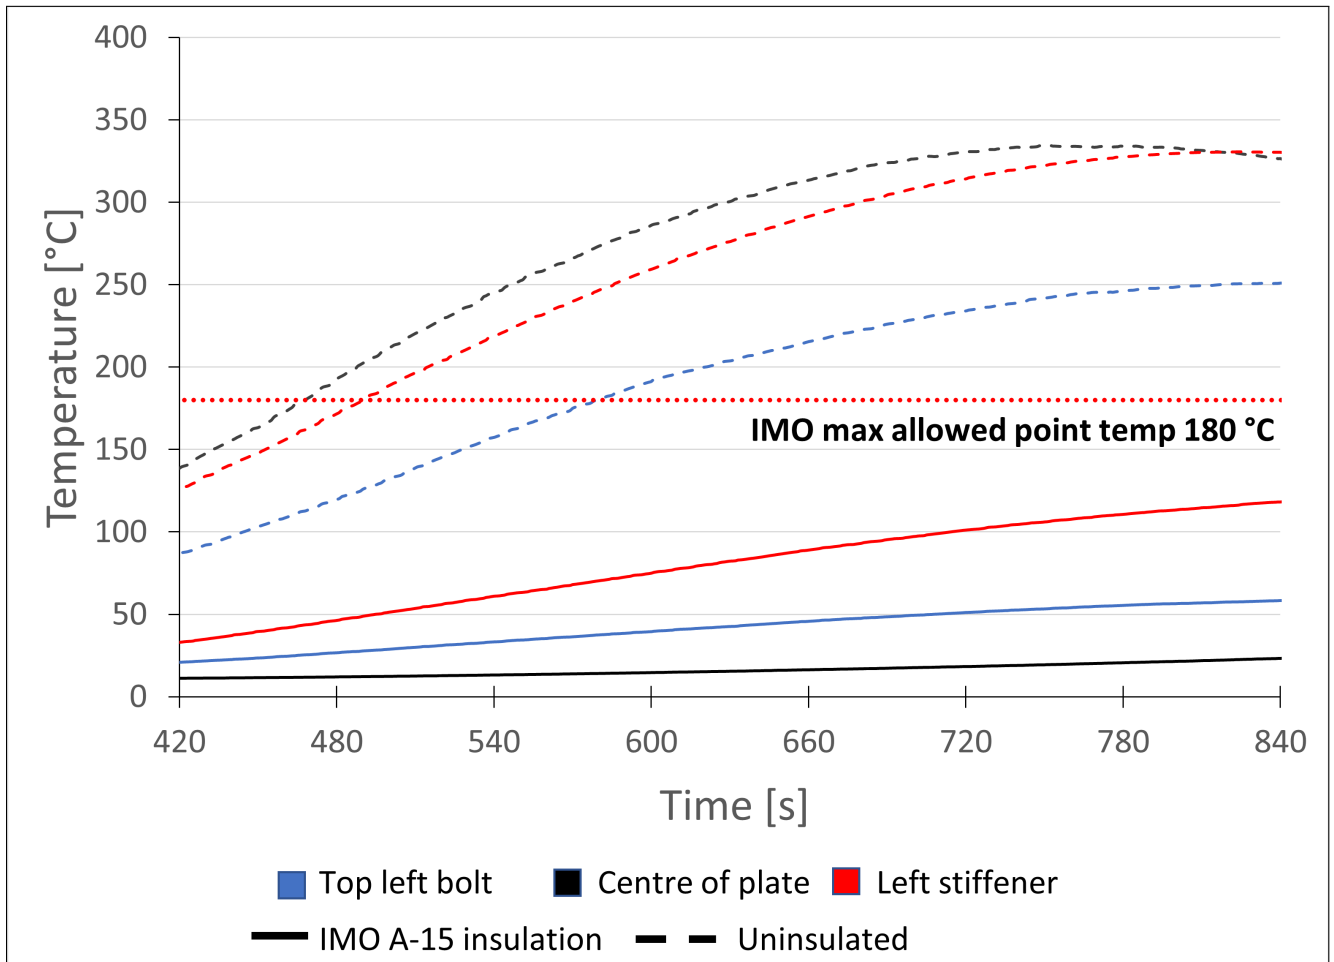
Figure 4.68: Comparison of a representative selection of key measuring points from the uninsulated versus the IMO A-15 insulated tests during the AT time interval
