Parks for all: Information on accessibility and associated experiences.

A thesis
presented to the University of Waterloo
in fulfillment of the
thesis requirement for the degree of
Master of Environmental Studies
in
Geography – Tourism Policy and Planning

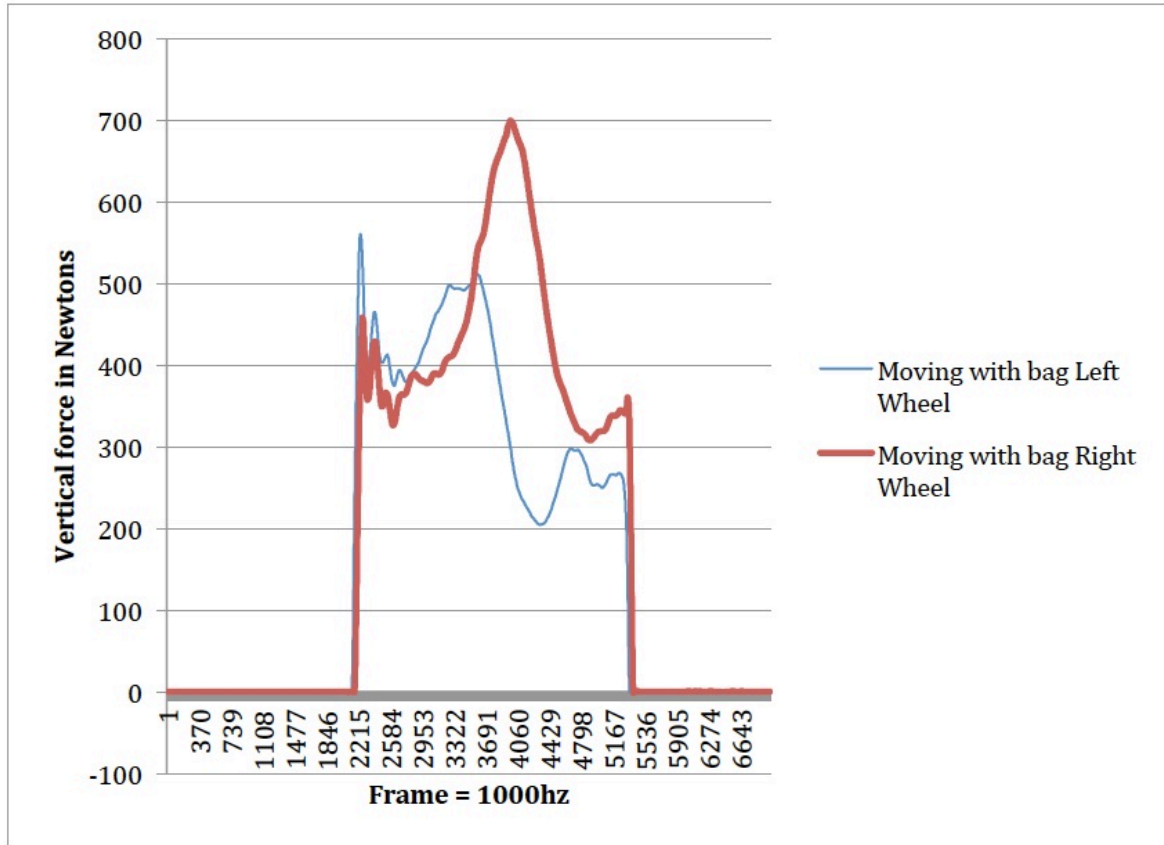
Figure 3.5.1, Graph of downward force on the front wheels of a Quickie GPV wheelchair. The graph illustrates the downward force and dispersal of weight over two wheels.

The penetration data collected in the fieldwork was based on the two front wheels of a Quickie GPV wheelchair. Two wheels may diffuse weight, and load bearing of the wheelchair’s occupant, to generate measurements directly related to the trail surface density. However, there are other variables to consider. The weight applied to the front wheels will vary with individuals. Dimensions of the front wheel may offer more or less penetration into surfaces based on the width of the wheel. Force plate data was collected on the GPV wheelchair’s front wheels.

Calculations for the front wheels are measured in newtons. Newtons are the measure of force collected at a rate of 1000hz (per second). The horizontal axis is frames per data point, 1000hz per second.

Figure 3.5 and figure 3.6, demonstrate the difference in vertical and shear force placed on two front wheels. The red and blue lines represent the left and right wheels respectively. The contact point has a surface area of 2.6 cm² for each wheel. The peaks on both figures illustrate the progression on and off the force plates. The difference in force from left to right side tires is attributed to the motion of a right turn before backing off the force plate. Low values (near zero) are lateral movements. Figure 3.5, the red line (right side front wheel) has higher force. Figure 3.6 shows a negative succession in the measures as it represents the shear force exerted in reverse direction.

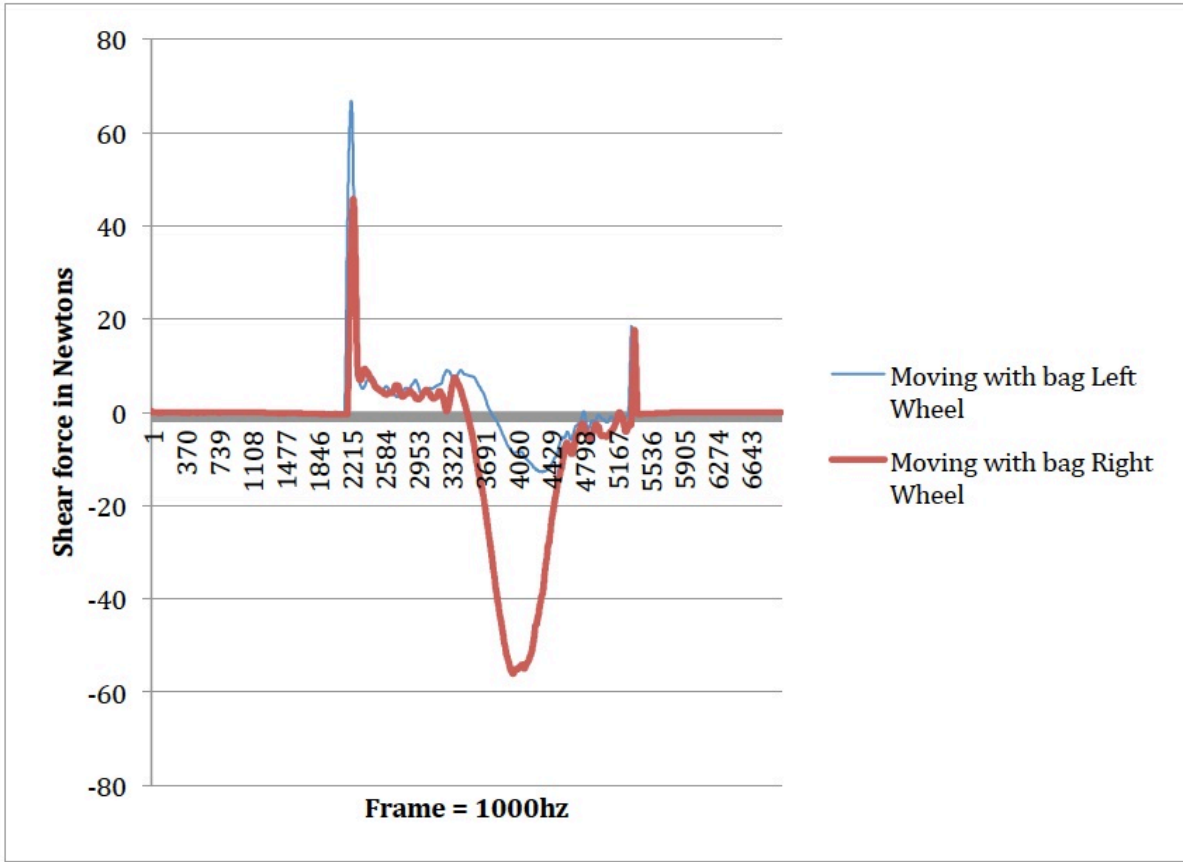
Figure 3.5.2, Graph of shear force on the front wheels of a Quickie GPV wheelchair. The graph illustrates the effects of shearing with a change in direction of two wheels.

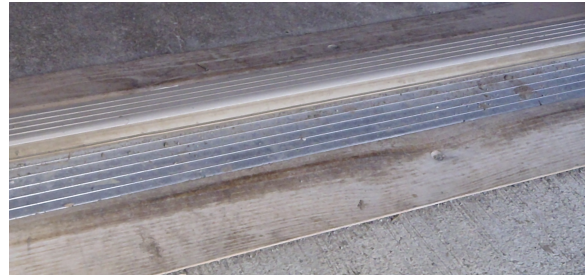
Figure 5.1.1 – The threshold into the doorway was higher than 1.27 cm. To fix the difference in transition over the threshold an angled board is placed on the in/outside of the threshold, which reduces the impact of a poor transition.

Numerous locations within the study sites had doorways with thresholds. The *Ontario Building Codes Barrier-free Design 1992* indicates accessible threshold heights should be 1.27 cm. This height was exceeded in numerous locations; however, this could be easily remedied with use of an angled piece of wood (Fig.7) fastened to the exterior or interior threshold. The cost for door replacements may exceed budget allotments but the proposed remedy would be cheaper than replacement with a positive return on access.

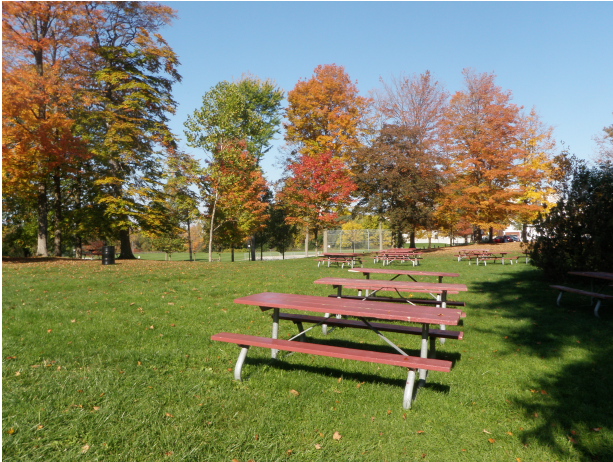
Some picnic areas within the park have large grass surfaces, which are difficult to traverse. Two accessible picnic tables were found.

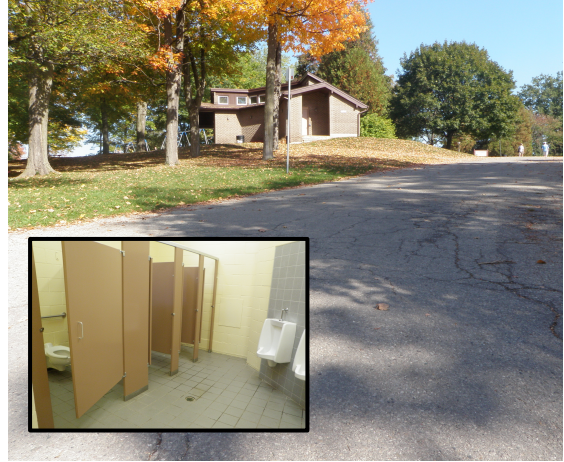
Washrooms were not listed accessible. However the eastside site provided access. The hillside location may be limiting.

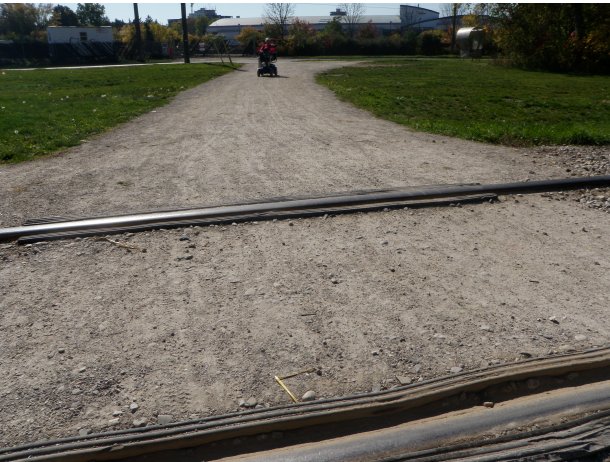
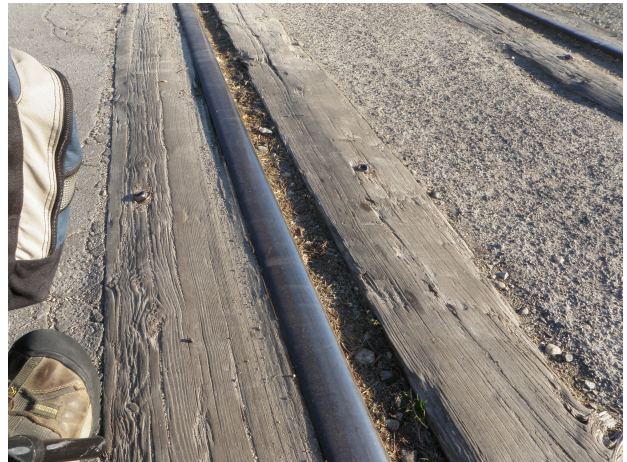
The rail crossings in Waterloo Park are difficult to cross for a person in a wheelchair. The two photos illustrate how surface material choice may limit accessibility. Through use and weathering the crossings have deteriorated, which act as a barrier to use.

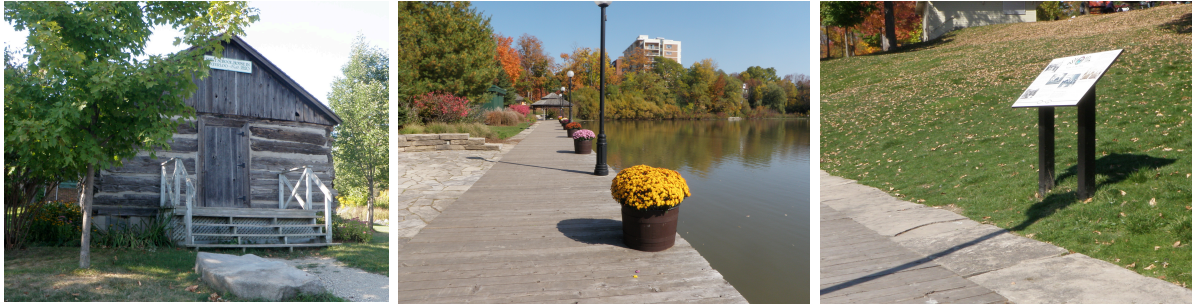
A variety of park features offer an equal array of accessibility. The Schoolhouse (left photo) is not accessible to people with impairments. The boardwalk (middle photo) around Silver Lake is level and wide. Transitions from the boardwalk are inconsistent and may be limiting. Interpretive panels (right photo) educate visitors of the park's history. Placement of the panel does not provide an equal opportunity to access.

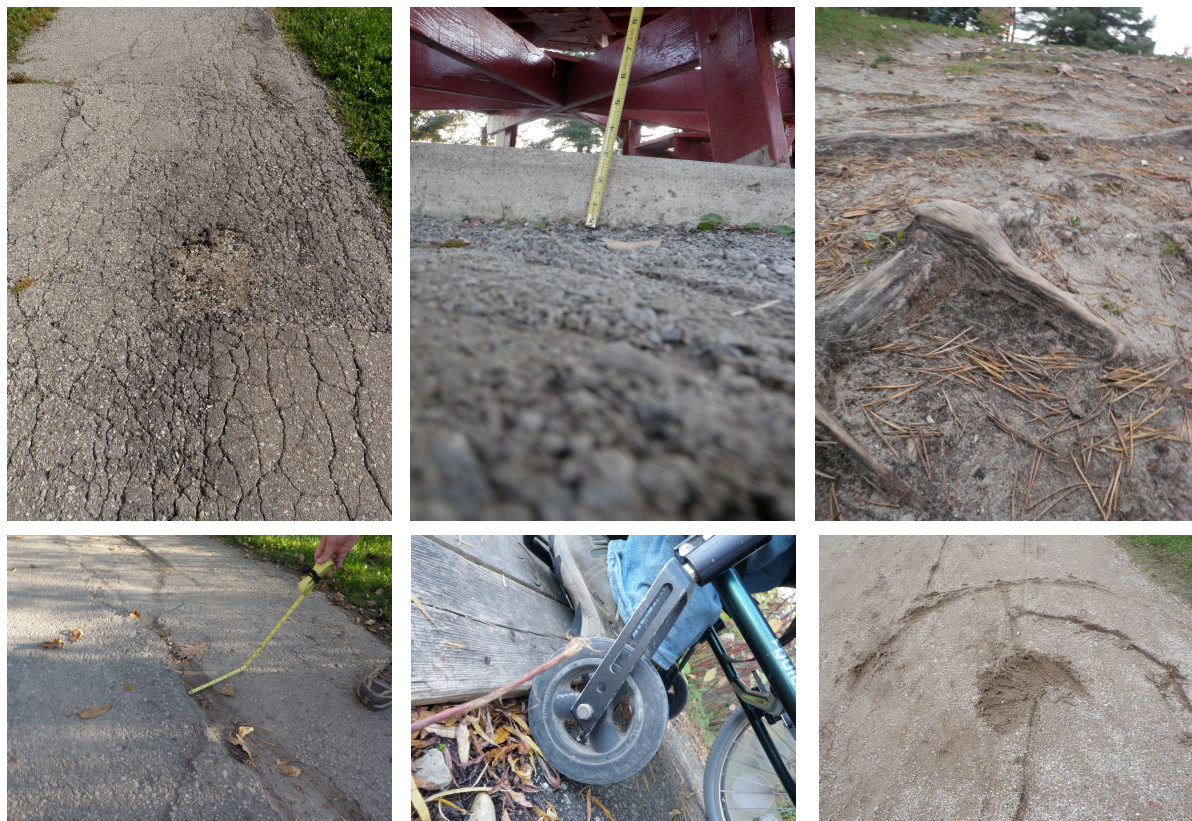
Trail surfaces in the park vary in density and materials. Deterioration of asphalt (left photos) creates hazards for people of any ability. Transitions (middle photos) were substantial onto various surfaces. Trail surfaces (right photos) were found marred with roots and loose density, which created limitations.

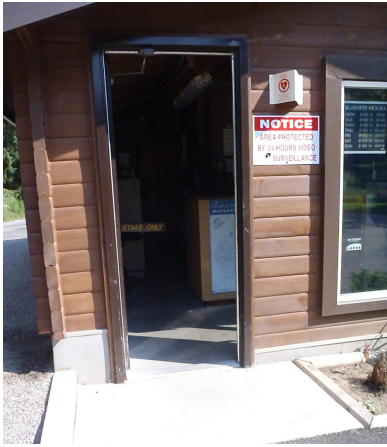
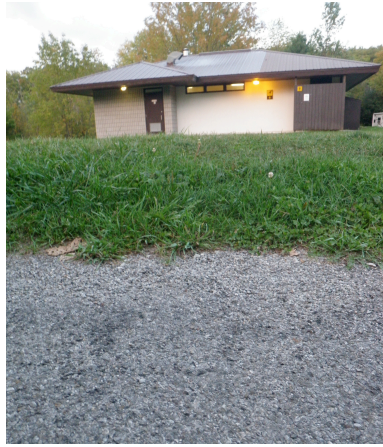
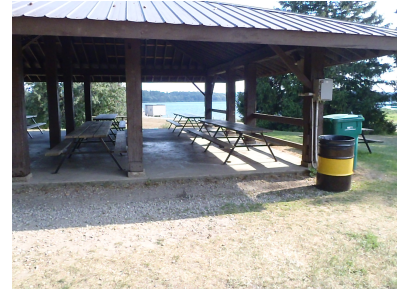
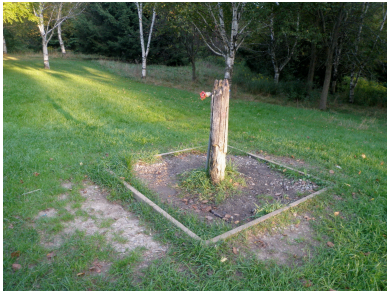
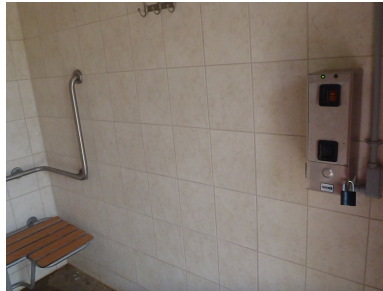
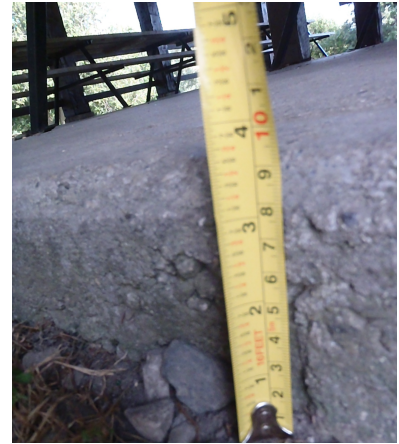
The gatehouse's (top left photo) modernity furnishes an ease of use. Yet, constructed obstacles (bottom left photo) around water taps impede independent use. The one regularly available comfort station (middle photos) is limited by design. The large grass crossing is a barrier to access. Placement of fixtures within the accessible shower prevents independent use. Picnic shelters (right photos) have considerable transitions onto the shelter floor.

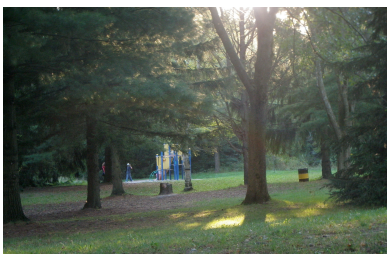
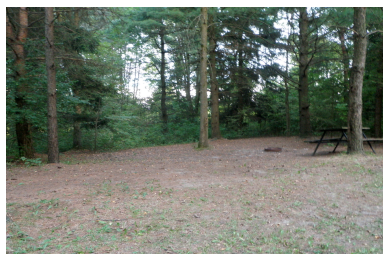
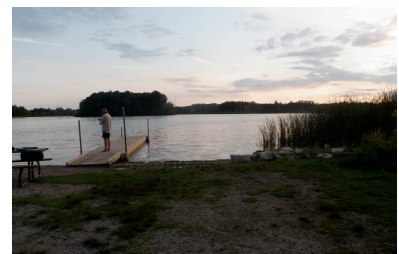
Independent outdoor experiences will be determined by the limitations of one's impairment. The inaccessible playground (left photo) is not convenient to any accessible parking. Campsites (middle photo) have a multivariate of ground surfaces. Visitors with impairment need to determine if a specific site will suit their personal needs. The boat launch (right photo) offers the closest access to the water's edge.

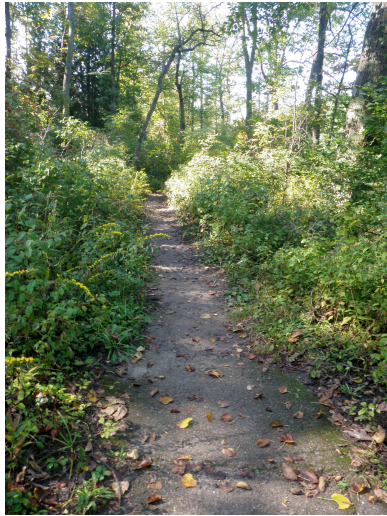
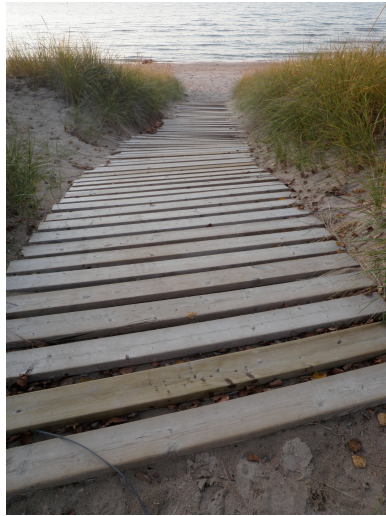
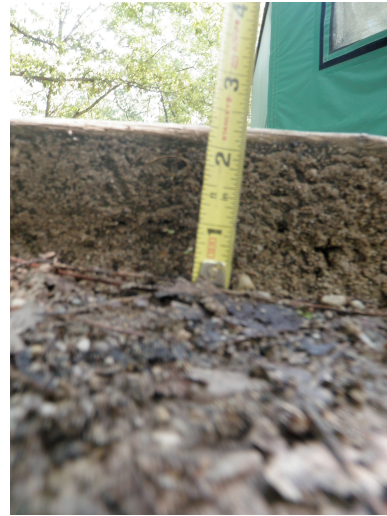
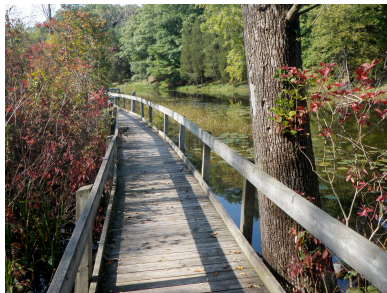
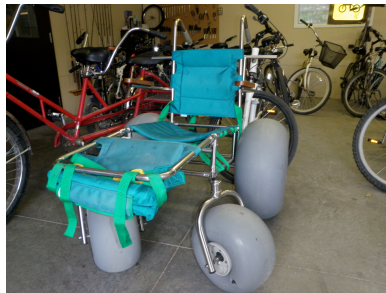
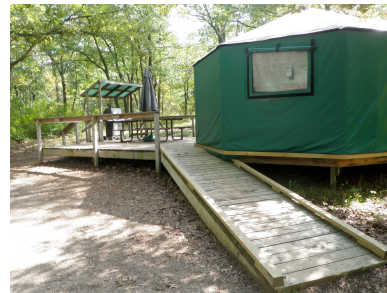
Sections of the Riverside Trail (left photos) alternate between accessible and inaccessible. Beach access (middle photos) is severely restricted. There is no independent beach access for a person in a wheelchair. Yurts (right photos), in the Riverside campground, provide access. However, there are limitations by design. Ramps were noted to have transition differences. Yurt entrance configurations may limit ingress.

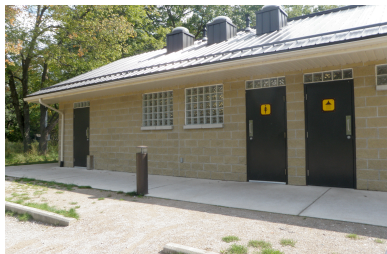
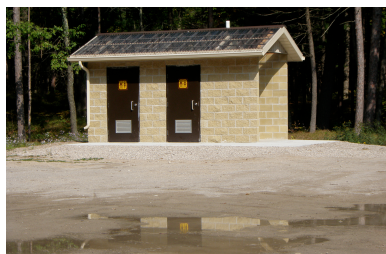
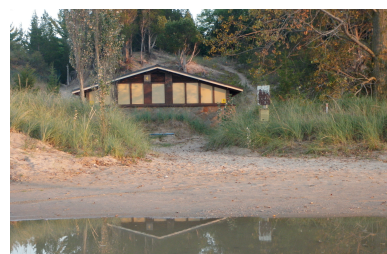
Washroom structures within the park are picture here. Modern washrooms (left photo) have the greatest access. Updated campground washrooms may have very few limitations. Vault toilets (middle photo) are being renovated at various locations in the park. Access may be slightly reduced by the type of fixtures (sinks and faucets) and their location. Beach comfort stations (right photo) were not accessible by design and location. Burley Beach comfort station is reportedly updated – due to seasonality the location was not observed.

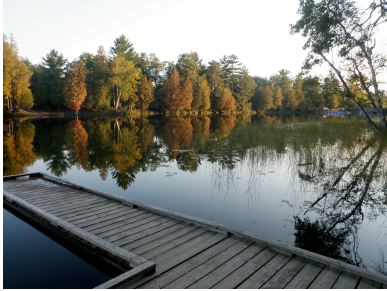
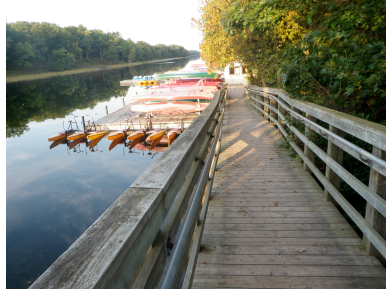
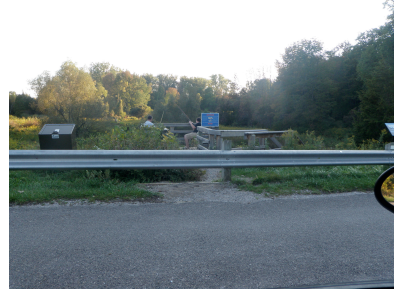
There are points of access along the Old Ausable Channel. The canoe launch (left photo) has the closest access to the waterline. Fishing is not permitted at this location. The canoe rental dock (middle photo) has an extensive ramp with smooth transitions. However, there is no equipment for people with impairment that may facilitate use of watercraft. Entrance to the fishing platform (right photo) is blocked by a roadside guardrail.

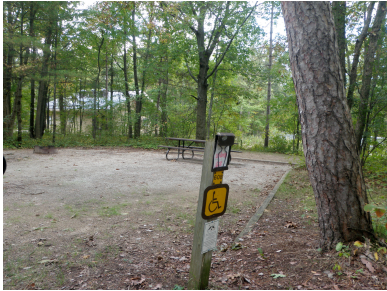
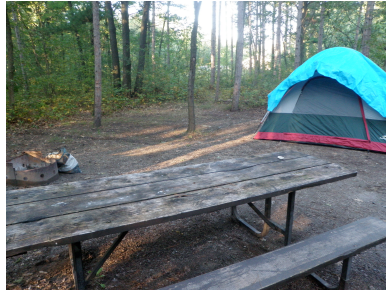
Though accessible campsites are provided (left photo), a regular campsite in the Riverside campground was preferable to the researcher (right photo).

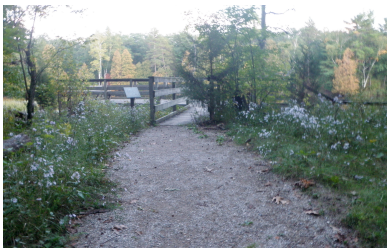
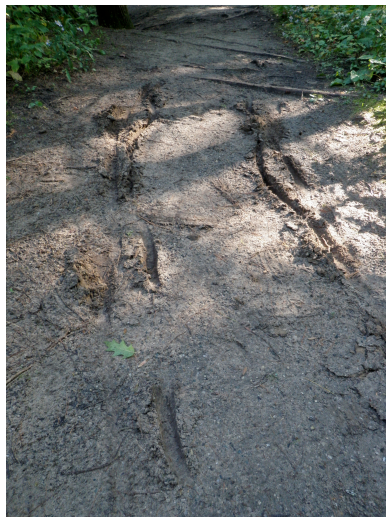
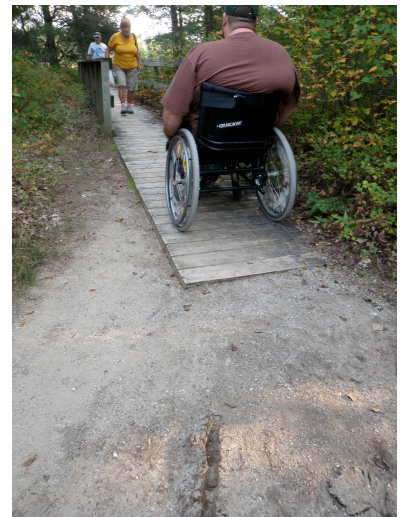
Trails in the park provide an independent experience for visitors with impairment. The accessible trails (left photos) have wide level pathways. Yet, limits to access can be found. Loose trail surface density (middle photo) can impede forward progression along some trails. Dimensions of access infrastructure (right photo) are narrow. Furthermore, vegetation may cause additional narrowing.

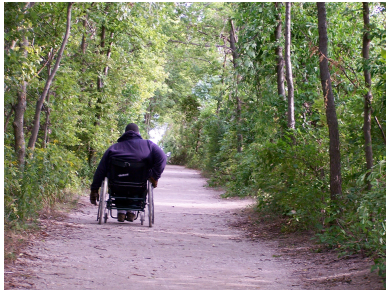
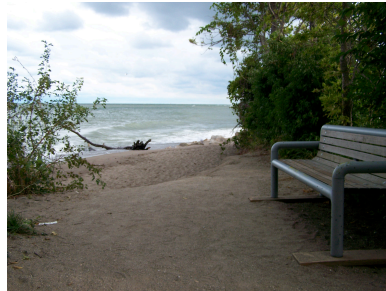
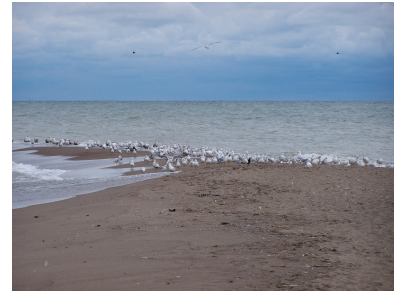
Access to the tip of Point Pelee dashed expectations. Trails leading to the tip (left photo) reached a point where access was stopped (middle photo). It was the researchers' hope to sit on the tip of Canada's southern most point. Due to the constant geomorphic changes at the tip, permanent accessibility infrastructure cannot be placed.

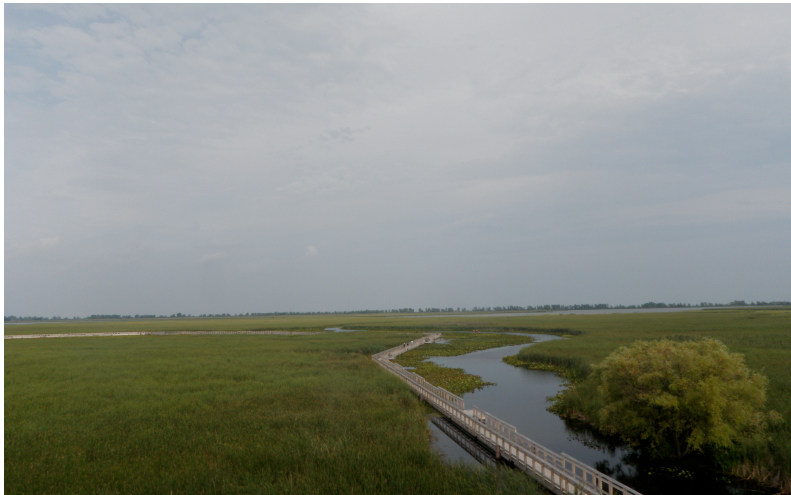
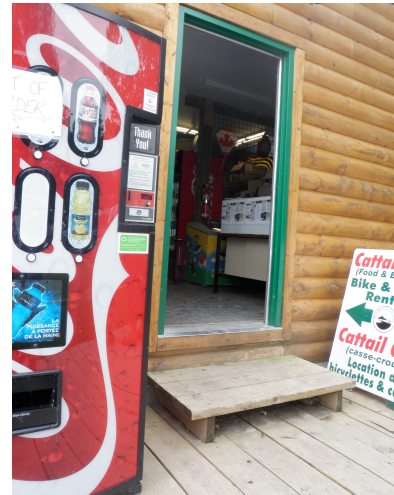
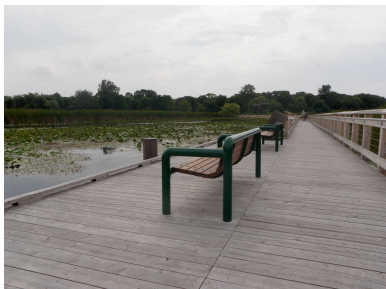
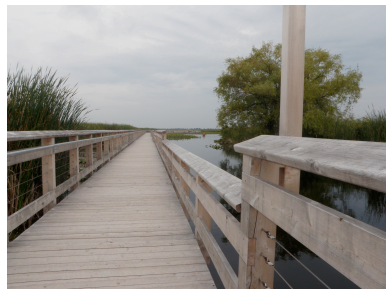
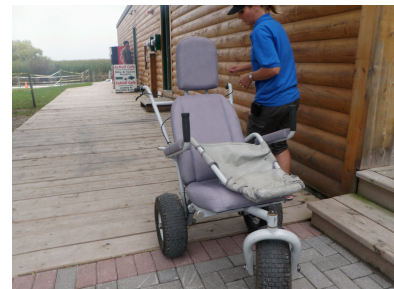
The Marsh Boardwalk (top left photo) is an excellent example of how user feedback yielded access beyond any standard. Sections of boardwalk without handrails (bottom left photo) create unobstructed views and access for nature appreciation. The alternate levels of handrails (middle photo) demonstrate the park's willingness to incorporate input from the disabled community. However, there are issues of access (right photos), the office for securing the all-terrain chair (ATC) is not accessible. The size of the device is limiting and does not grant independent use.

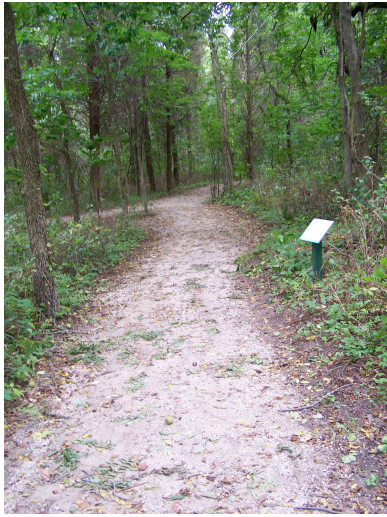
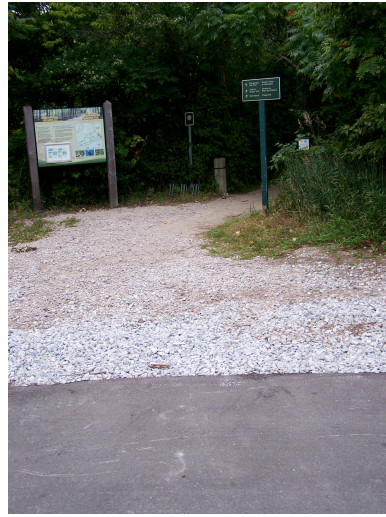
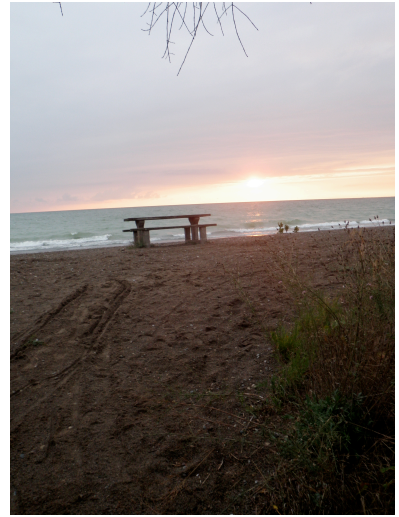
Trails in the park provide an independent experience for visitors with impairment. The accessible trail (left photos) has a wide level path with dense surface material. Yet, limits to access can be found. Crushed rock (middle photo) limited access at the trailhead. Independent access onto any of the park's beaches (right photo) is severely limited by loose sand surfaces.

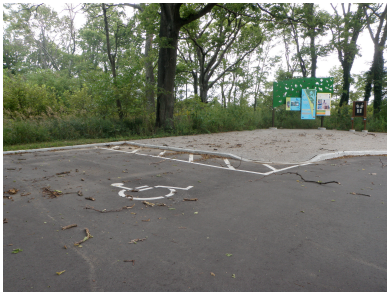
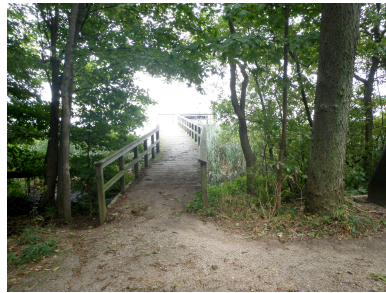
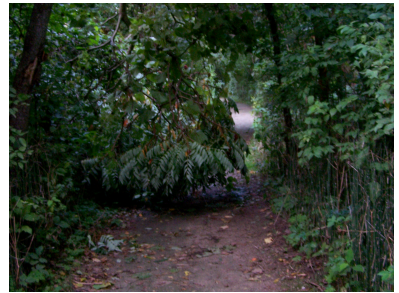
Upgraded accessibility (left photo) is an example the ongoing focus to improve the park experience for visitors. Access improvements are tied to infrastructure replacement. The Marsh Outlook (middle photo) may receive accessibility improvements when the boardwalk and platform has exceeded its lifecycle. The damaging effects of severe weather impeded access in various locations of the park (right photo).

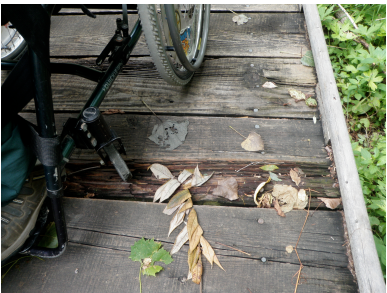
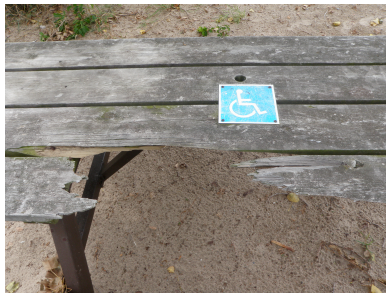
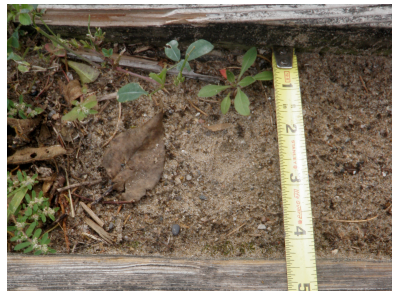
Deteriorated and damaged accessibility (above photos) is an example where increased monitoring may generate improvements.
