**Landslides triggered by the 1946
Ancash Earthquake (Peru) and geologic
controls on the mechanisms of initial
rock slope failure**

A thesis
presented to the University of Waterloo
in fulfillment of the
thesis requirement for the degree of
Master of Science
in
Earth Sciences

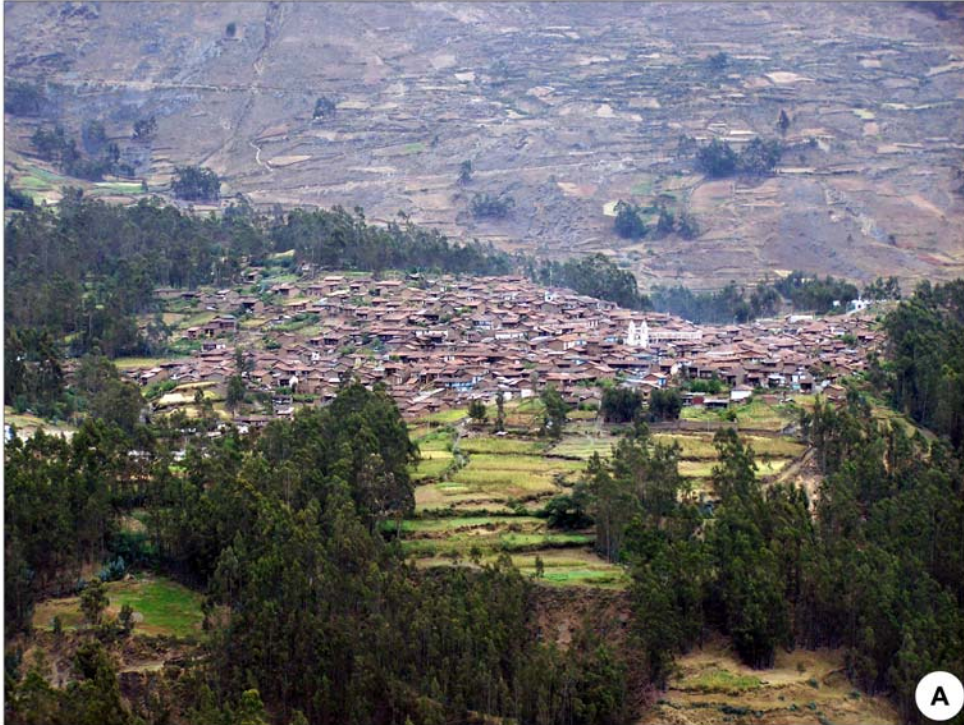
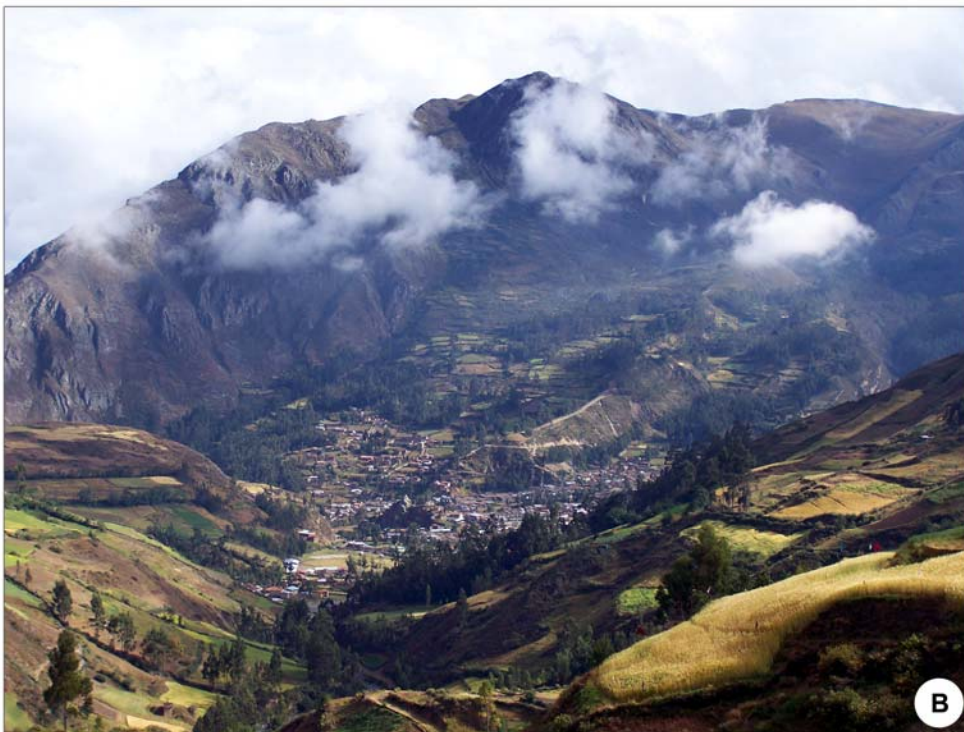
Figure 2. 4: The present day setting (2008) of the villages Pampas (A) and Conchucos (B)

Both villages are located within the epicentral area of the 1946 Ancash earthquake and were more or less destroyed during the earthquake.

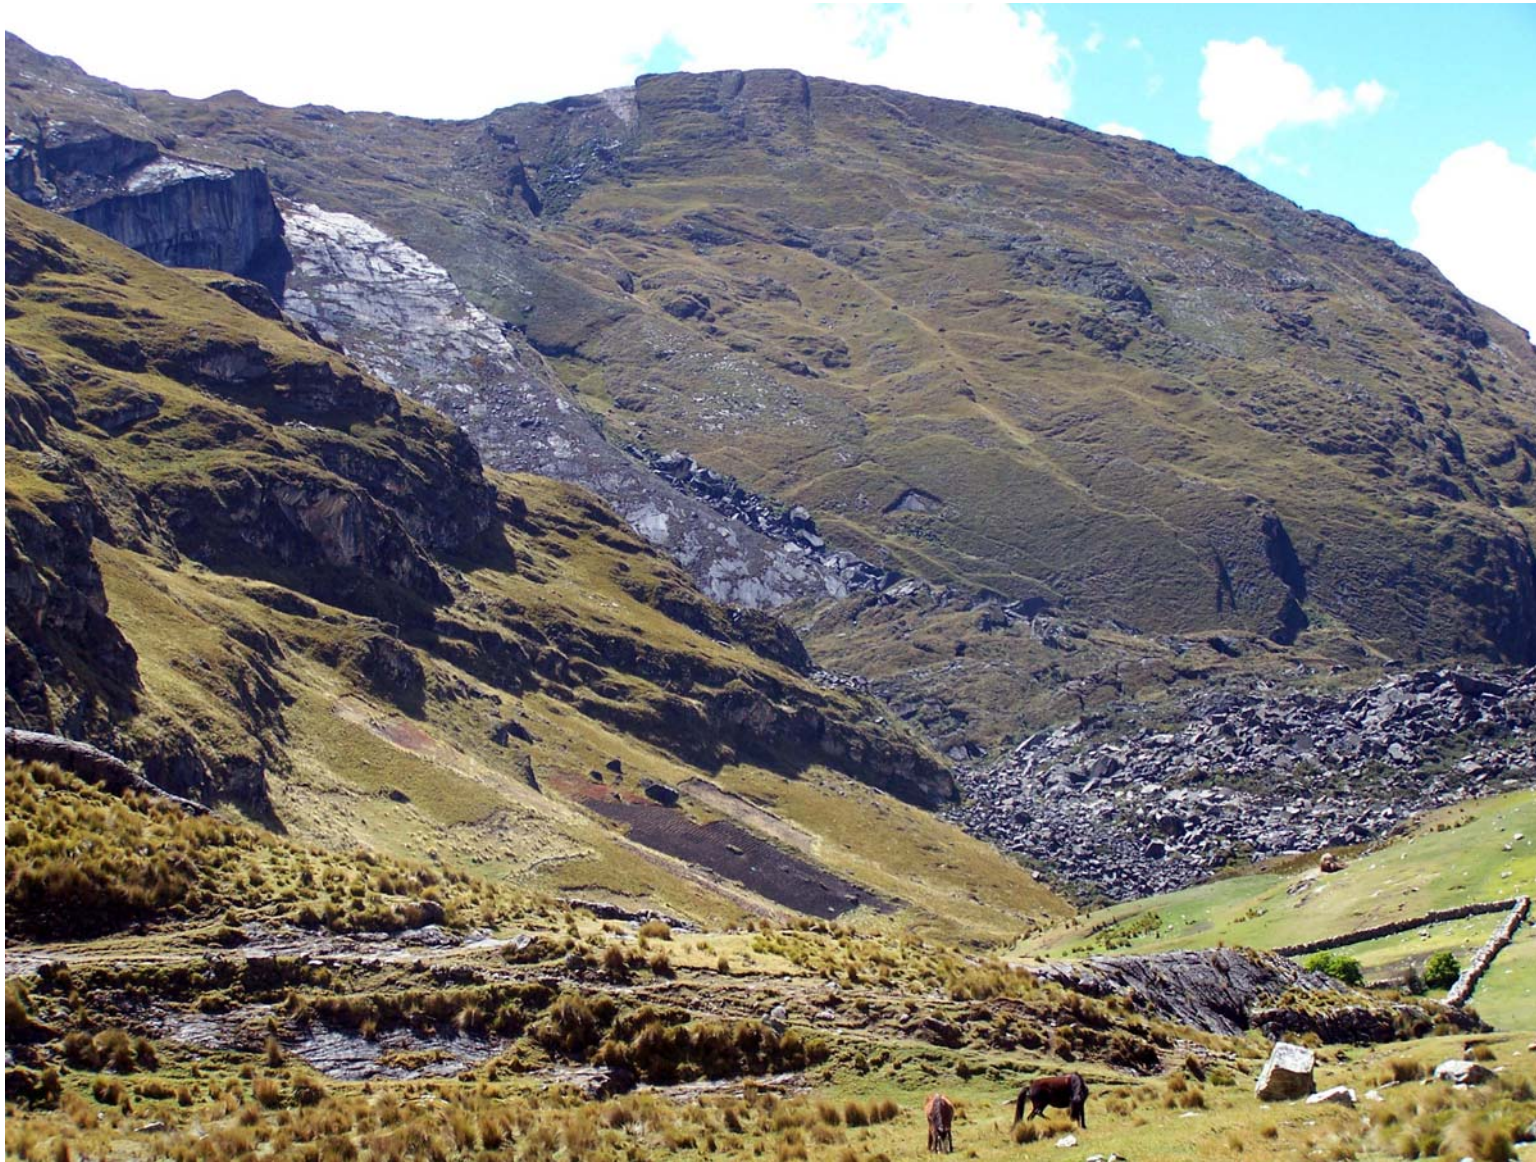
Figure 2. 17: View of the Suytucocha rock avalanche looking northeast

The Suytucocha rock avalanche is a wedge failure formed by the intersection of a set of southwest dipping bedding planes shown on the right and a set of east dipping discontinuities shown on the left. A nearly-vertical southeast dipping set of discontinuities forming the backscarp is also evident near the top of the source slope.

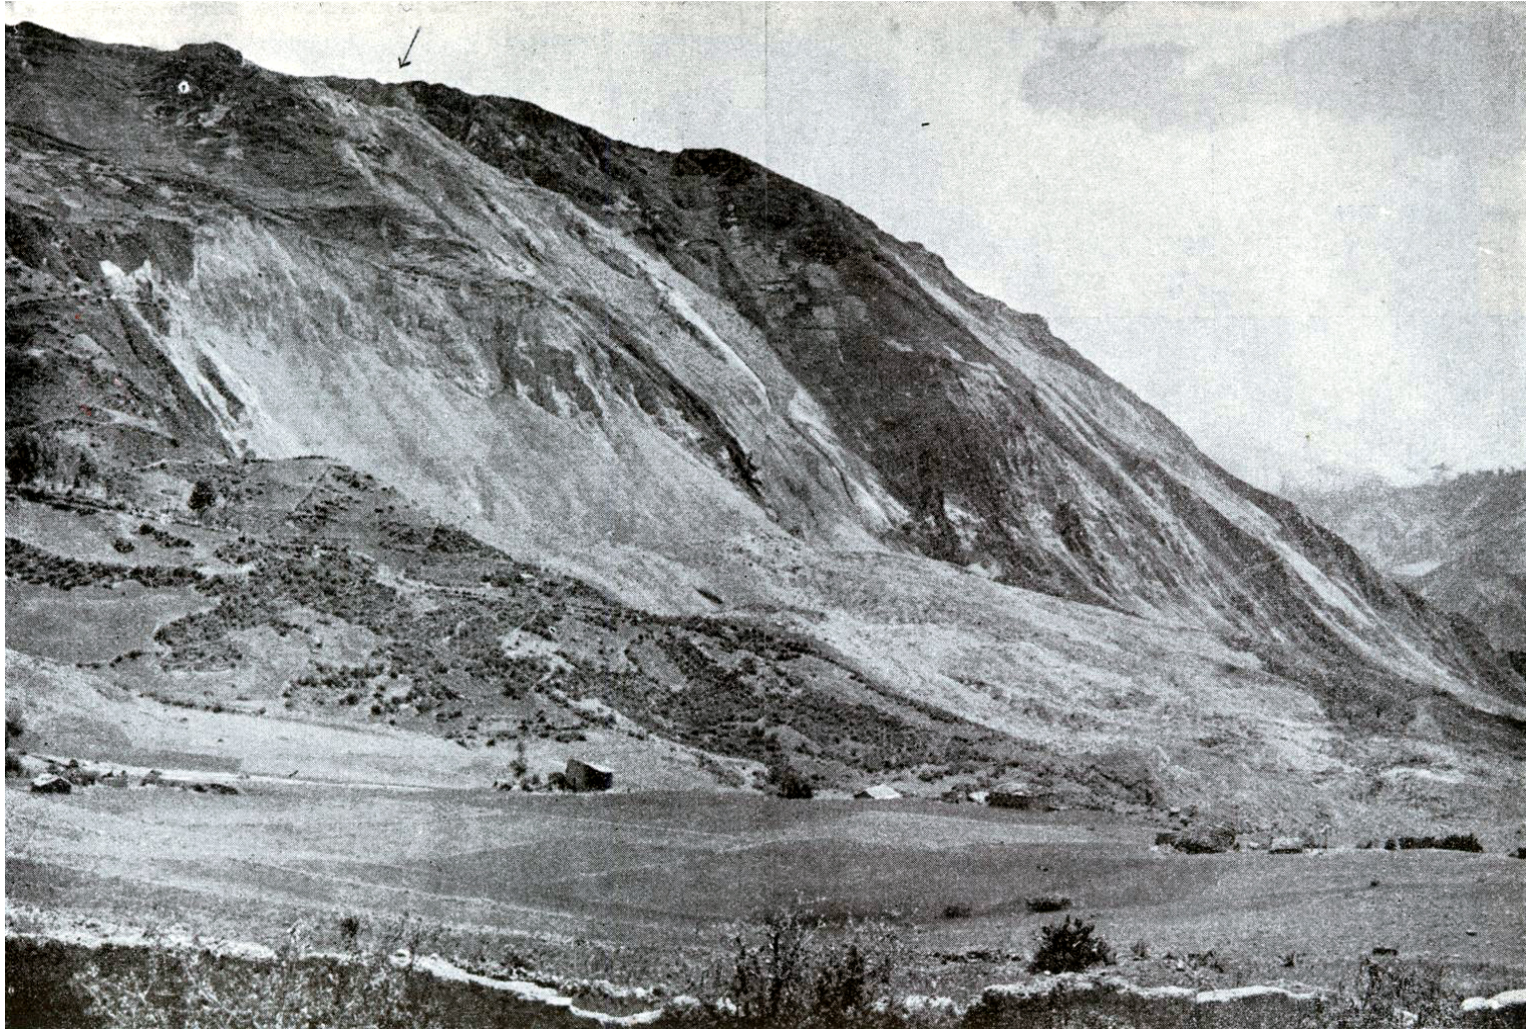
Figure 2. 19: View of Quiches debris avalanche looking northwest taken by Heim (1949)

The Quiches debris avalanche (Figure 2. 19, 2. 20 and 2. 21) (8° 23' 35" S, 77° 30' 18" W) is located approximately 38 km from the earthquake epicentre within the IX intensity isoseismal (Figure 2. 12). The debris avalanche was reported as the failure of Huaychachaco hill due to the 1946 Ancash earthquake (Heim, 1949; Silgado, 1951). The Quiches debris avalanche along with associated failures along the same slope are shown in an aerial photograph by Heim (1948) (Figure 2. 20). Field observations indicated that the Quiches debris avalanche and the other earthquake-triggered failures noted in Figure 2. 20 occurred along a reverse slope where the dip of the Cretaceous strata is into the slope. This is also evident in the profile of the Quiches debris avalanche (Figure 2. 22) (Heim, 1949).

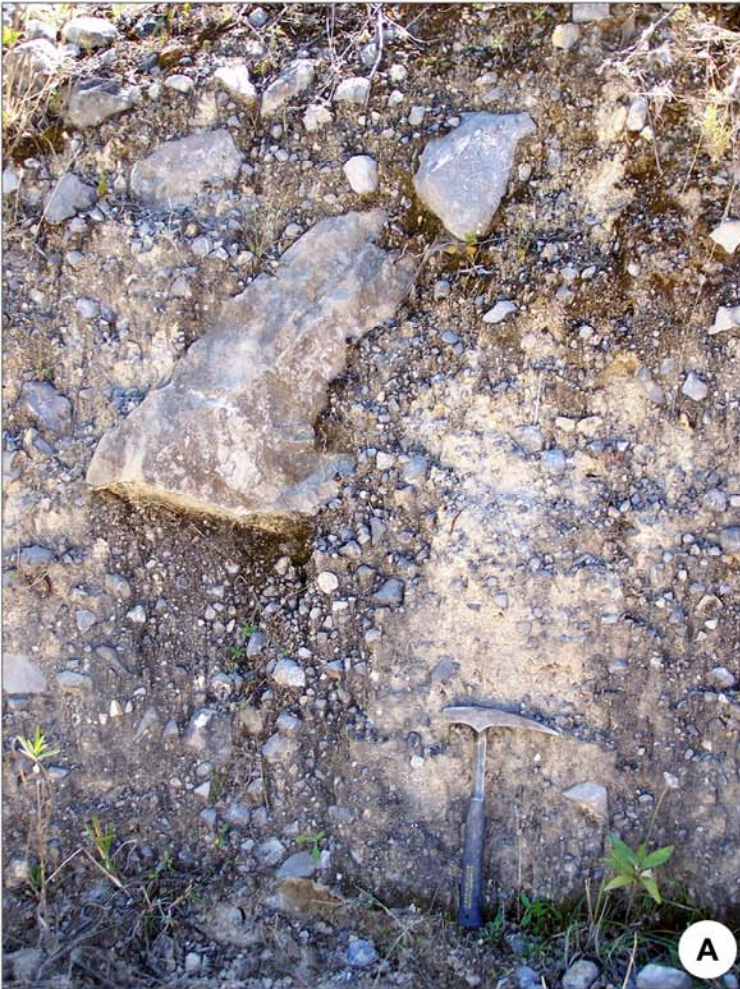
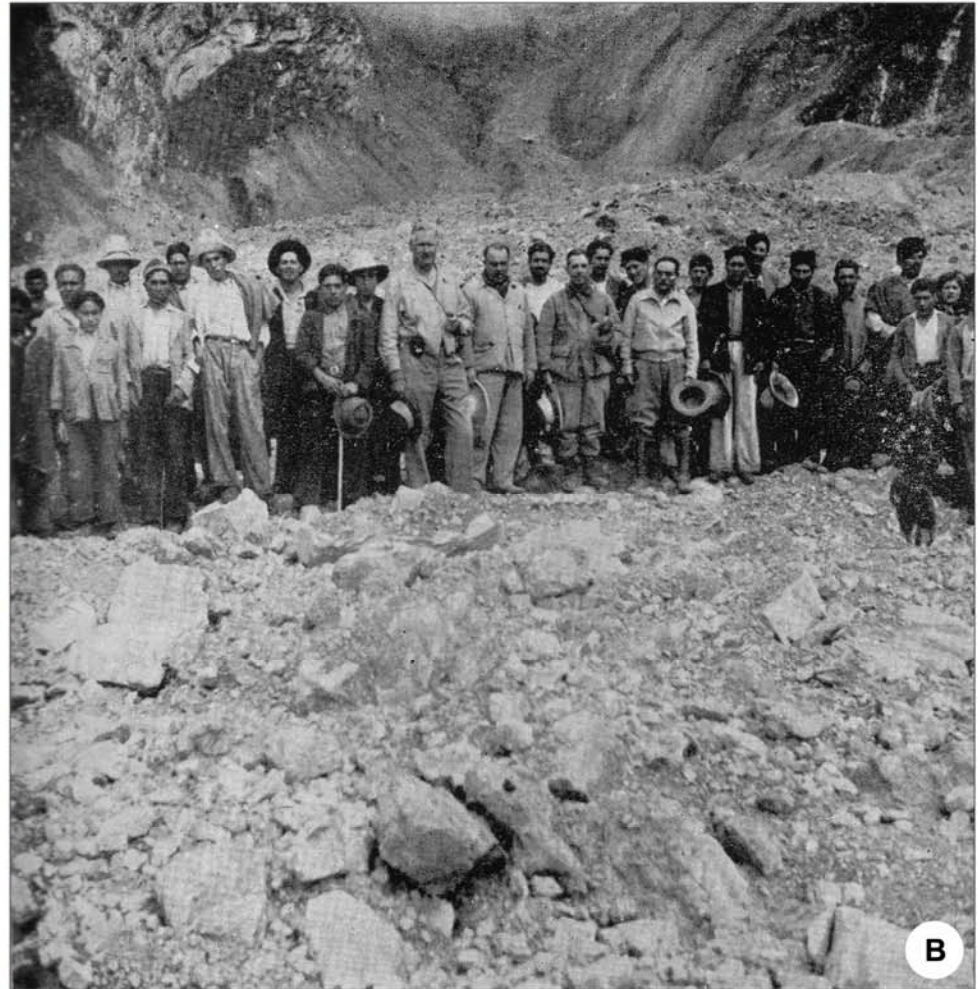
Figure 2. 30: Debris at the Acobamba rock/debris avalanche

The source slope is underlain by limestone, shale and calcareous sandstone of the Parihuanca, Chulec and Pariatambo formations (Sanchez Fernandez, 1995) (Figure 2. 7). The debris of the Acobamba rock/debris avalanche is composed of small blocks in a finer matrix of colluvium (Figure 2. 30) which is also demonstrated in a 1946 photograph taken at the site following the occurrence of the failure (Figure 2. 30).

A - Photo of debris from the Acobamba rock/debris avalanche showing large boulders within a finer matrix. B - Photograph taken on-site at the Acobamba rock/debris avalanche in 1946 showing debris consisting of large boulders within a finer matrix. Reproduced from Silgado (1947).

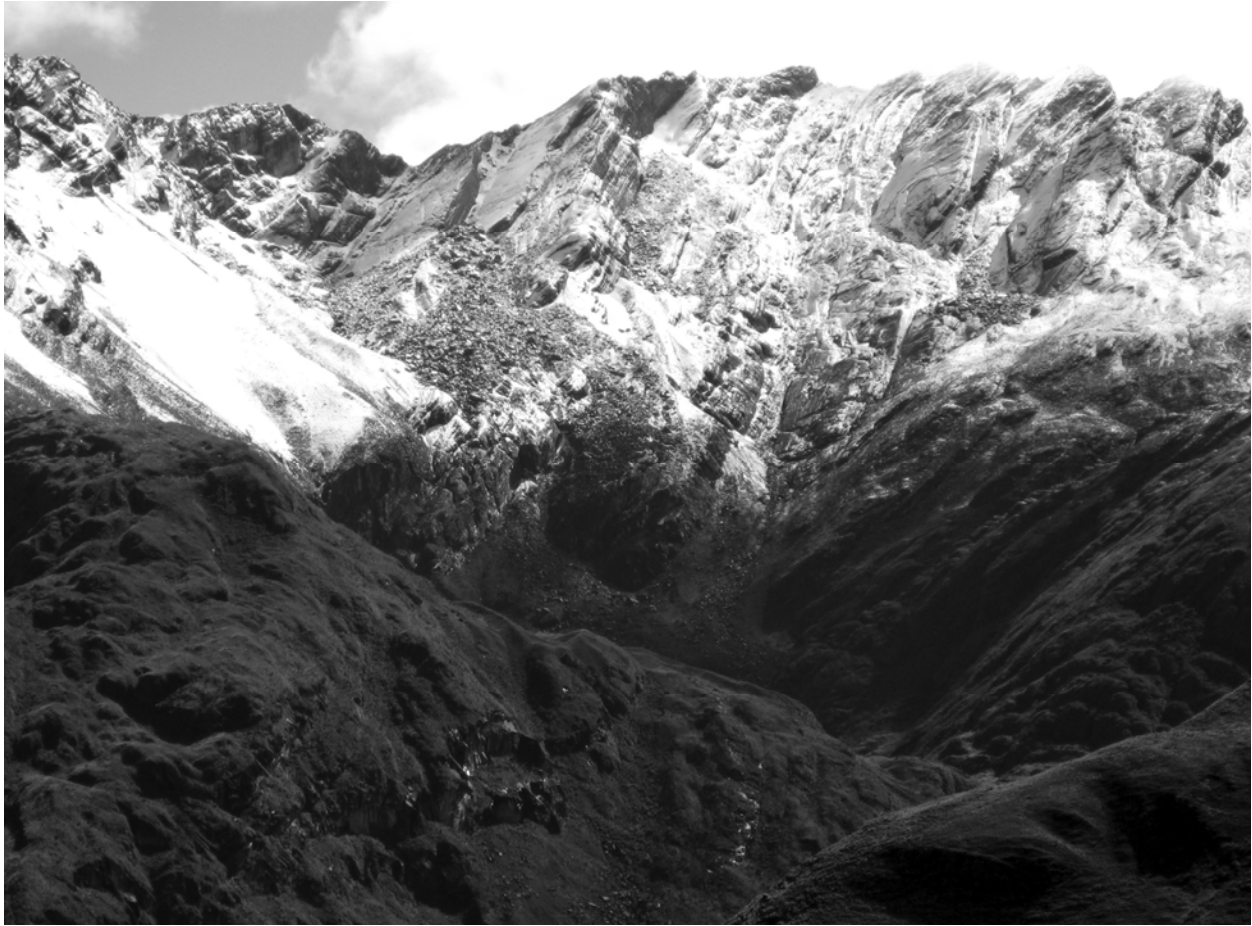
Figure 2. 31: The Lechecocha 1 rock avalanche, looking north

The rock avalanche initiated as a wedge failure in Cretaceous limestone formed by the intersection of southwest dipping bedding planes and a nearly-vertical northeast dipping joint set. The ridge forms the continental divide between the Atlantic (Amazon) and the Pacific.

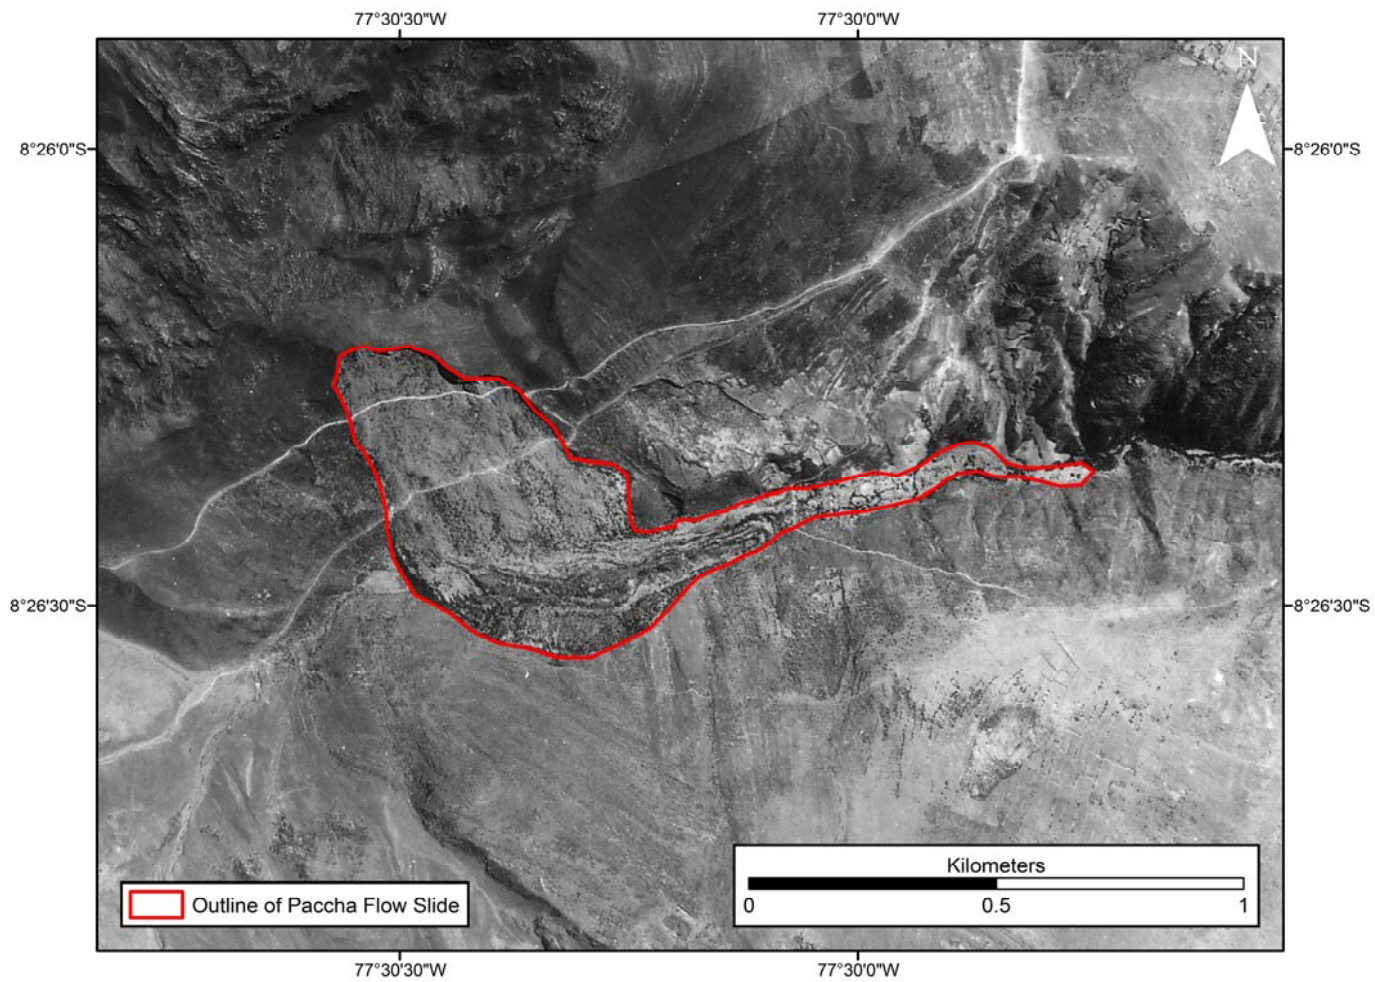
Figure 2. 34: Aerial photograph (1370PMW-M173-22497) of the Paccha flowslide

An average slope angle of 23° and slope dip direction of S 139° E was estimated for the Paccha flowslide. The failure occurred on the north side of the valley and debris flowed downslope into the valley bottom, running up the other side before being deflected downstream to the east (Figure 2. 34). The run-up is estimated to be approximately 30 m. A fahrböschung of 15° was calculated based on an approximate height of 300 m and length of 1000 m for the flowslide path.

The debris covers an approximate area of 150,000 m² with an approximate volume of 1,400,000 m³. The high mobility of the debris is evident from the run-up which occurred on the opposite side of the slope which probably caused a temporary landslide dam, before continuing further downstream.

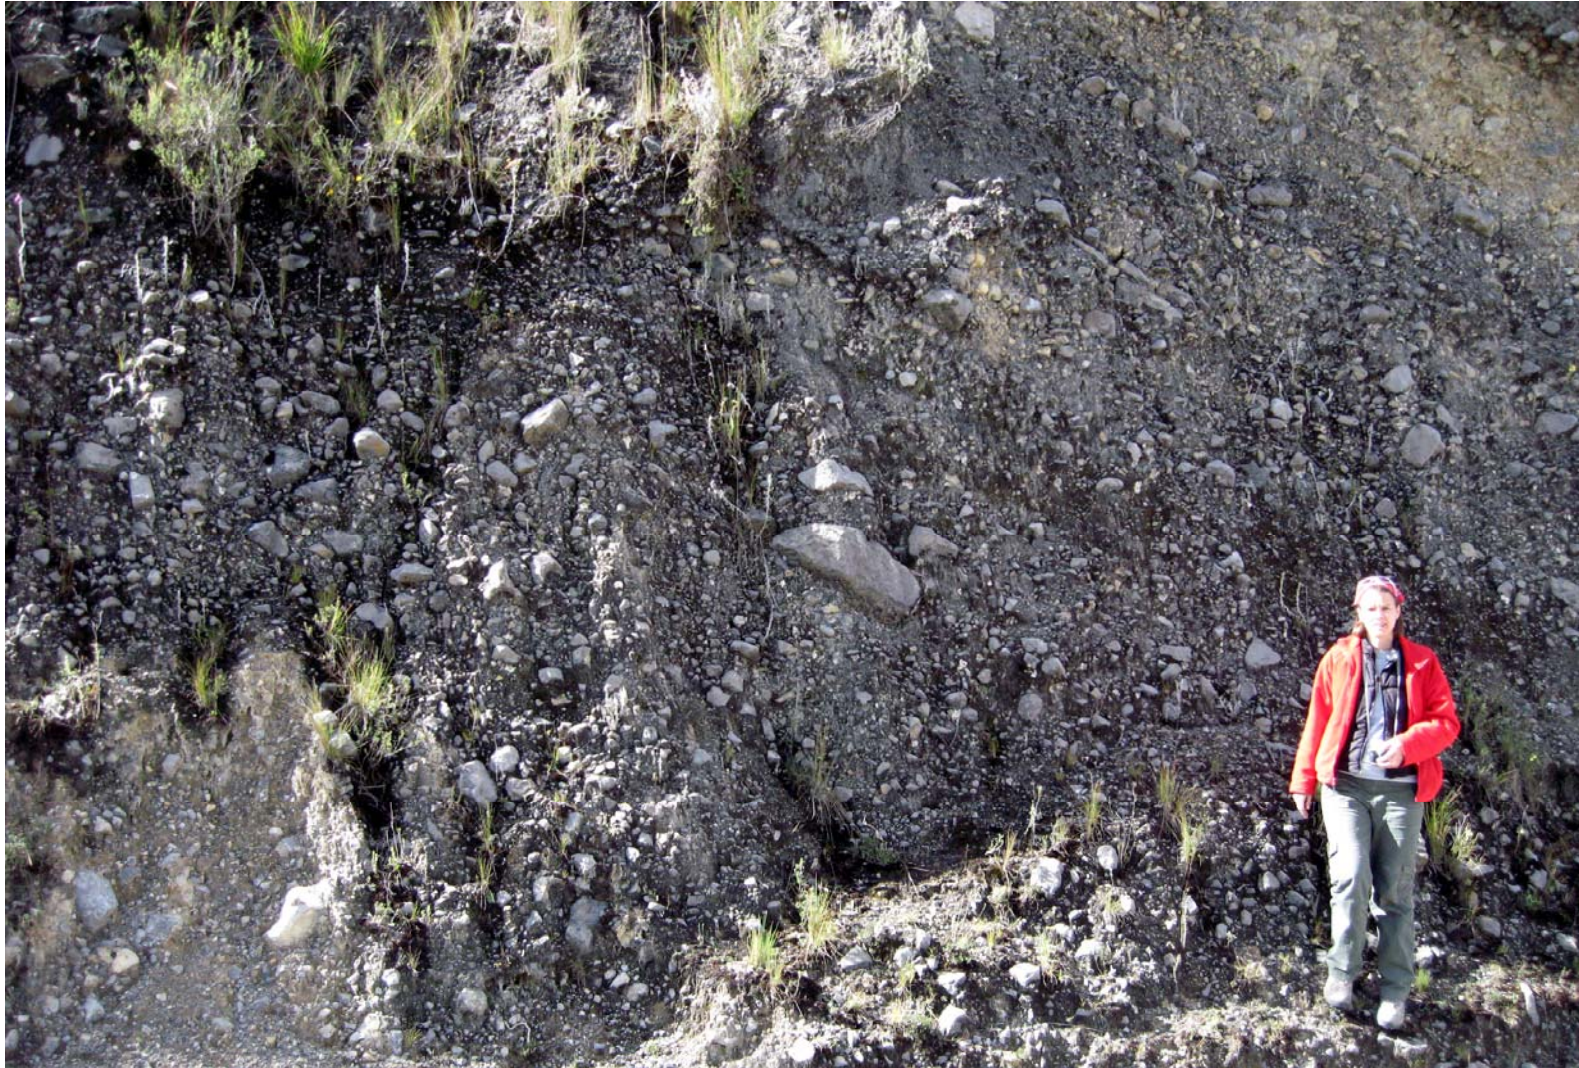
Figure 2. 35: Glacial (colluvial) materials involved in the Paccha flowslide

Exposure is located in the lateral scarp of the source area. The materials consist of limestone blocks in an argillaceous matrix.

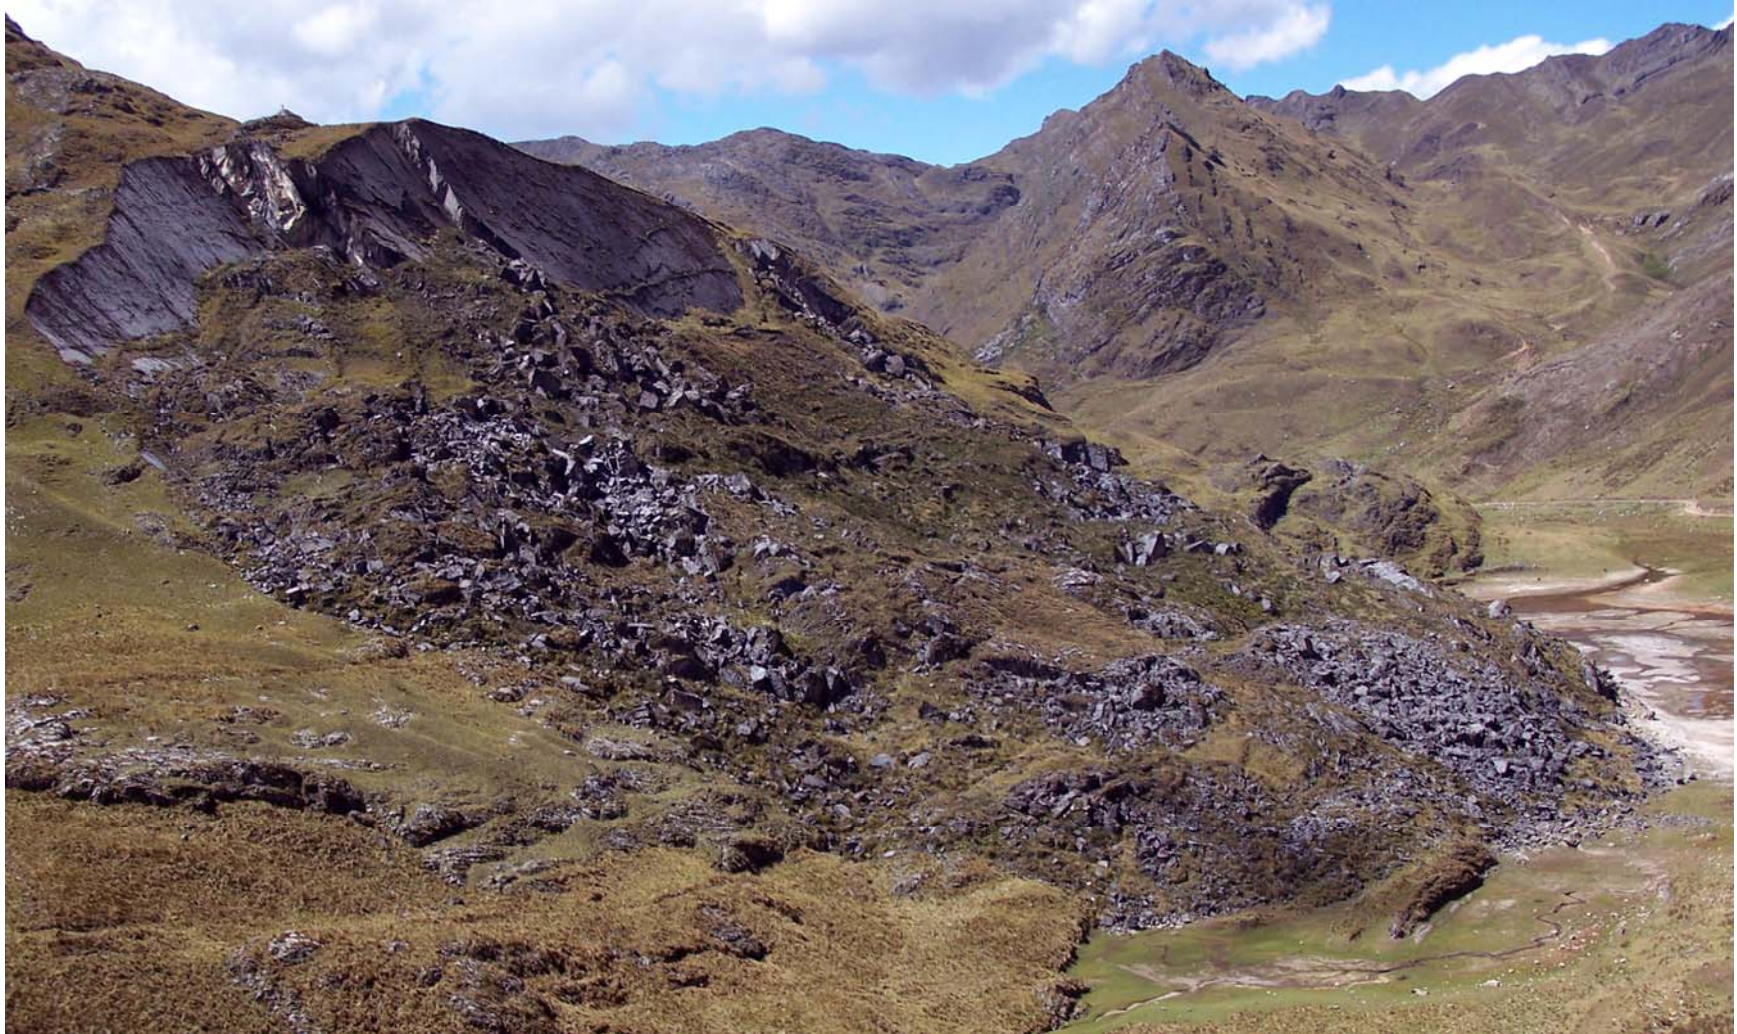
Figure 2. 36: The Peñacocha rock slide

Peñacocha rock slide showing failure along southwest dipping bedding planes into the valley bottom below.

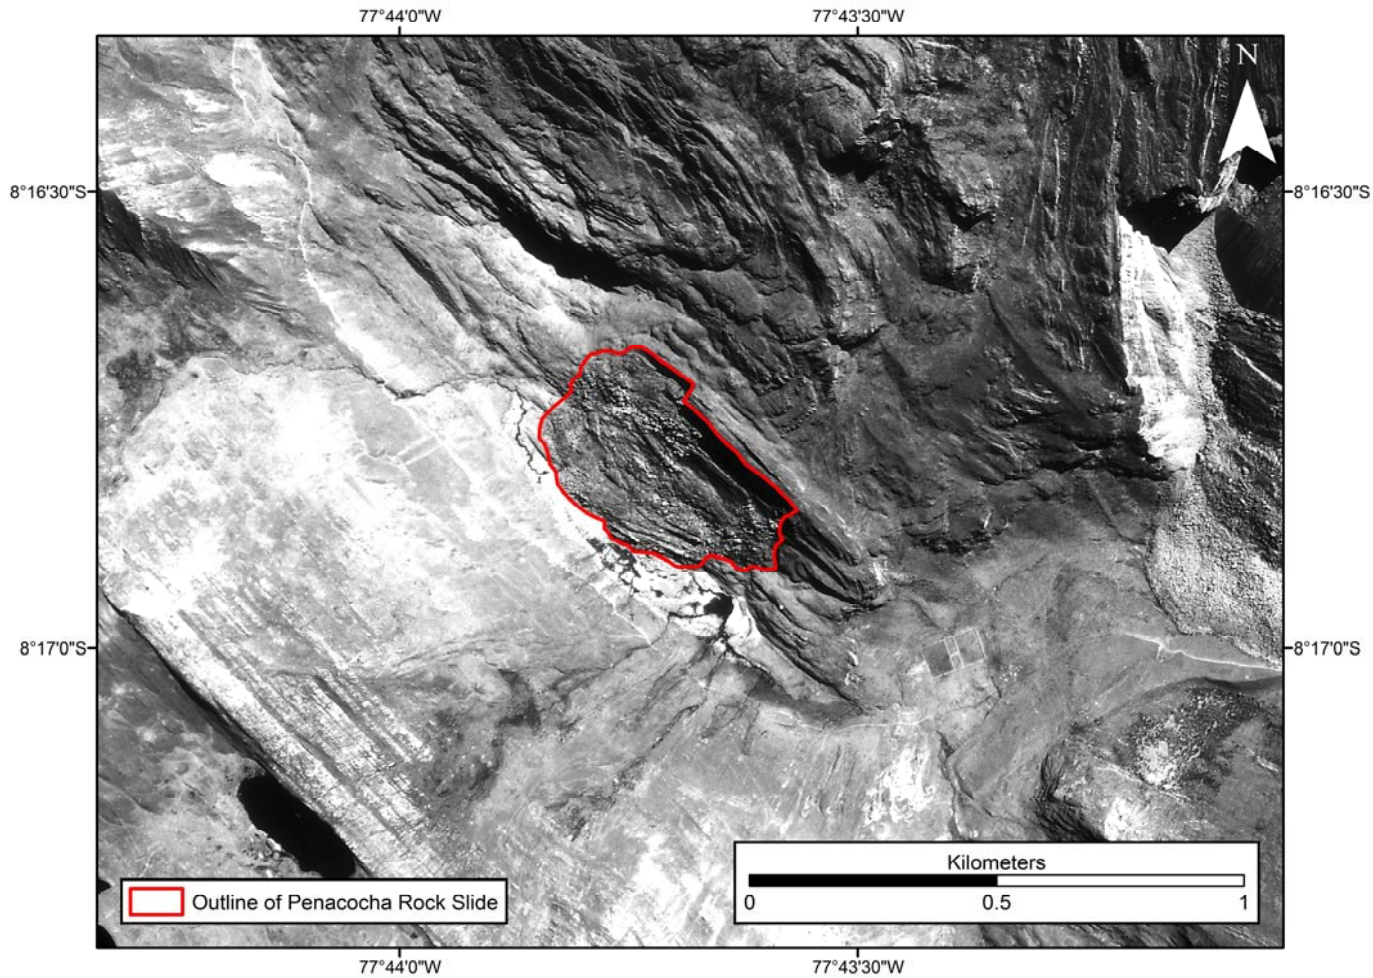
Figure 2. 37: Aerial photograph (1370PMW-M130-16416) of the Peñacocha rock slide

Note Suytucocha rock avalanche at right margin of photograph.

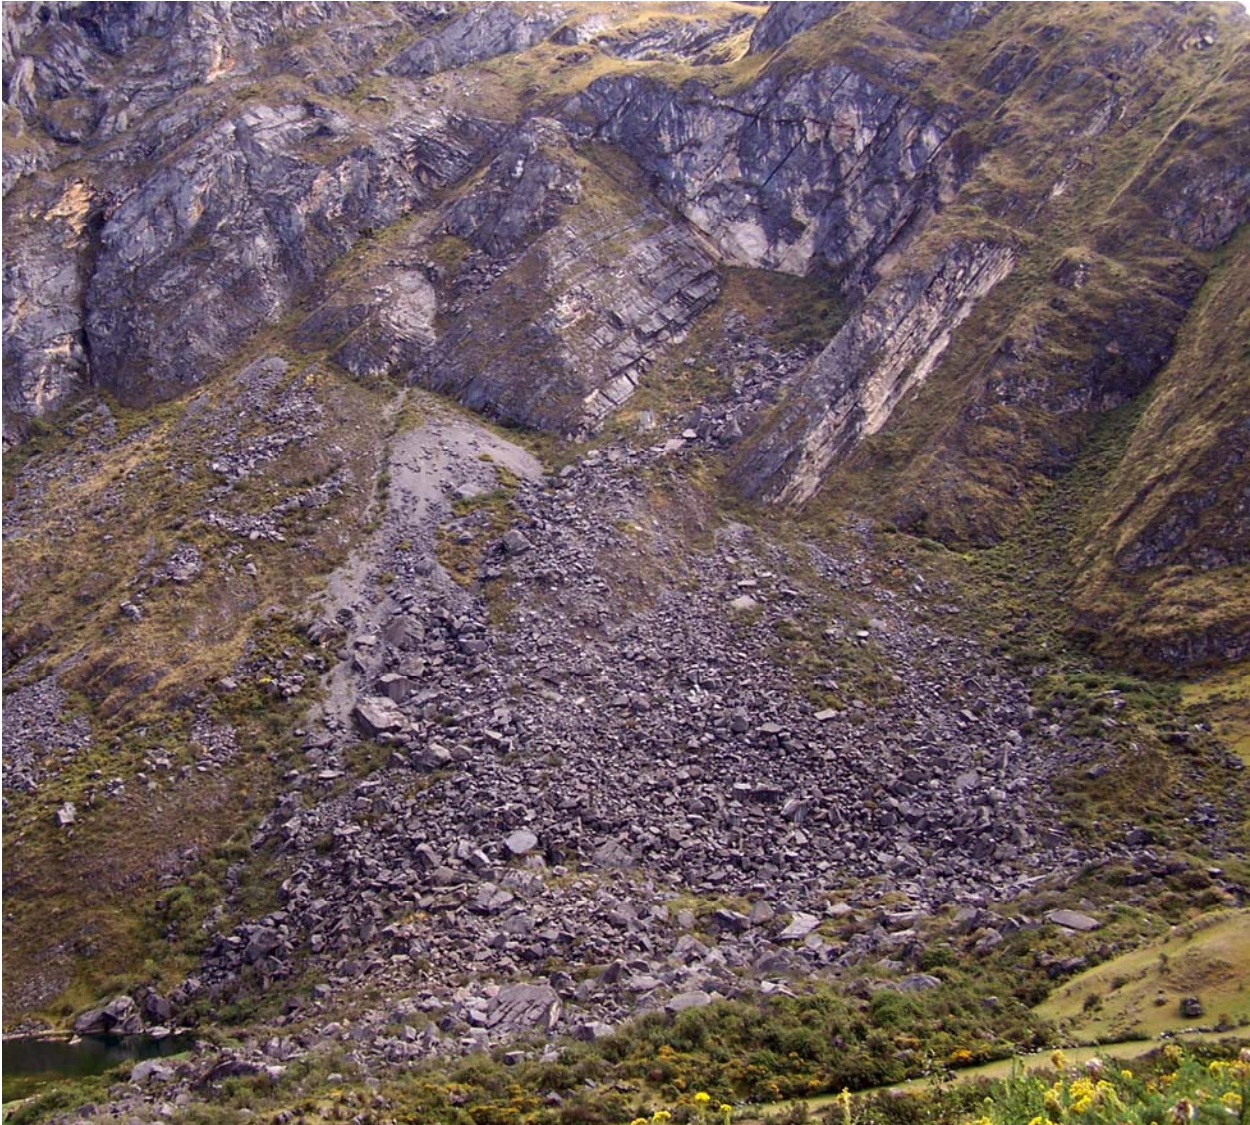
Figure 2. 38: The Trucha rock avalanche, looking north

Field observations indicate that the Trucha rock avalanche is a wedge failure formed by the intersection of west dipping bedding planes and a set of east dipping joints. In addition, nearly-vertical to south dipping joints form the backscarp of the wedge failure (Figure 2. 40). An average slope angle of 38° and slope direction of $S 180^{\circ}$ was estimated in the source slope area. Striations measured in the scar (Figure 2. 41) indicated that the wedge moved along an approximate orientation of 203° to 224° . The debris was directed out of the slope by the line of intersection and continued downslope into the valley bottom where it followed the valley downstream to the west (Figure 2. 39).

Initial wedge failure formed by two intersecting discontinuities and prominent nearly-vertical backscarp. View is to the north and bedding is dipping to the west.

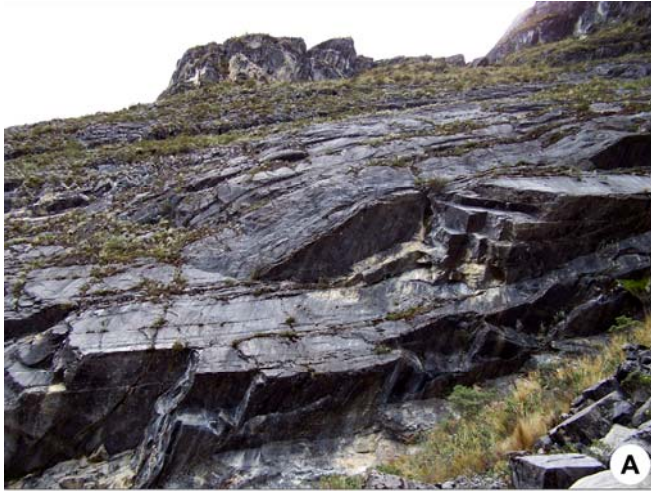
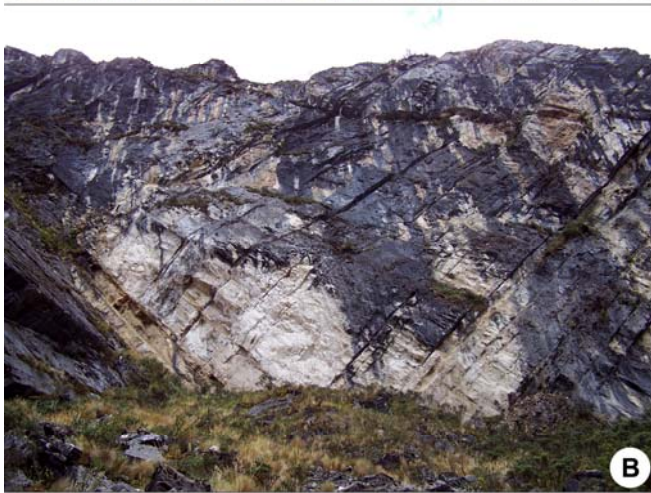
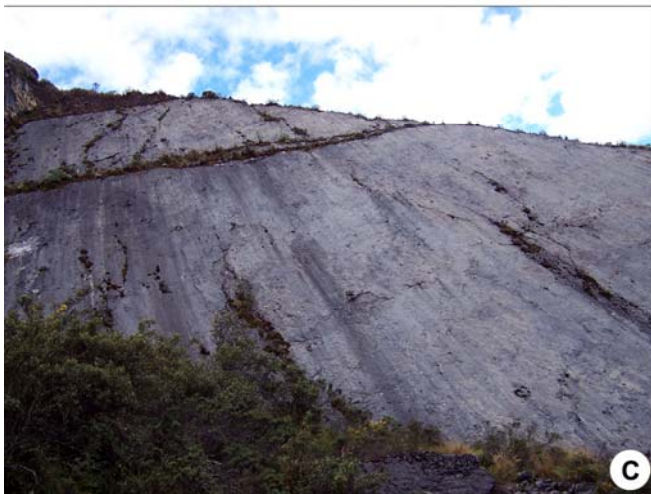
Figure 2. 40: Field observations at the Trucha rock avalanche

Wedge formed by A - east dipping discontinuities and C - west dipping bedding plane. B - Prominent nearly-vertical discontinuity forms backscarp.

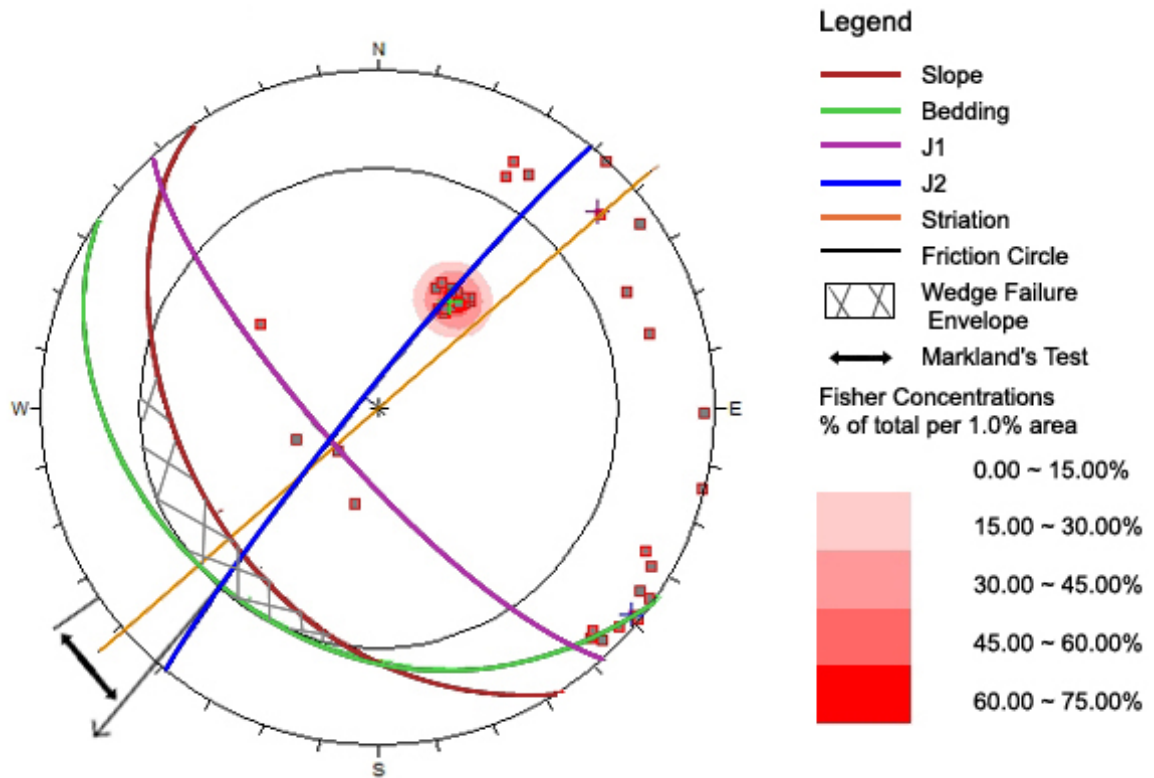
Figure 3. 10: Undisturbed rock fabric at the Camino Peligroso rock avalanche site – wedge failure

Poles and contours of 52 discontinuities are plotted on a lower hemisphere of equal area stereographic projection. Discontinuity sets are bedding, J1 and J2. Slope, striation and friction circle are indicated. Conventional wedge failure envelope is shown in hatched area. The direction of wedge failure is indicated by the arrow pointing to the southwest.

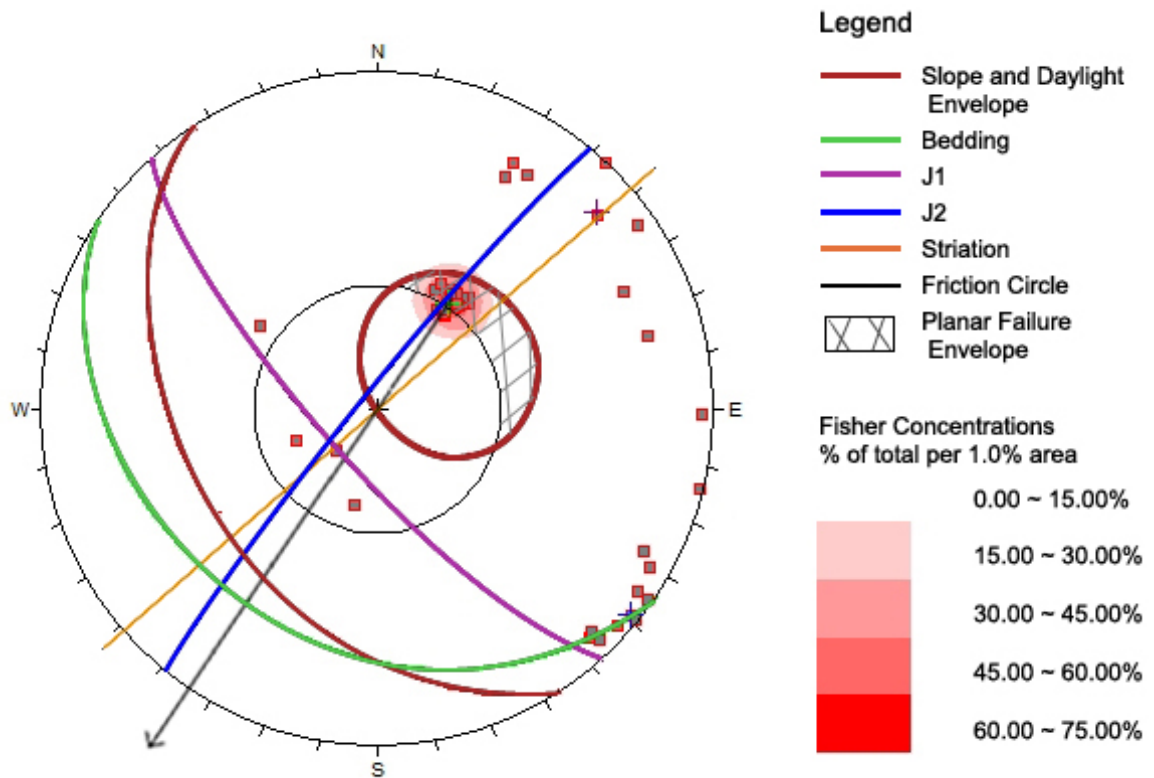
Figure 3. 11: Undisturbed rock fabric at Camino Peligroso rock avalanche site – planar failure

Poles and contours of 52 discontinuities are plotted on a lower hemisphere of equal area stereographic projection. Discontinuity sets are bedding, J1 and J2. Slope, daylight envelope, striation and friction circle are indicated. Planar failure envelope is shown in hatched area. The direction of potential planar failure is indicated by the arrow pointing to the southwest and corresponds to the direction of true dip of the bedding. Note that the strike of J2 is more or less parallel to the true dip direction. Also note the orientation of the striation on the sliding surface indicates a trend to the west of the true dip direction indicating the influence of J2 in “guiding” the failure.

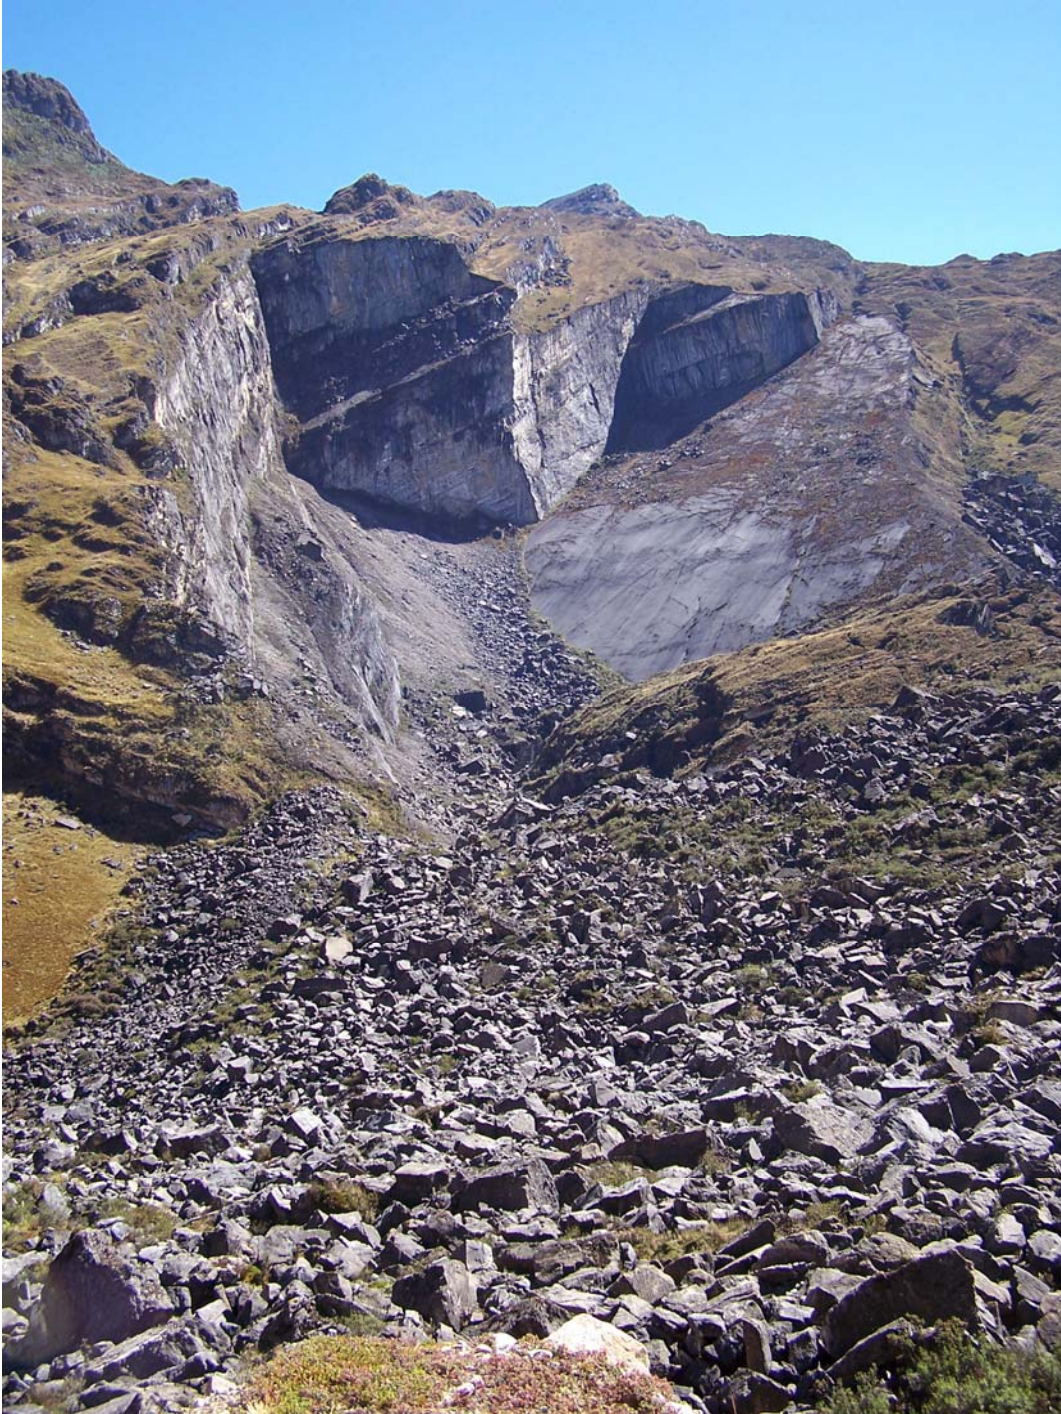
Figure 3. 12: View of the source of the Suytucocha rock avalanche, looking north

Wedge is formed by southwest dipping bedding (at right) and nearly-vertical east dipping joint set J1 (at left). The backscarp is formed by northwest dipping joint set J2.

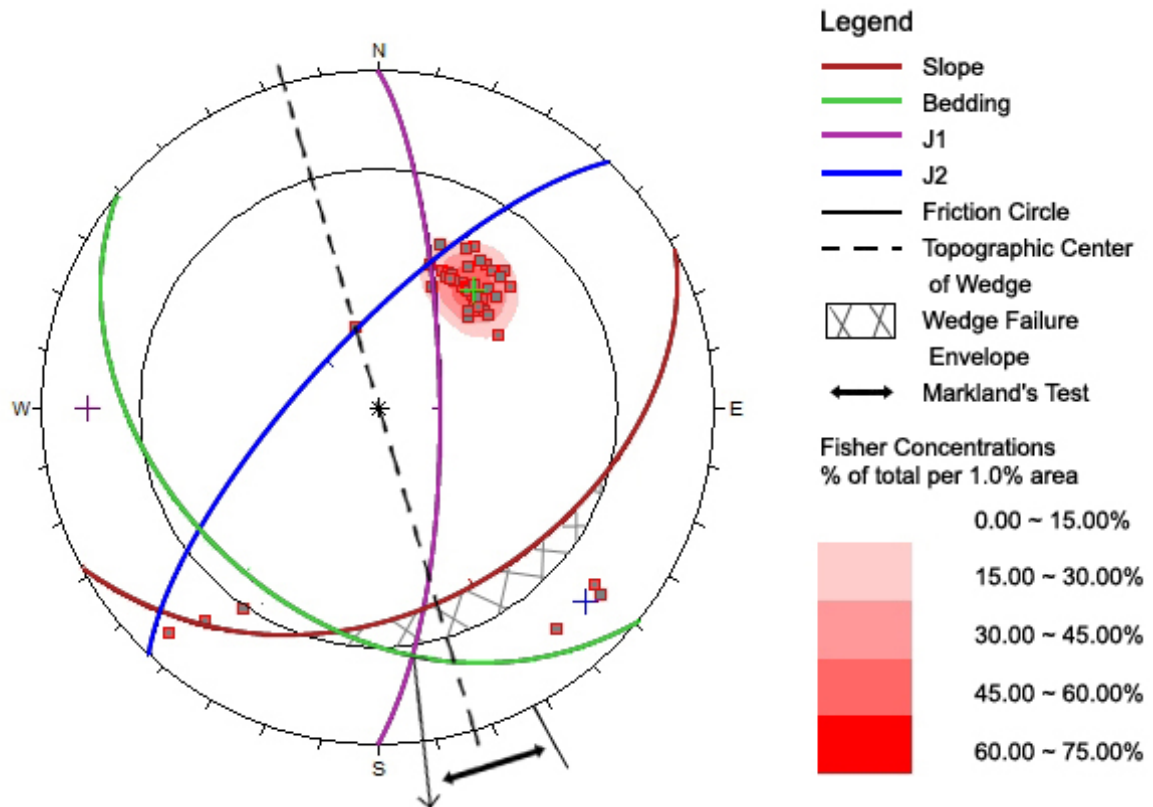
Figure 3. 16: Undisturbed rock fabric at Suytucocha rock avalanche site – wedge failure

Poles and contours of 47 discontinuities are plotted on a lower hemisphere of equal area stereographic projection. Discontinuity sets are bedding, J1 and J2. Slope, friction circle and topographic center of wedge are indicated. Conventional wedge failure envelope is shown in hatched area. The direction of wedge failure is indicated by the arrow pointing to the south.

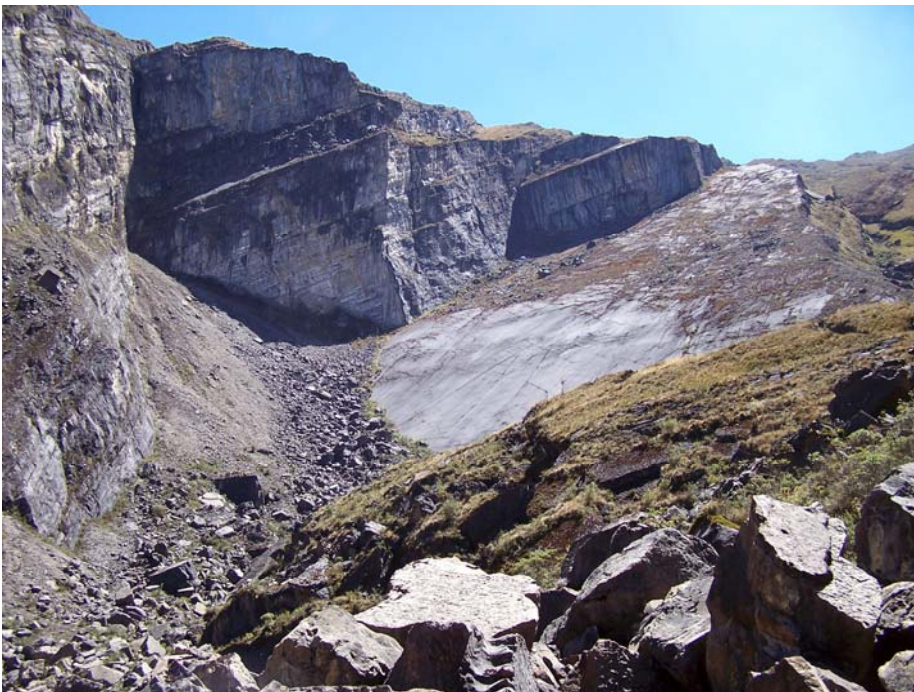
Figure 3. 20: View of bedding plane, J1 and J2 at Suytucocha rock avalanche, looking north
