**Landslides triggered by the 1946
Ancash Earthquake (Peru) and geologic
controls on the mechanisms of initial
rock slope failure**

A thesis
presented to the University of Waterloo
in fulfillment of the
thesis requirement for the degree of
Master of Science
in
Earth Sciences

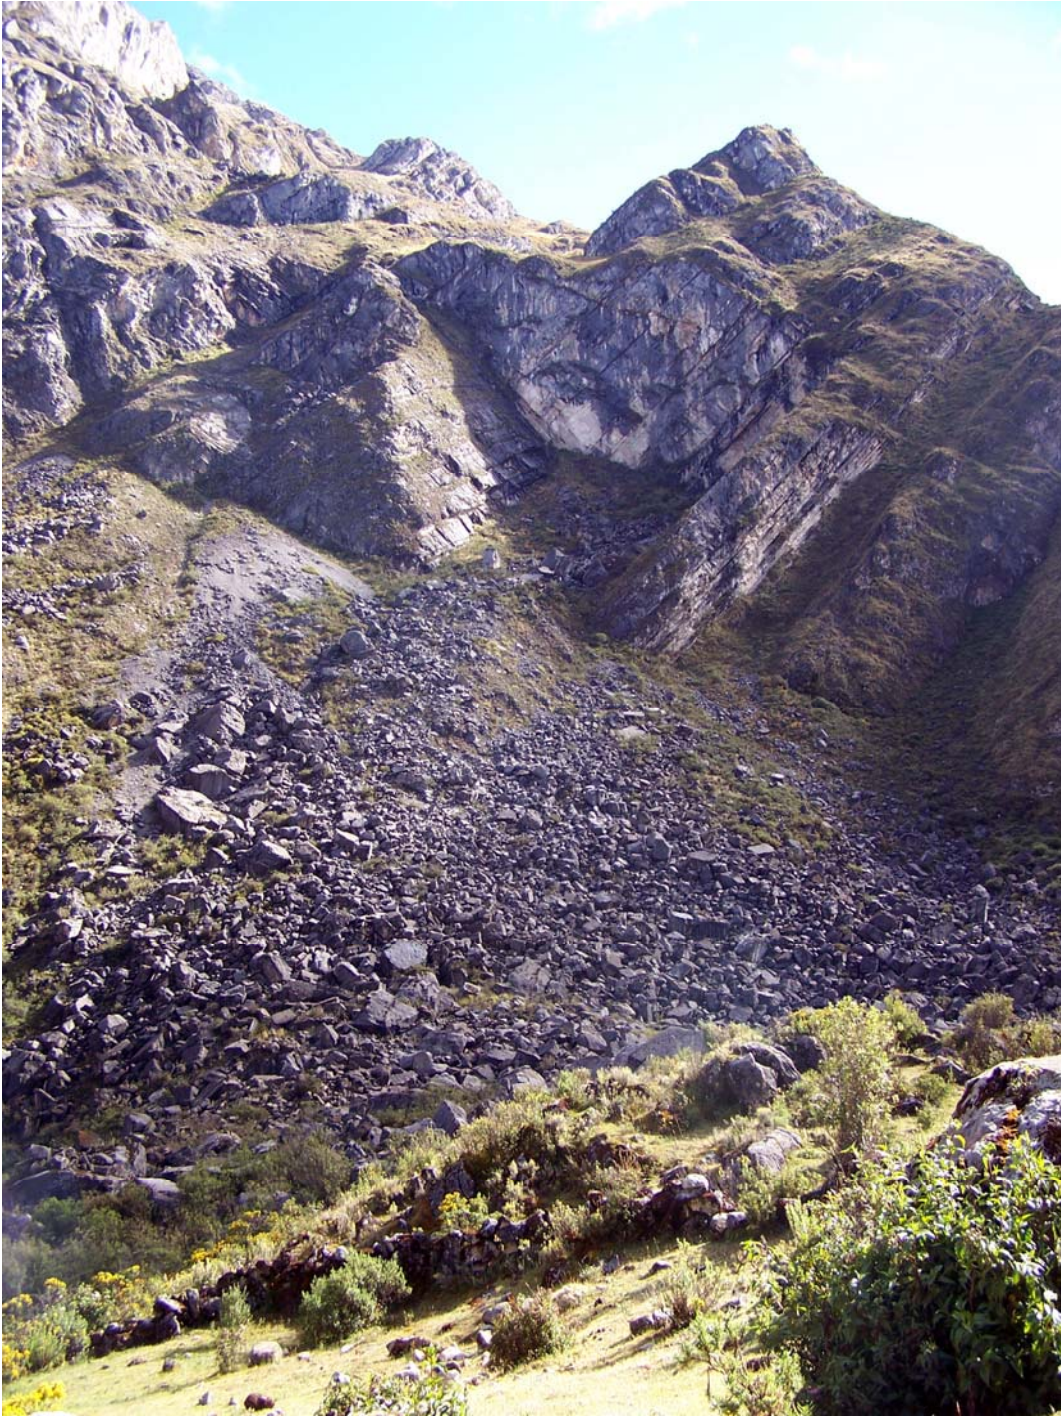
Figure 3. 21: View of Trucha rock avalanche, looking north

Wedge is formed by west dipping bedding plane and east dipping joint set J1. The backscarp is formed by nearly-vertical south dipping joint set J2.

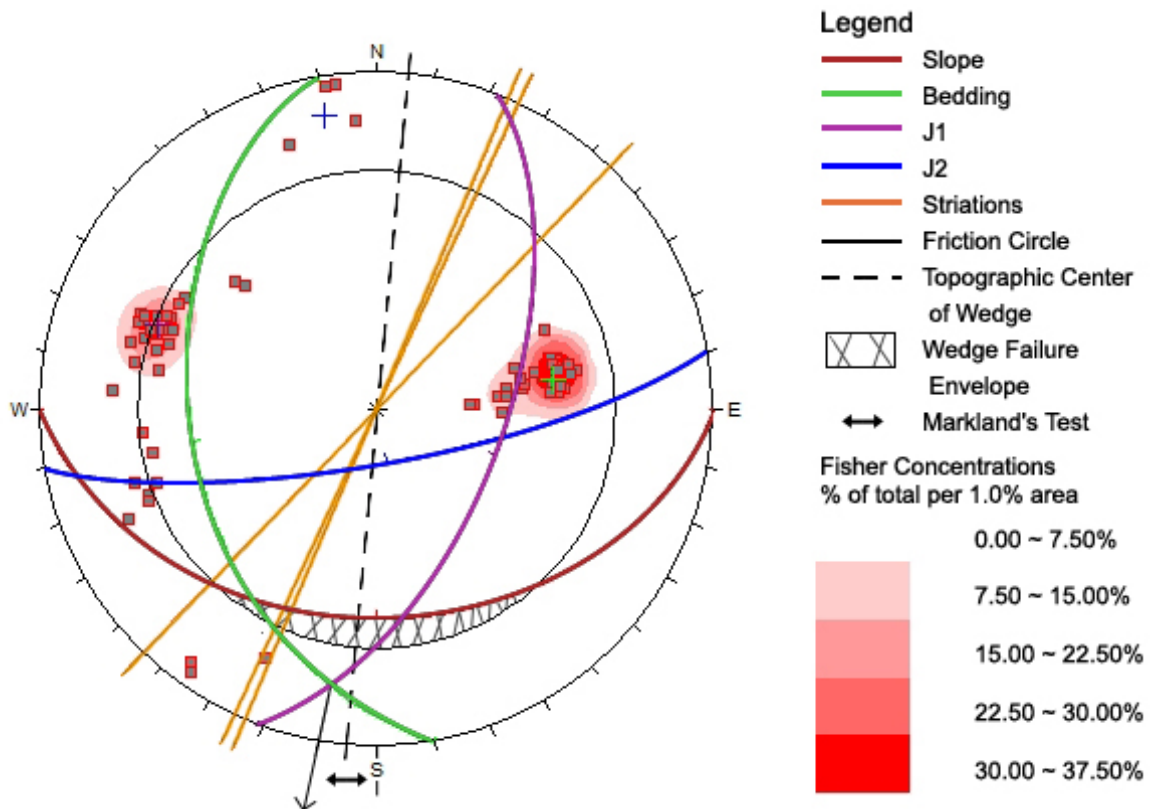
Figure 3. 25: Undisturbed rock fabric at the Trucha rock avalanche site – wedge failure

Poles and contours of 82 discontinuities are plotted on a lower hemisphere of equal area stereographic projection. Discontinuity sets are bedding, J1 and J2. Slope, striations, friction circle and topographic center of wedge are indicated. Conventional wedge failure envelope is shown in hatched area. The direction of wedge failure is indicated by the arrow pointing to the south.

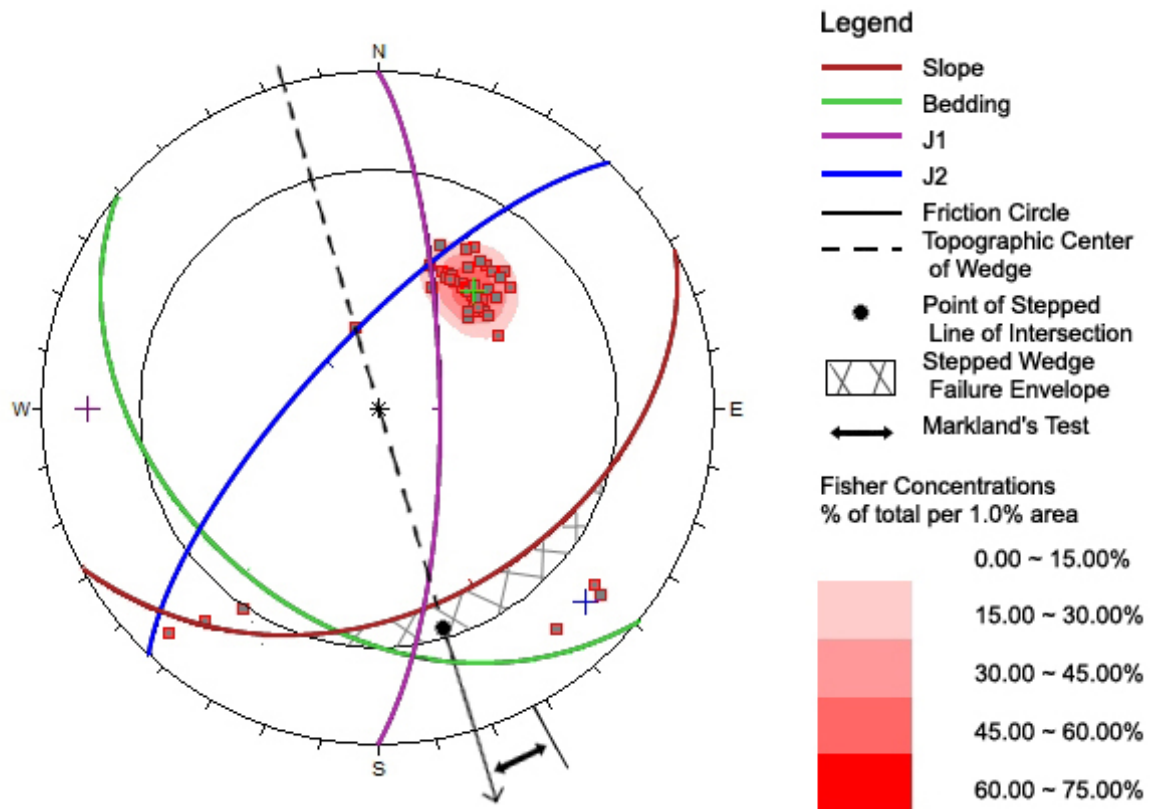
In order for stepped wedge failure to occur at the Suytucocha rock avalanche site, three criteria for stepped wedge failure must be met. Suytucocha satisfies the stepped wedge shape criteria, since bedding B and joint set J1 intersect. The trend (α_{si}) and plunge (ψ_{si}) of the stepped line of intersection of bedding B and joint set J1 can be determined by estimating the trend and plunge of the topographic center of the wedge indicated by the point of the stepped line of intersection. The point of the stepped line intersection indicates a trend of 163° and a plunge of 39° (Figure 3. 33).

Based on the criteria outlined for stepped wedge failure, the analysis suggests that the Suytucocha rock avalanche occurred due to stepped wedge failure (Figure 3. 33). The point assumed to represent the plunge and trend of the stepped line of intersection (the plunge and trend of the topographic centre of the wedge) lies within the stepped wedge failure envelope. Thus the stepped wedge kinematic criteria is satisfied. The stereonet (Figure 3. 33) also shows J2 striking roughly parallel to the slope, dipping nearly-vertical, which aids in release of the wedge block. As a result, stepped wedge failure is indicated at Suytucocha with the intersection of the bedding (B) and joint set 1 (J1), with a moderately steep stepped line of intersection dipping in a south direction out of the slope.

Figure 3. 33: Undisturbed rock fabric at Suytucocha rock avalanche site – stepped wedge failure

Poles and contours of 47 discontinuities are plotted on a lower hemisphere of equal area stereographic projection. Discontinuity sets are bedding, J1 and J2. Slope, friction circle and topographic center of wedge are indicated. Stepped wedge failure envelope is shown in hatched area. The point of stepped line of intersection represents the plunge and trend of the stepped line of intersection and corresponds to the plunge and trend of the topographic centre of the wedge. The direction of wedge failure is indicated by the arrow pointing to the southeast.

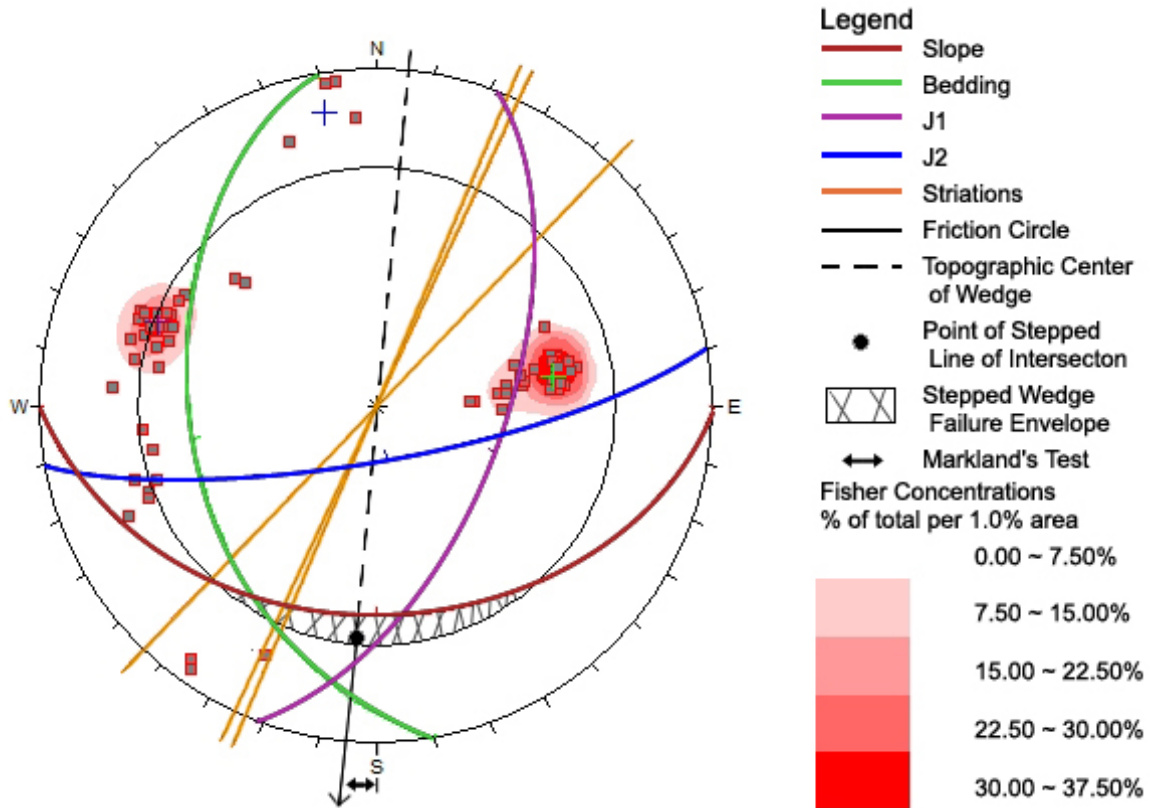
In order for stepped wedge failure to occur at the Trucha rock avalanche site, three criteria for stepped wedge failure must be met. The Trucha rock avalanche satisfies the stepped wedge shape criteria, since bedding B and joint set J1 intersect. The trend (α_{si}) and plunge (ψ_{si}) of the stepped line of intersection of B and J1 can be determined by estimating the plunge and trend of the topographic center of the wedge indicated by the point representing the orientation of the stepped line of intersection. The point of the stepped line of intersection indicates a trend of 185° and a plunge of 32° (Figure 3. 34).

Based on the criteria outlined for stepped wedge failure, the analysis indicates that the Trucha rock avalanche occurred due to wedge failure along a stepped line of intersection (Figure 3. 34). The point assumed to be the plunge and trend of the stepped line of intersection lies within the stepped wedge failure envelope. Thus the stepped wedge kinematic criteria is satisfied. The stereonet (Figure 3. 34) also shows J2 striking roughly parallel to the slope, dipping nearly-vertical, which aids in release of the wedge block. As a result, stepped wedge failure at the Trucha rock avalanche resulted from the intersection of the bedding (B) and joint set 1 (J1), with a moderately steep stepped line of intersection dipping in a south direction out of the slope.

Figure 3. 34: Undisturbed rock fabric at Trucha rock avalanche site – stepped wedge failure

Poles and contours of 82 discontinuities are plotted on a lower hemisphere of equal area stereographic projection. Discontinuity sets are bedding, J1 and J2. Slope, striations, friction circle and topographic center of wedge are indicated. Stepped wedge failure envelope is shown in hatched area. The point of stepped line of intersection represents the plunge and trend of the stepped line of intersection and corresponds to the plunge and trend of the topographic centre of the wedge. The direction of wedge failure is indicated by the arrow pointing to the south.

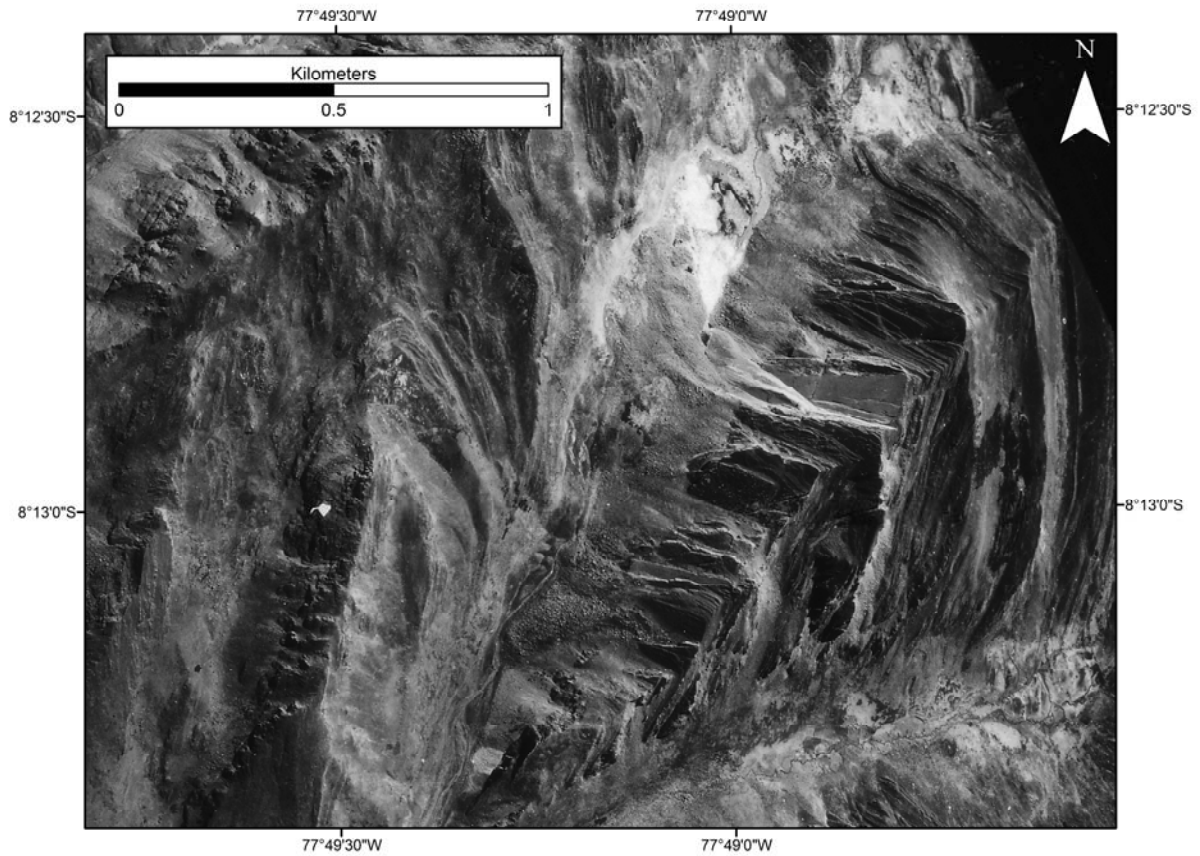
- 2) Stepped wedge failures occur along valleys which are transverse to the dominant northwest-southeast structural features in the epicentral region along the continental divide. In addition to the Suytucocha and Trucha rock avalanches, a series of wedge failures were observed within this region at the Blanca rock avalanches (Figure 3. 35).

Figure 3. 35: Aerial photograph (1370PMW-MWM173-22474) Blanca rock avalanches

A series of wedge failures along a transverse valley trending northeast-southwest forming the Blanca rock avalanches (Blanca 1, 2, 3, and 4, in Table 2. 3). Wedges have moved to the northwest and are formed by southwest dipping bedding planes (the planar surfaces visible in the image) and steep northeast dipping joints (corresponding to J1 in Figure 3. 5).
